Arhitektura i arhitektonska plastika burga Vrbovca kraj Huma na Sutli

Architecture and Architectural Stonework of the Mediaeval Castle of Vrbovec near Hum na Sutli

Izvorni znanstveni rad
Srednjovjekovna arheologija

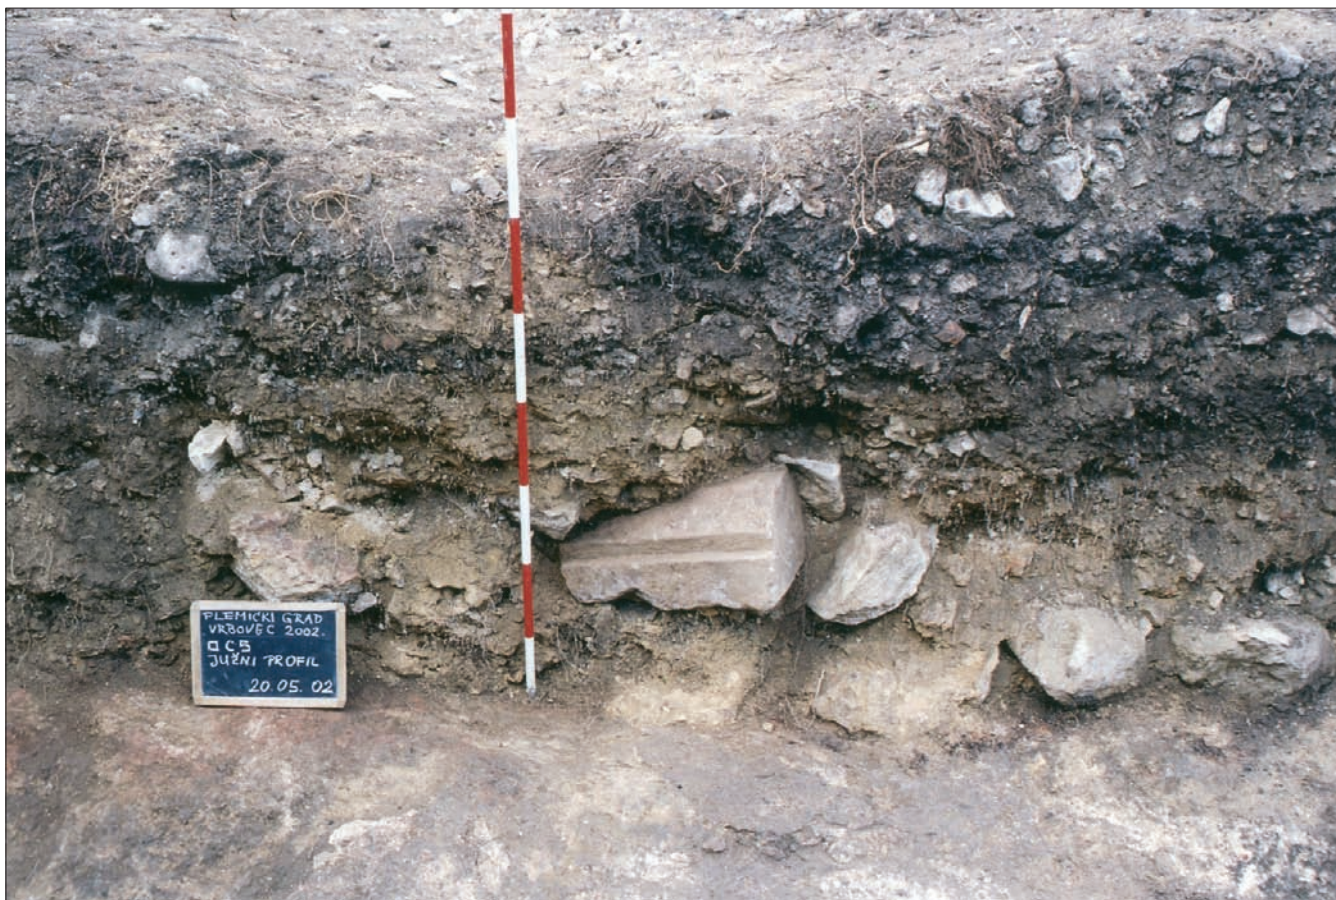
Sl. 8 Burg Vrbovec, položaj ulomka prozora srednje veličine PN 183 *in situ* u sloju ruševine SJ 003 (foto: T. Tkalčec)

Fig. 8 The castle of Vrbovec, the position of a fragment of a medium-sized window SF 183 *in situ* in the debris layer SU 003 (photo: T. Tkalčec)

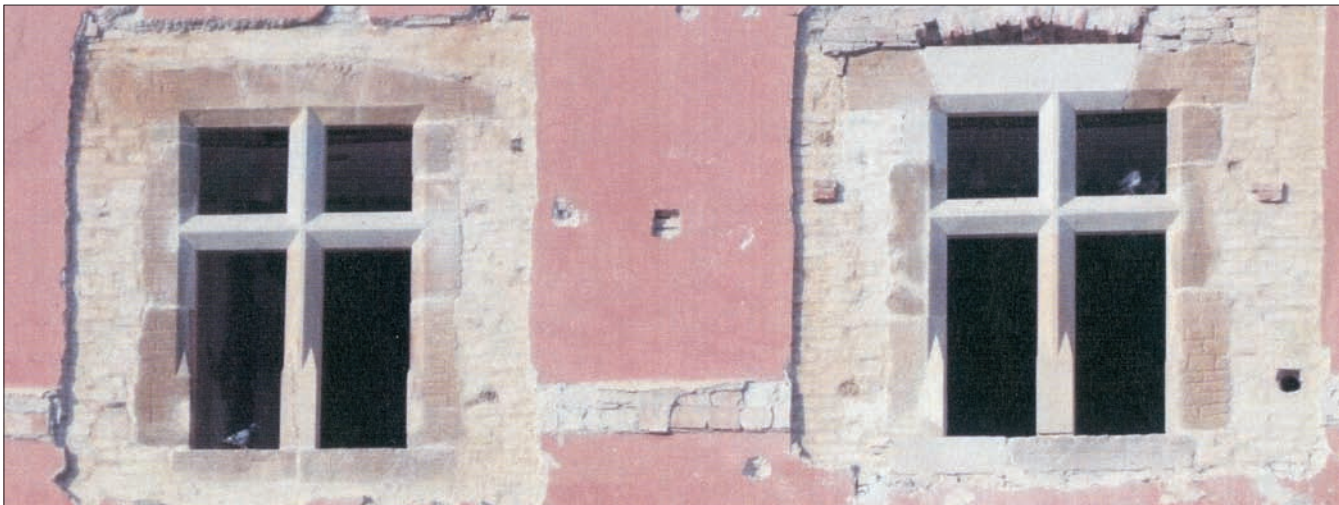
Sl. 12 Ilok – palača Odescalchi, nekadašnji palas knezova Iločkih, južno pročelje II. kata (foto: Đ. Šimičić)

Fig. 12 Ilok – Odescalchi palace, former palace of the Dukes of Ilok, southern façade of the 2nd floor (photo: Đ. Šimičić)

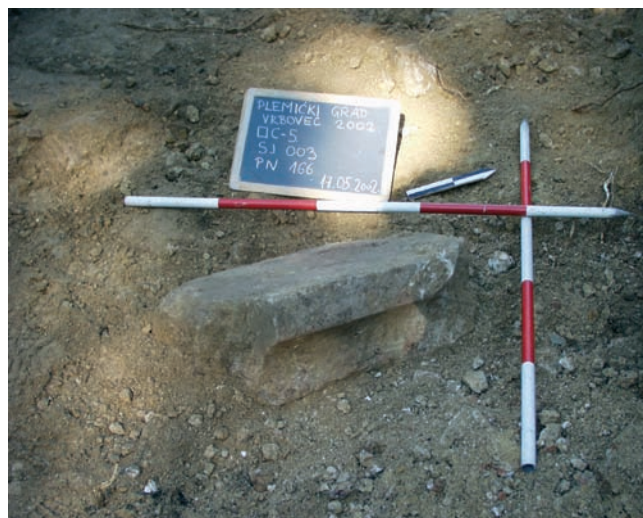
Sl. 14 Burg Vrbovec, ulomak vanjske prozorske klupčice PN 166 *in situ* (foto: T. Tkalčec)

Fig. 14 Vrbovec castle, a fragment of an exterior stone bench SF 166 *in situ* (photo: T. Tkalčec)

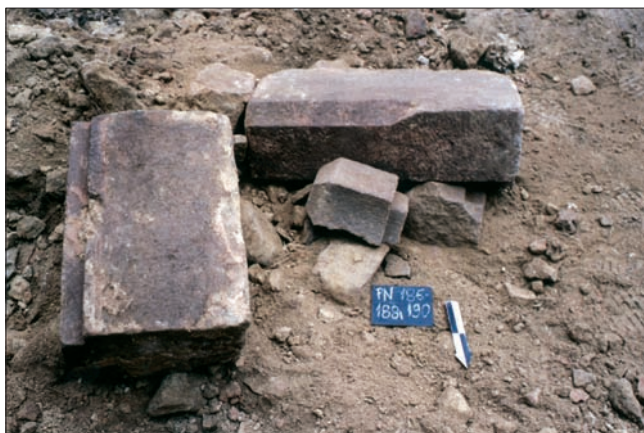
Sl. 16 Burg Vrbovec, dijelovi okvira vrata – lijevo PN 190, u sredini PN 187, gore PN 186 (foto: T. Tkalčec)

Fig. 16 Vrbovec castle, fragments of a door frame – left SF 190, centre SF 187, above SF 186 (photo: T. Tkalčec)

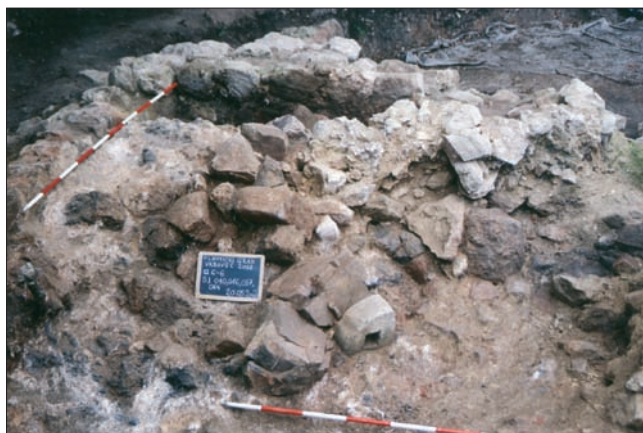
Sl. 17 Burg Vrbovec, pronalazak spolije PN 181 i neposredno do nje "češkog prozora" PN 182 (foto: T. Tkalčec)

Fig. 17 Vrbovec castle, a find of spolia SF 181 and adjacent to it a "Bohemian window" SF 182 (photo: T. Tkalčec)

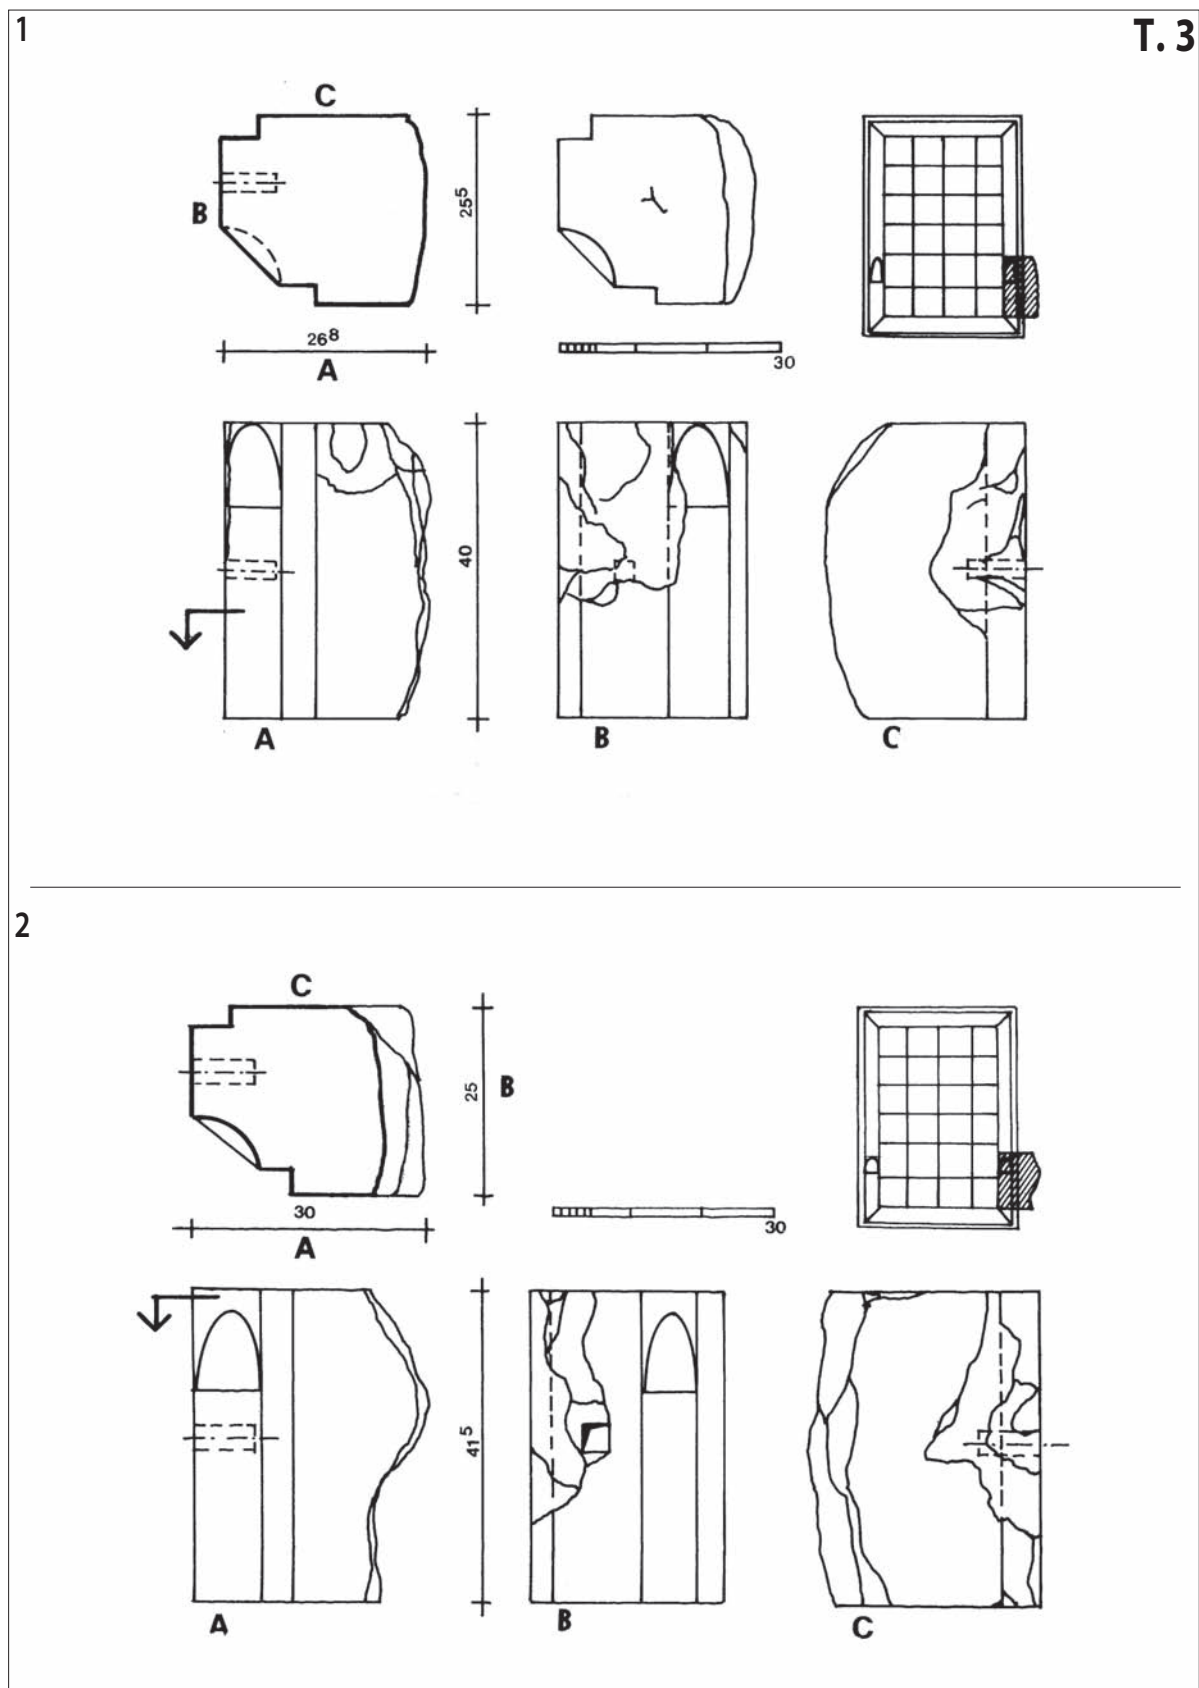
T. 3 Prozori srednje veličine – 1: PN 273; 2: PN 259 (crtež: Z. Horvat)
 Pl. 3 Medium-sized windows – 1: SF 273; 2: SF 259 (drawing: Z. Horvat)
