Arhitektura i arhitektonska plastika burga Vrbovca kraj Huma na Sutli

Architecture and Architectural Stonework of the Mediaeval Castle of Vrbovec near Hum na Sutli

*Original scientific paper
Medieval archaeology*

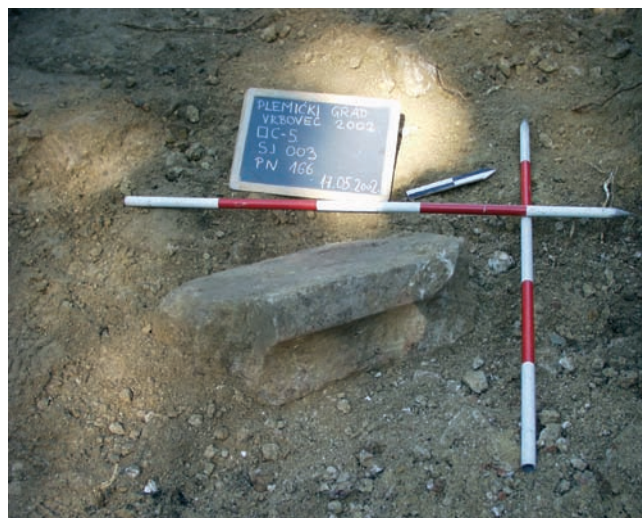
Sl. 14 Burg Vrbovec, ulomak vanjske prozorske klupčice PN 166 *in situ* (foto: T. Tkalčec)

Fig. 14 Vrbovec castle, a fragment of an exterior stone bench SF 166 *in situ* (photo: T. Tkalčec)

¹⁶The fragment of a bench could not have arrived in that place in the Modern period, because it was found in intact layer SU 003, a layer of collapse of the medieval fortified town. In the courtyard, this layer was covered with an undisturbed layer from the Modern period. This means that a contamination of that layer in the long period following the collapse of the fortified town could not have taken place.

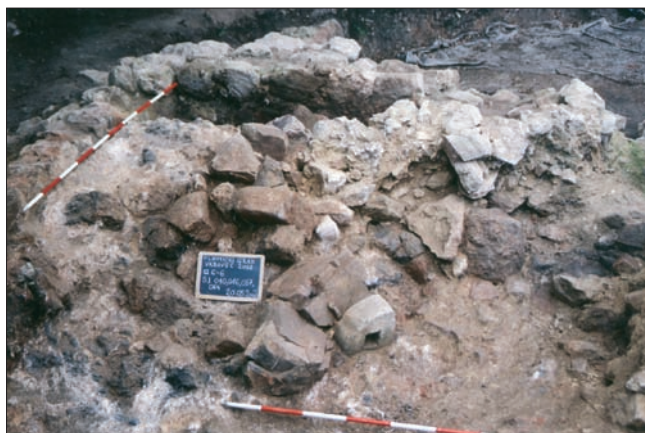
Sl. 17 Burg Vrbovec, pronalazak spolije PN 181 i neposredno do nje "češkog prozora" PN 182 (foto: T. Tkalčec)

Fig. 17 Vrbovec castle, a find of spolia SF 181 and adjacent to it a "Bohemian window" SF 182 (photo: T. Tkalčec)
