Source / Izvornik: **Materials**, 2024, 17

Article

Petrophysical Analyses of Rock Construction Materials from a Roman Rural Settlement in Podšilo Bay on Rab Island (North-East Adriatic, Croatia)

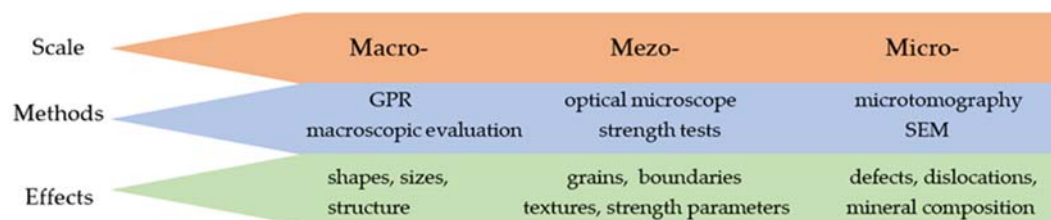
Figure 2. Scheme of methodological approach for the archaeological evaluation of construction materials.

These aims are achieved with a methodology that has not yet been applied to such structures in the region. In addition to the characterization of the stone materials used in the structures on Rab Island, the paper presents a previously unpublished research approach that uses imaging representative of full-scale magnifications (Figure 2).

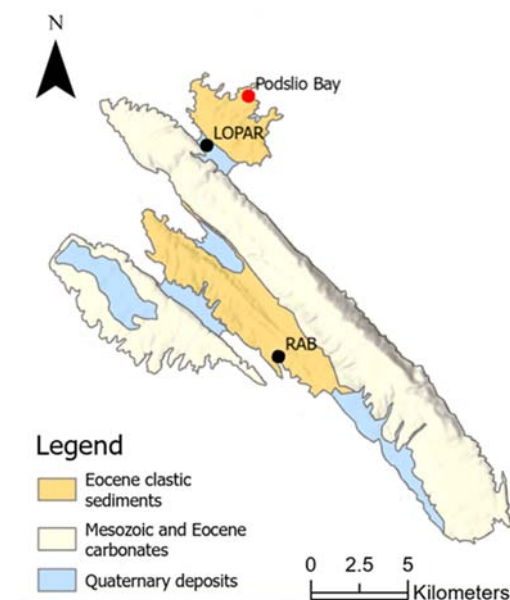
Figure 3. Geology of Rab Island (after [26], modified).

The geological setting of Rab Island consists of two synclines and two anticlines (Figure 3). The oldest rocks exposed on the island are Upper Cretaceous (Cenomanian—Turonian) grey-brown, bedded limestones with intercalations of dolomitic limestone, and white and yellowish, generally non-stratified, crystalline limestones. Upper Cretaceous (Turonian–Maastrichtian) strata comprise light grey and white, occasionally reddish limestones [26]. Deposits of the lower and middle Eocene consist of foraminiferal limestones (E1–E2), while those of the middle and upper Eocene comprise flysch deposits: marls (E2–E3, lower flysch) and yellowish sandstones (E2–E3, upper flysch). Flysch deposits are characterised by alternations of fine and coarse-grained sediments. Moreover, Eocene sandstones are dominated by detrital grains identified as angular to subangular quartz grains; feldspars; mica; heavy minerals, e.g., zircon; rutile; tourmaline; and other lithic fragments, e.g., pelitic, quartzite type, and quartz-feldspar aggregates. The carbonate content of the samples is 35% and 48%, and it is concentrated primarily in the matrix [27].

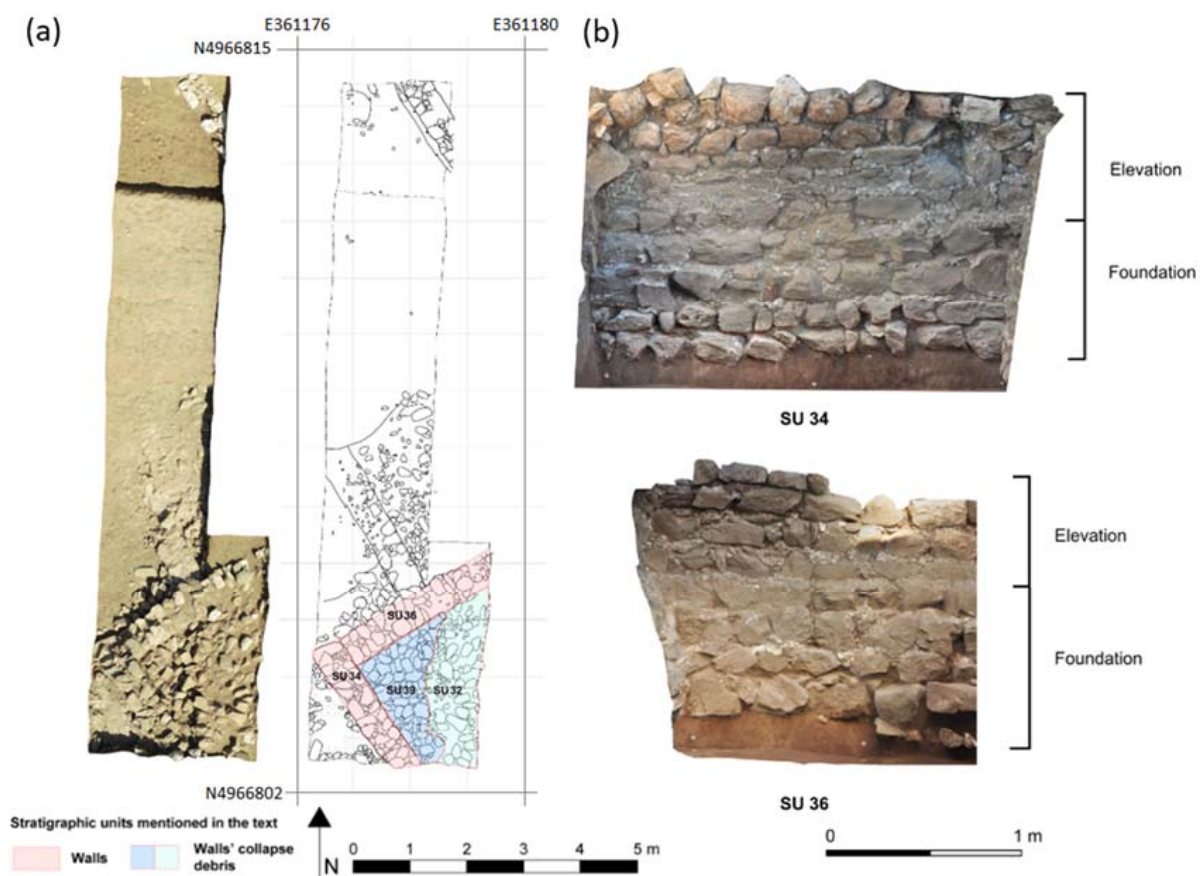
Figure 4. Excavation of the Roman structures at Beli grad. (a) Photograph and map of the trench with marked archaeological layers (drawing by K. Rabięga, modified), (b) cleared part of the preserved internal walls SU 34 and SU 36.

The material for petrophysical and endurance research was collected during excavation in Trench 2 in the Beli grad area of Podšilo Bay (Figure 4a,b). The trench was aimed to explore parts of the eastern wing of a building of probable residential use. Part of the stratigraphy in the southern part of Trench 2 comprised a thick layer of rubble collapsed from the adjacent walls—SU 34, 36. The foundation of these walls was mostly constructed with irregular, medium-sized blocks of sandstone and limestone, bound with lime mortar only in their upper part. The wall structure consists of two leaves built of roughly worked sandstone and limestone blocks, joined by lime mortar so that they form regular rows of various heights. The wall core consists of smaller stones bound together with mortar. Walls SU 34 and SU 36 were probably the internal walls of the building (Figure 4b).

Stone samples were collected from SU 32, SU 36, and SU 39 (Figure 4a). SU 32 constitutes the upper part of the destruction debris mixed with soil, SU 36 is the wall extending from NE to SW in the trench from which a loose stone was extracted, while SU 39 is another layer of collapsed stones that lies below SU 32, roughly mixed with soil.

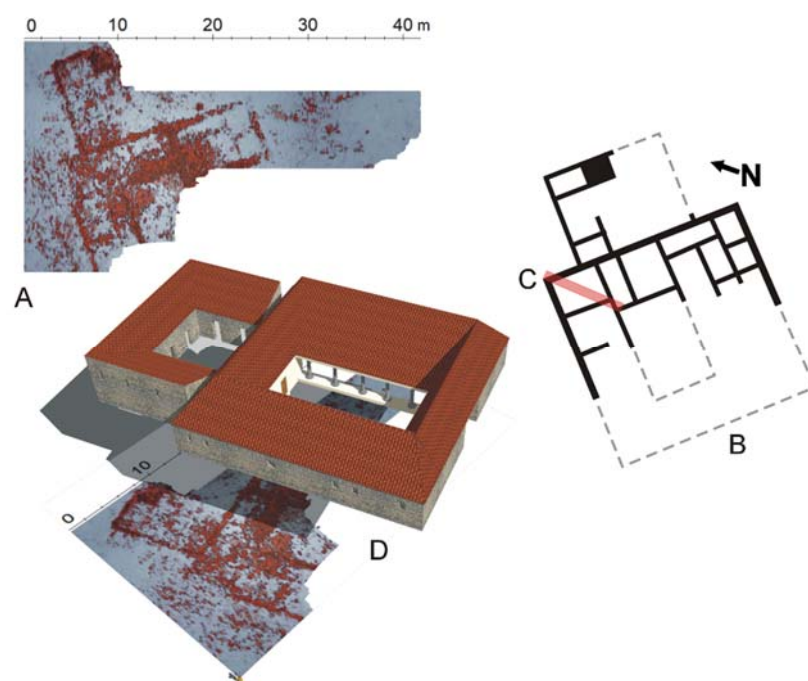
Figure 5. (A) Ground-penetrating radar prospecting results showing the remains of a villa at the depth of approximately 0.40 m. Notable is the central courtyard—atrium. (B) A tentative reconstruction of the villa plan on the basis of geophysical surveys and excavations. (C) Location of the archaeological excavation; see text for a detailed discussion. (D) A tentative reconstruction of the villa appearance. (Elaboration of GPR results and drawings: F. Welc).

Following the discovery of a Roman pottery kiln on the shore of the bay, conducted geophysical surveys have identified the location of the settlement's complex structure. Based on the excavations, two structures were identified: a smaller, possibly auxiliary building on the southern slope and a larger complex on the northern slope, interpreted as the settlement's central building (villa). As shown by GPR measurements (GPR), the structure of these buildings is located around an enclosed space [9], perhaps a courtyard, with wings divided into multiple rooms of a yet undetermined function. The surveys have provided the basis for inferring the size of the buildings on the plan (Figure 5), but, unfortunately, when applied to the buildings in their current state, they did not provide answers to either their size or the number of storeys. Most of the Roman archaeological sites in Croatia from the discussed period, including buildings, whether residential or productive structures, are usually preserved only at the foundation level. This is the main reason why it is difficult to reconstruct their original appearance.

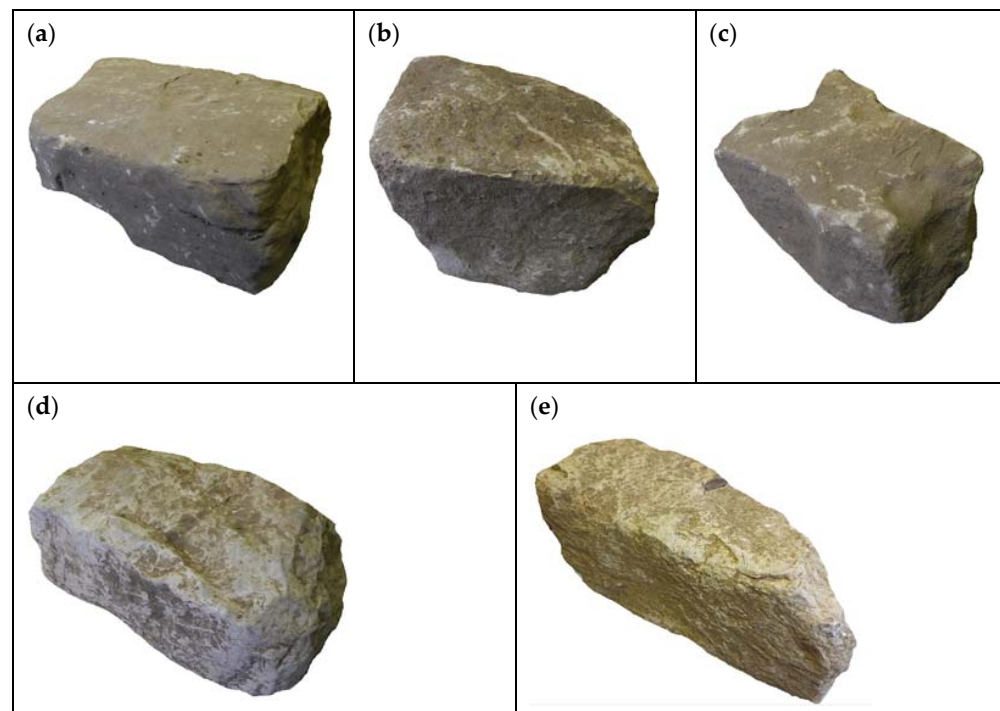
Figure 6. Stone blocks selected for further analysis. (a) Type LS_1, dark-grey fine-grained sandstone; (b) type LS_3, light-brown medium-grained sandstone; (c) type LS_6, light grey fine-grained sandstone; (d) type LL_7, dark grey mudstone; (e) type LL_10, grey sparitic limestone; LS (Lopar Sandstone), LL (Lopar Limestone).

Three lithological types of sandstones were distinguished (Figure 6). The studied stone blocks mainly had rounded edges. Macroscopically, for the fresh fracture in sample LS_1, they were dark grey with a low-intensity and short-lived reaction with 10% hydrochloric acid, in sample LS_3—light brown with an intense and long-lasting reaction with 10% hydrochloric acid, while in sample LS_6—light grey with the most intense reaction with hydrochloric acid. The reaction occurred with both the grains and the binder. Based on the grain size (Figure 6a–c), the rock types were classified as medium-grained (LS_3) and fine

Macroscopically, two lithological types of limestone were distinguished (Figure 6): dark grey LL_7 with an intense but short-lived reaction with 10% hydrochloric acid, and grey LL_10 with an intense and long-lived reaction with 10% hydrochloric acid. Figure 6 clearly shows the rounded edges of the stone blocks. Optical microscopy observations show that, according to the classification by Folk [35,36], the rock types include mudstone (LL_7) and sparitic limestone (LL_10), whose matrix is intersected with veins of coarse crystalline calcium carbonate. In both cases, numerous small bivalve and foraminifera shells were observed in thin sections (Figure 7d,e). SEM images show a grey background, which, according to the chemical analysis, is composed entirely of calcium carbonate. SEM-EDS analysis revealed average oxygen contents at 28.7 and 28.5 percent and calcium contents of

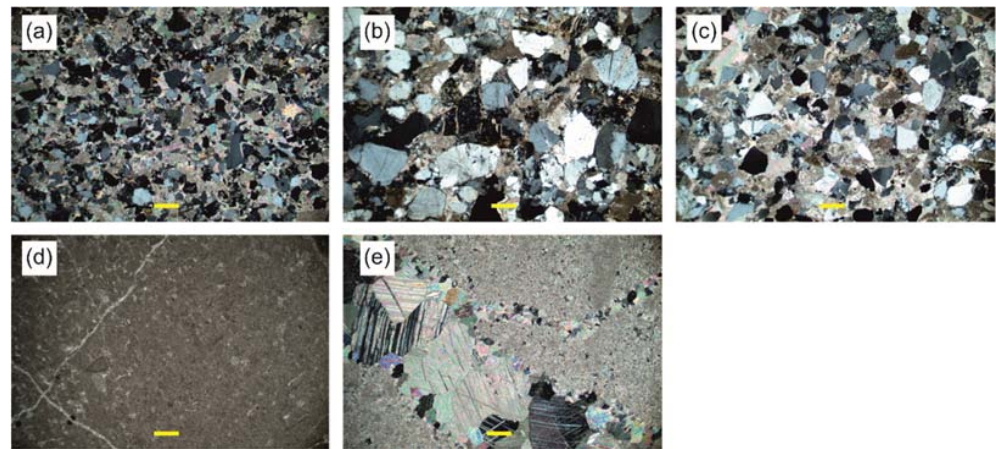
Figure 7. Thin-section photomicrographs with transmitted light optical microscope under crossed polarizers. Scale-bar is 200 μm (marked with a yellow line). (a) Type LS_1, moderately sorted, fine-grained sandstone with carbonate cement; (b) type LS_3, moderately sorted, medium-grained sandstone with carbonate cement; (c) type LS_6, well-sorted, fine- to medium-grained sandstone with carbonate cement; (d) type LL_7, mudstone with visible fine veins of recrystallized calcite and foraminifera; (e) type LL_10, fine grained limestone with veins of calcite crystals.

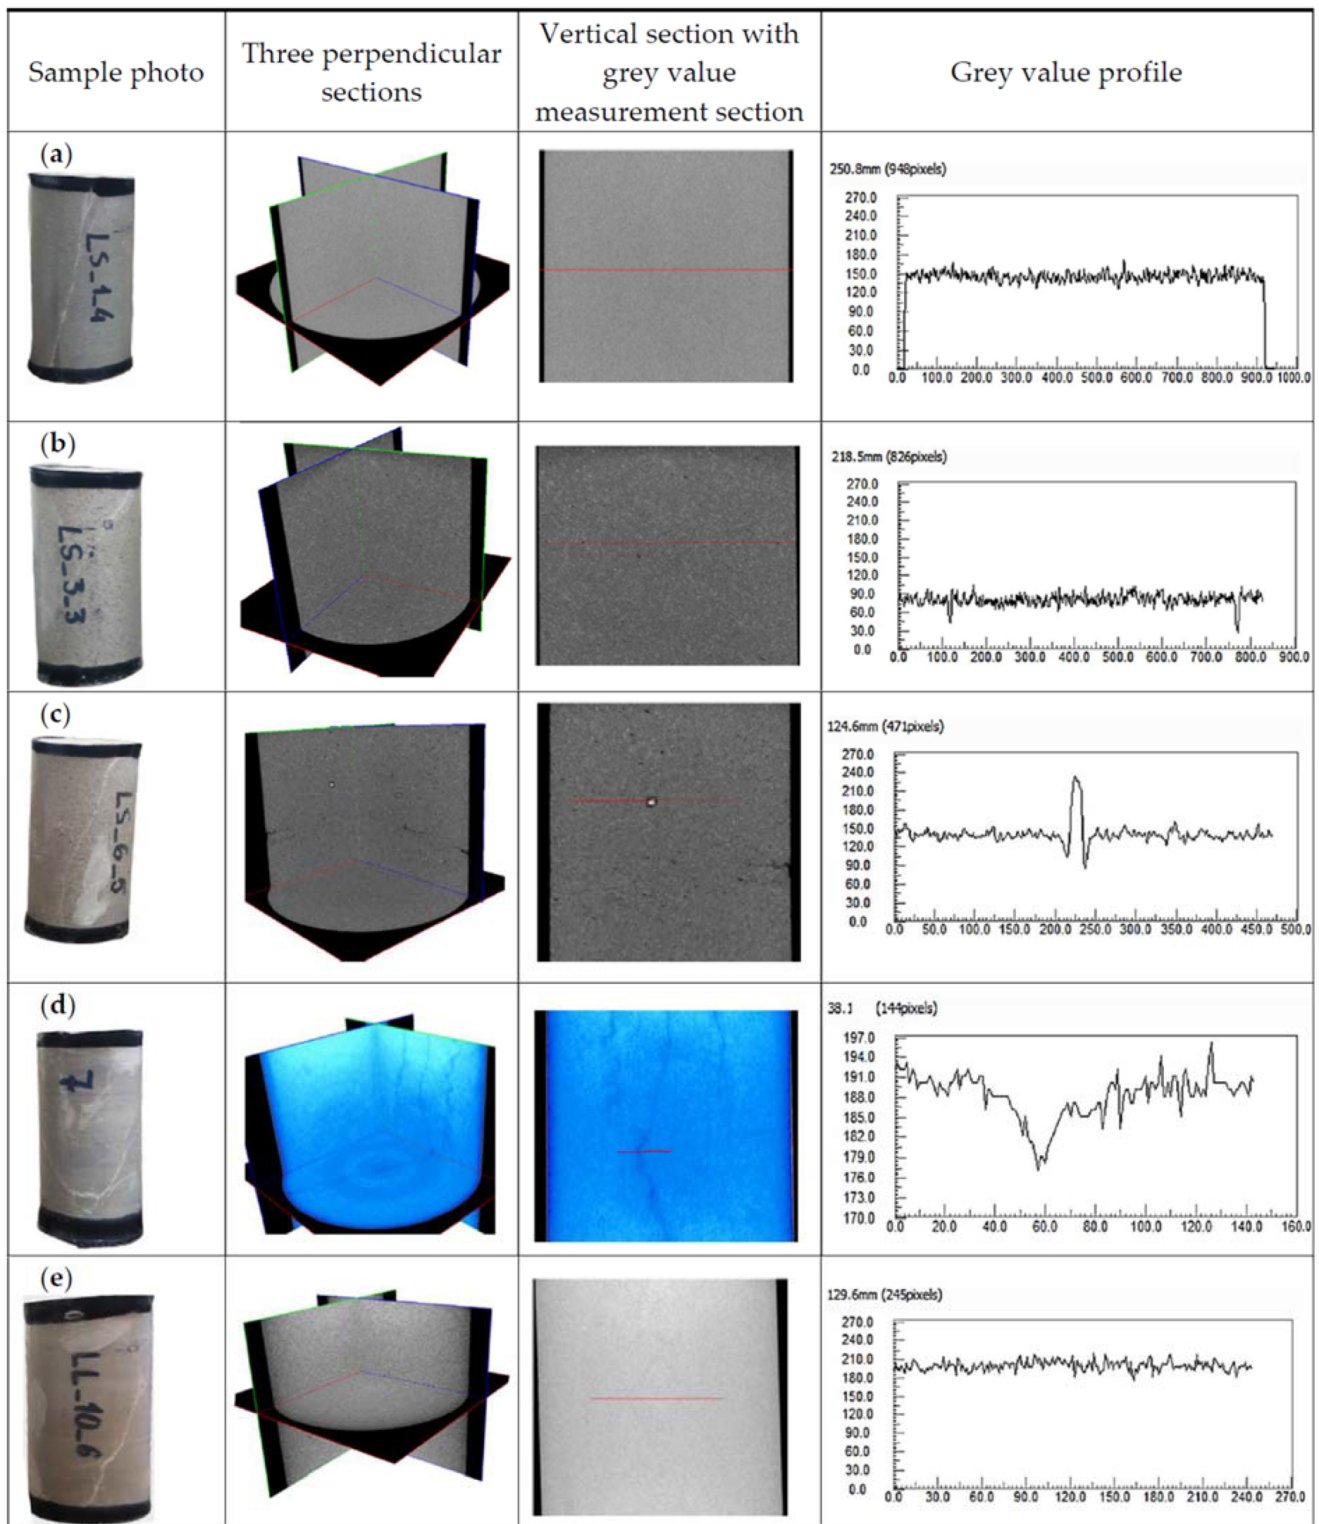
Figure 8. Microtomography images with grey value profiles for (a) type LS_1, (b) type LS_3, (c) type LS_6, (d) type LL_7, (e) type LL_10. — section line.

An image analysis of sample LS_1 showed no structural defects (Figure 8a). The entire stone was homogeneous with regard to grain size. Due to the size of individual grains being close to the imaging resolution, it was not possible to observe their details. To complement this magnification range, a SEM analysis was used, which is very suitable for such type of study (despite the small area of recognition, it provides a detailed identification of the grain characteristics)—Figure 8a. The porosity is very low, about 0.02%, and comprises pores with equivalent diameters in the range of 1.5–124.5 μm (about 97%).

The image of sample LS_3 is very similar to that of sample LS_1. The rock has a compact structure with a low porosity of about 0.08% and with a predominance of pores with an equivalent diameter of up to 0.1 mm (about 73%). The density analysis performed in the cross-section showed very high homogeneity (Figure 8b).

The XCT scan of the last sample in the sandstone group (LS_6), except for the evenly dispersed porosity, showed the presence of small voids in the sample volume, which may affect the strength. Besides voids, the presence of grains composed of very-high-density minerals was observed as white “grains” in microtomographic images (Figure 8c).

The 3D image of limestone LL_7 reflects the internal structure of the sample, where the weakness areas (depicted with a darker colour) are identified in three perpendicular sections—they most likely represent fracture/gap areas filled with secondary mineralization. These zones of weakness are characterised by quasi-parallelism, and their course is not straight. The degree of weakening of the rock’s solid fraction may correspond to the grey value profile (related to the density value) (Figure 8d).

CT images are presented with shaded grey or black colours for low CT-values and light grey or white colours for high CT-values in all subsequent shaded grey colours. The total number of levels in these colours is 256. It is well known that this CT-value is linearly related to the material density [37]. The grey value profile in Figure 8 shows the distributions of CT-values along exemplary lines in all specimens, showing the relative density variance of the analysed materials.

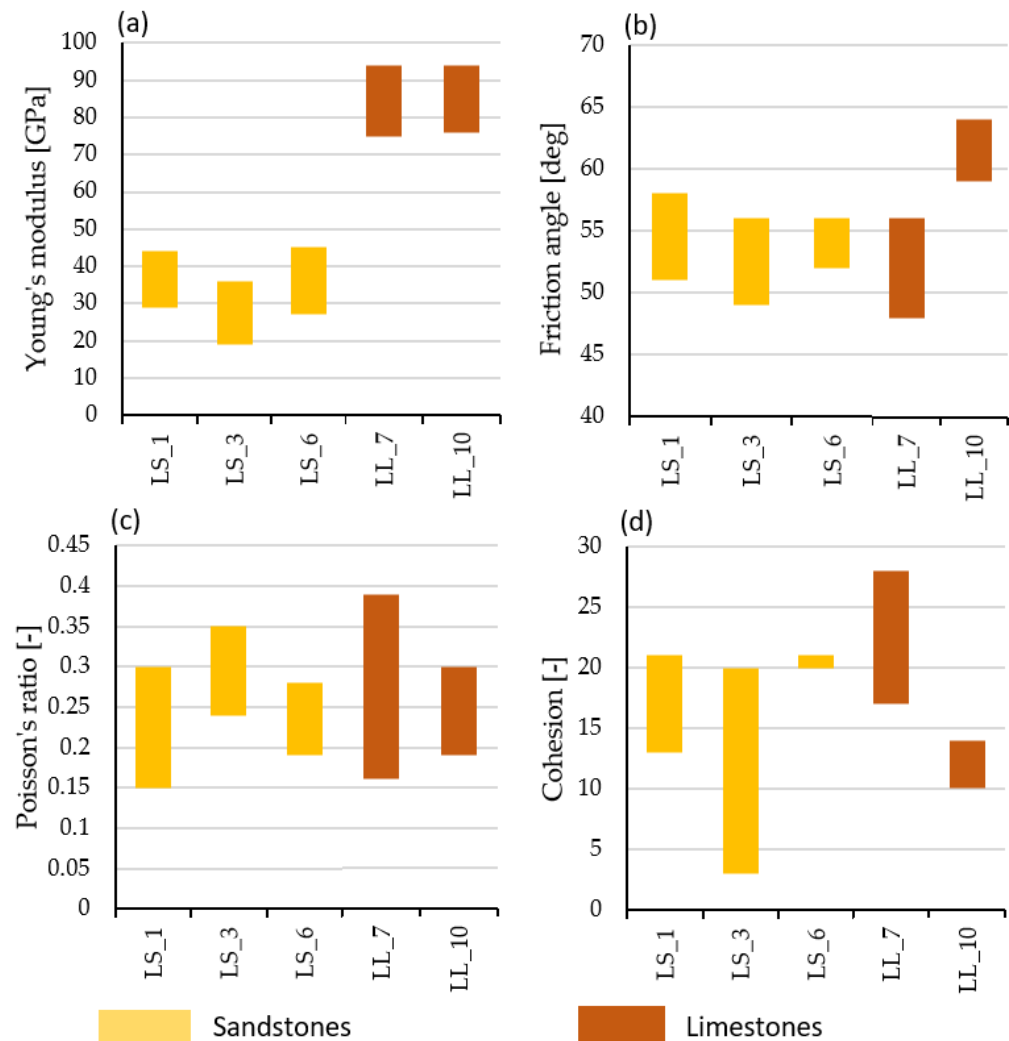
Figure 9. Triaxial multiple failure test results. (a) Young's modulus E [GPa], (b) friction angle ϕ [deg], (c) Poisson's ratio ν [-], (d) cohesion c [MPa].

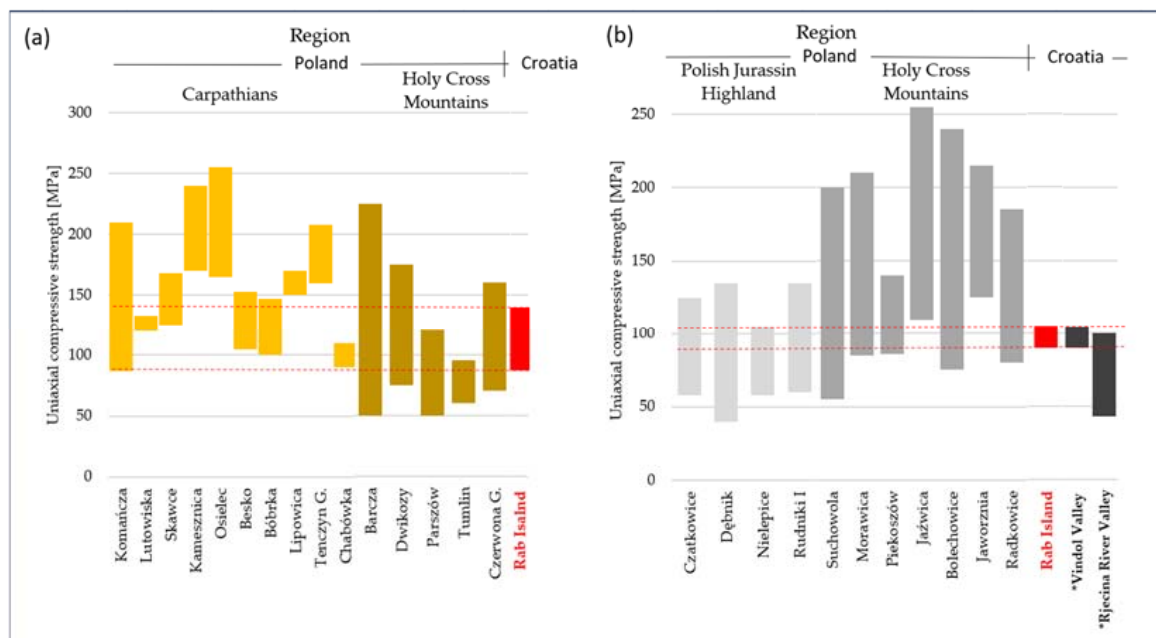
Figure 10. Uniaxial compressive strength of rock tests against the strength of rocks from the region of Poland and Croatia: (a) sandstones, (b) limestones. *—Limestone USC results from Vindol Valley and Rječina River Valley based on [47].

The analysis of the endurance values resulting from uniaxial compression indicates that the investigated rocks are characterised by high or very high endurance. Taking into consideration the endurance of sedimentary rocks, subject to the same processes from the area of Poland, their parameters range from 40 to 250 MPa (Figure 10). Thus, the values obtained in this study are in the middle of this range.

The results of uniaxial compressive tests for limestones were also compared with the results of rocks from Croatia from the literature. The range of USC results for the studied Rab Island limestones are very similar to the results of limestones from the area of the western part of Croatia, specifically the Vindol Valley and Rječina River Valley sites [45], except that the Rječina River Valley limestones are more weathered than the Rab Island limestones. The macroscopic comparison of the Rab Island limestones to limestones from Western Croatia indicates that they are closer to the Rječina River Valley limestones, whose strength is lower. The UCS studies reported by Pollak et al. [48] from 11 sites spread mainly around Southern and Western Croatia present a very large range of results (UCS—25–273 MPa, mean 127 MPa). The authors explain this fact by the structural and lithological changes and limestone weathering effects, and they propose an equation to estimate the UCS based on a visual assessment. Following the classifications presented in [47], the limestones from Rab Island are characterised by significantly lower uniaxial compressive strength than the similar ones presented there, and they are closer in strength to the highly fractured, moderately weathered, and moderately porous limestones.
