Source / Izvornik: **Materials**, 2024, 17

Petrophysical Analyses of Rock Construction Materials from a Roman Rural Settlement in Podšilo Bay on Rab Island (North-East Adriatic, Croatia)

Keywords: Roman Dalmatia; heritage; ancient materials; sedimentary rocks; SEM-EDS; microtomography; mechanical properties

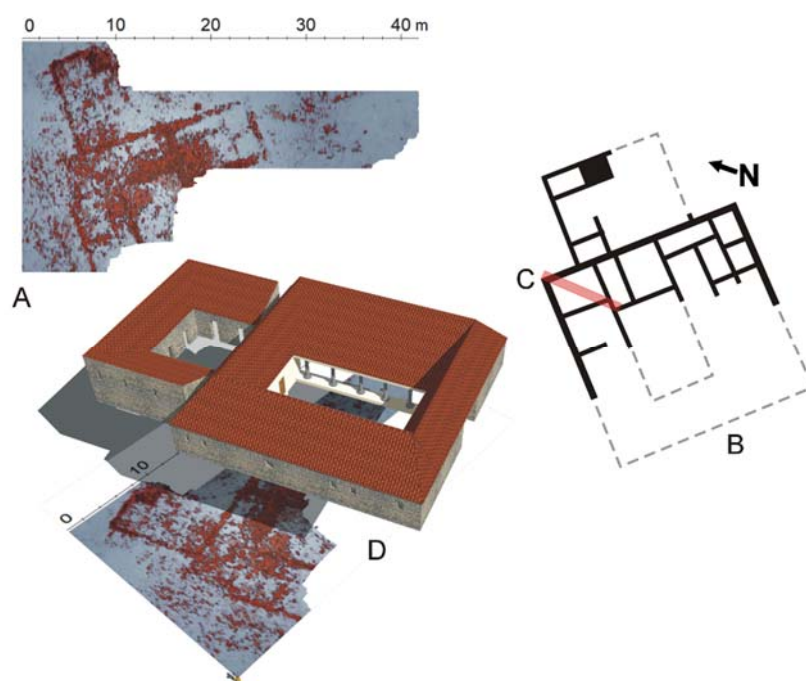
Figure 5. (A) Ground-penetrating radar prospecting results showing the remains of a villa at the depth of approximately 0.40 m. Notable is the central courtyard—atrium. (B) A tentative reconstruction of the villa plan on the basis of geophysical surveys and excavations. (C) Location of the archaeological excavation; see text for a detailed discussion. (D) A tentative reconstruction of the villa appearance. (Elaboration of GPR results and drawings: F. Welc).

Following the discovery of a Roman pottery kiln on the shore of the bay, conducted geophysical surveys have identified the location of the settlement's complex structure. Based on the excavations, two structures were identified: a smaller, possibly auxiliary building on the southern slope and a larger complex on the northern slope, interpreted as the settlement's central building (villa). As shown by GPR measurements (GPR), the structure of these buildings is located around an enclosed space [9], perhaps a courtyard, with wings divided into multiple rooms of a yet undetermined function. The surveys have provided the basis for inferring the size of the buildings on the plan (Figure 5), but, unfortunately, when applied to the buildings in their current state, they did not provide answers to either their size or the number of storeys. Most of the Roman archaeological sites in Croatia from the discussed period, including buildings, whether residential or productive structures, are usually preserved only at the foundation level. This is the main reason why it is difficult to reconstruct their original appearance.
