Arhitektura i arhitektonska plastika burga Vrbovca kraj Huma na Sutli

Architecture and Architectural Stonework of the Mediaeval Castle of Vrbovec near Hum na Sutli

Izvorni znanstveni rad
Srednjovjekovna arheologija

*Original scientific paper
Medieval archaeology*

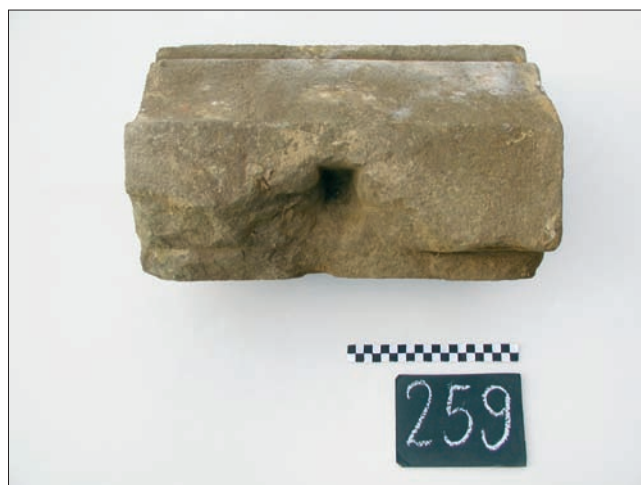
Sl. 7 Burg Vrbovec, PN 259 – desna baza profilacije prozora s tragovima naknadnoga nasilnog oštećenja utora za ugrađivanje željezne rešetke (foto: T. Tkalčec)

Fig. 7 The castle of Vrbovec, SF 259 – the right base of a window moulding with traces of subsequent violent damage of the groove for the iron railing (photo: T. Tkalčec)

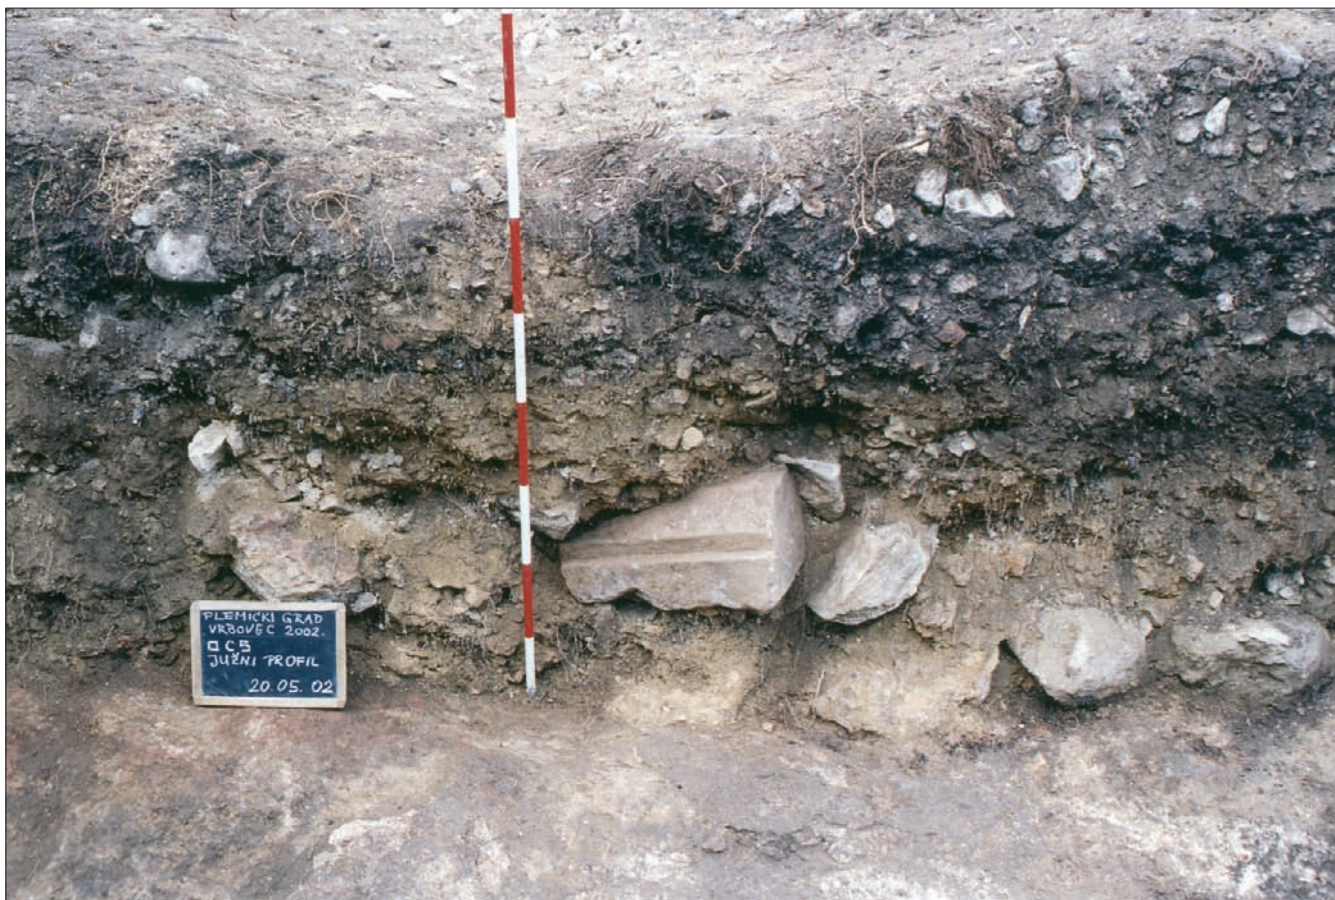
Sl. 8 Burg Vrbovec, položaj ulomka prozora srednje veličine PN 183 *in situ* u sloju ruševine SJ 003 (foto: T. Tkalčec)

Fig. 8 The castle of Vrbovec, the position of a fragment of a medium-sized window SF 183 *in situ* in the debris layer SU 003 (photo: T. Tkalčec)

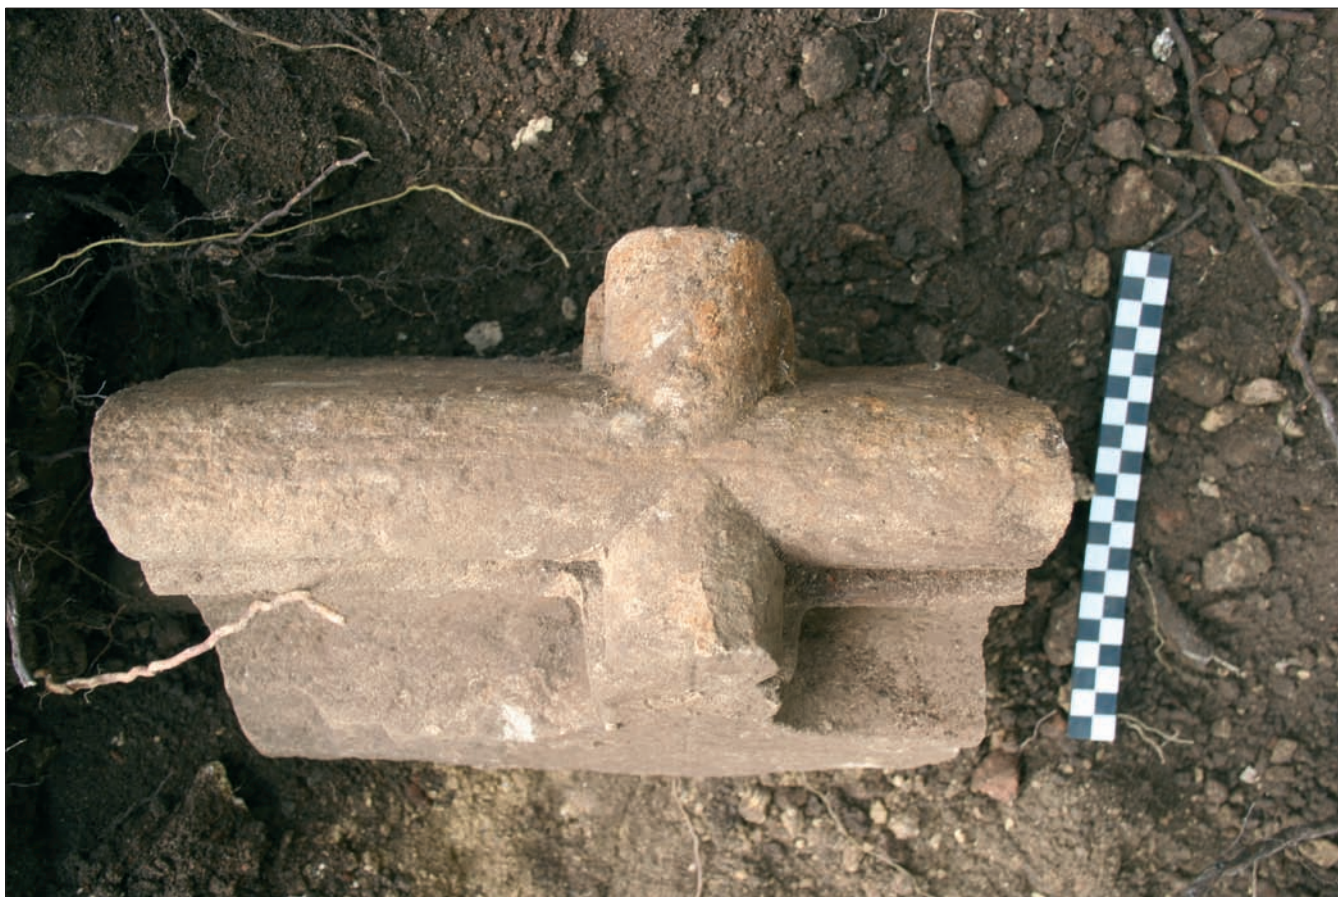
Sl. 10 Burg Vrbovec, ulomak horizontalnog šprljka "češkog prozora" PN 448 (foto: T. Tkalčec)

Fig. 10 The castle of Vrbovec, a fragment of a horizontal glazing bar of a "Bohemian window" SF 448 (photo: T. Tkalčec)

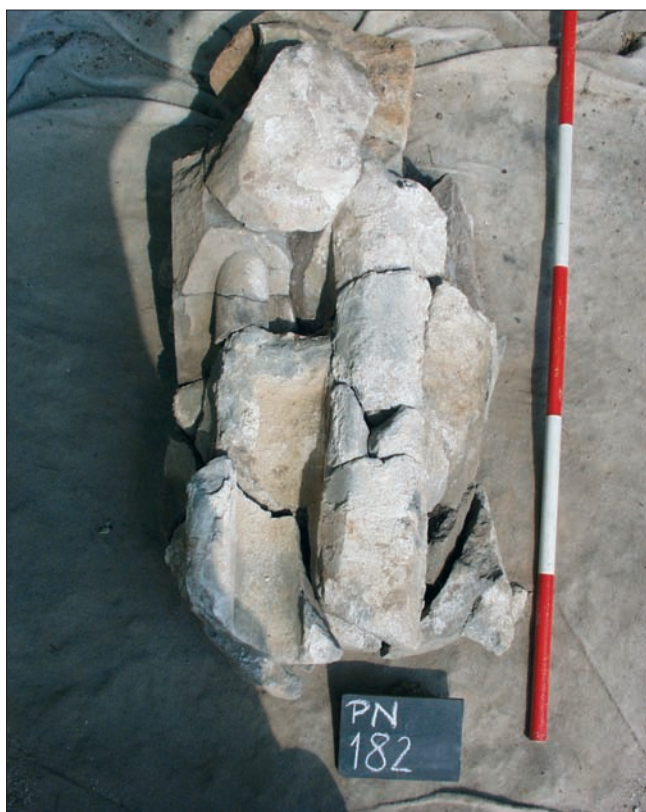
Sl. 11 Burg Vrbovec, PN 182 – "češki prozor" pronađen razmrvljen u mnoštvo ulomaka (foto: T. Tkalčec)

Fig. 11 The castle of Vrbovec, SF 182 – a "Bohemian window" preserved in a number of fragments (photo: T. Tkalčec)

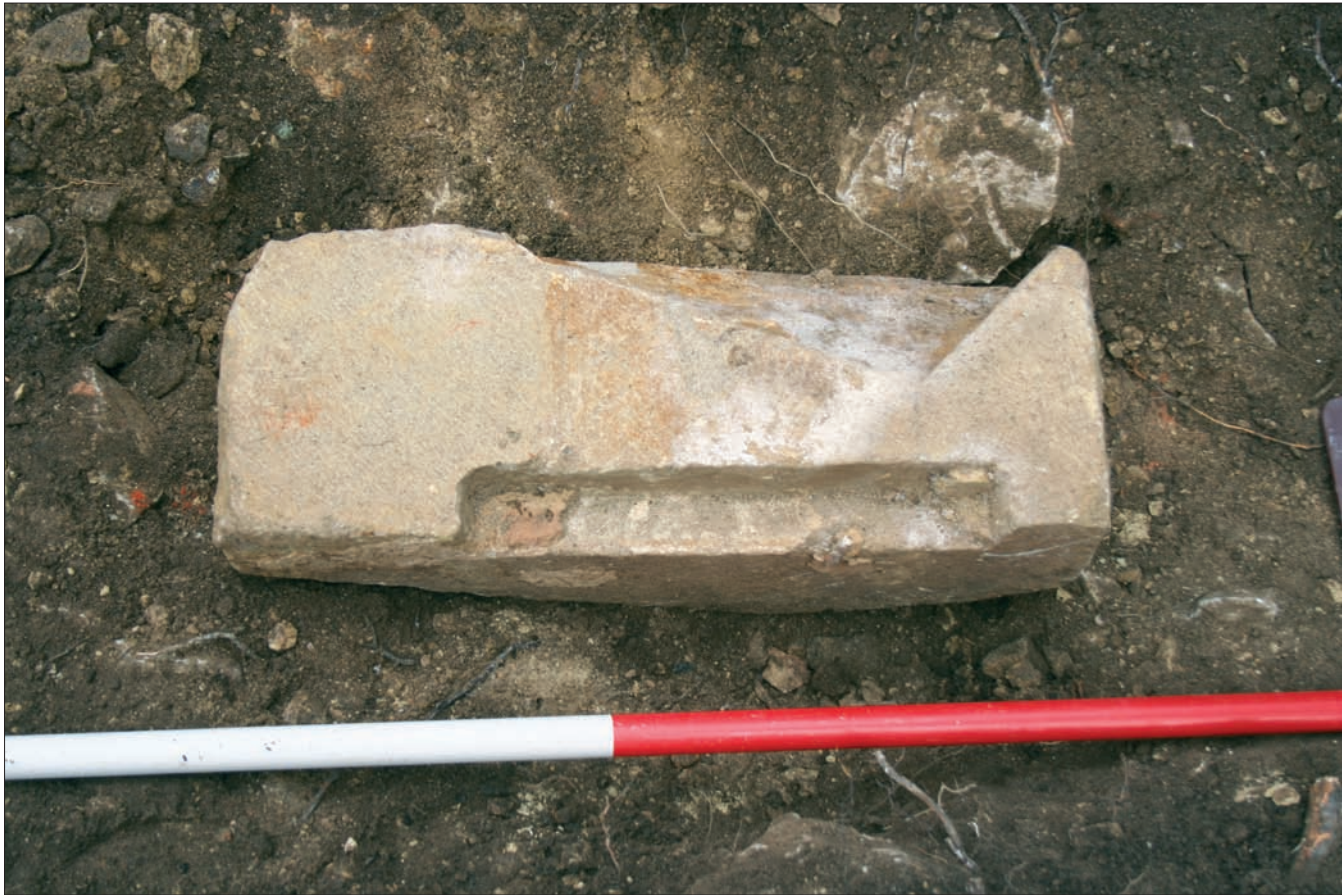
Sl. 18 Burg Vrbovec, pronalazak okvira manjeg prozora PN 447 (foto: T. Tkalčec)
 Fig. 18 Vrbovec castle, a find of a frame of a smaller window SF 447 (photo: T. Tkalčec)

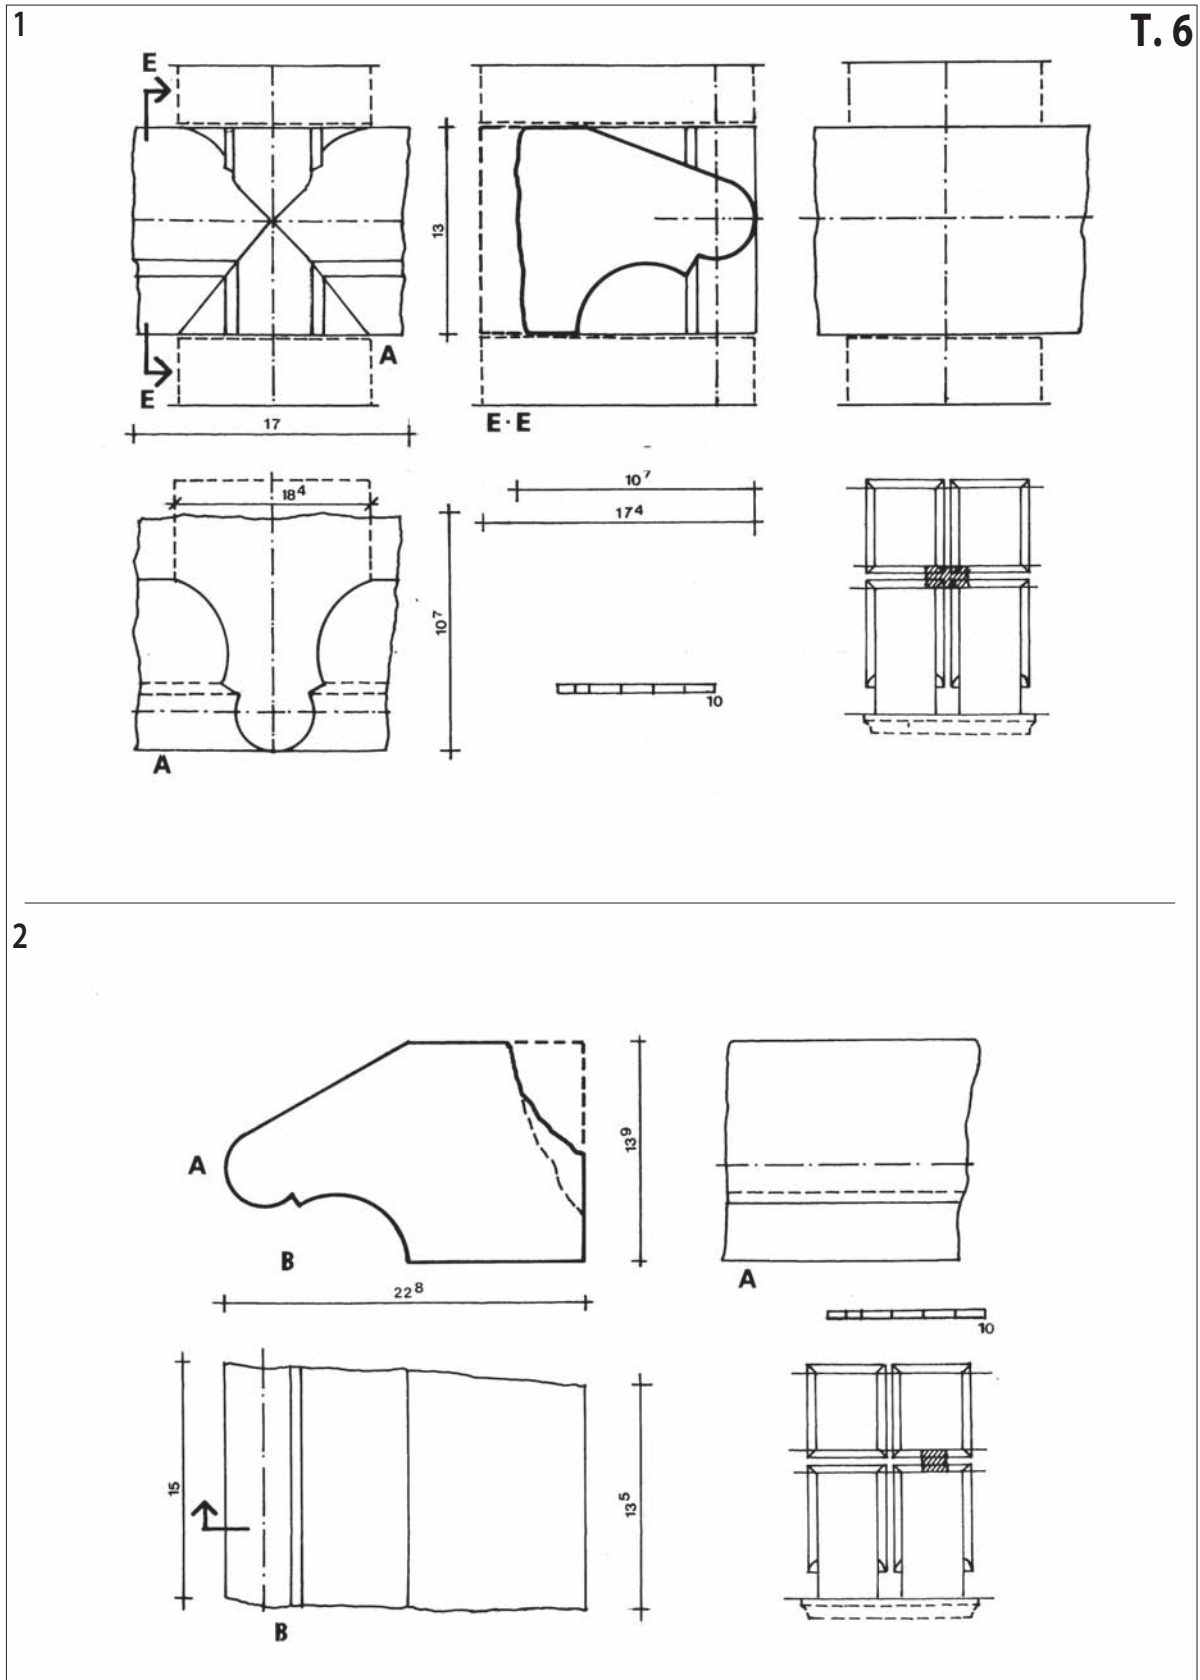
T. 6 "Češki prozori" – 1: PN 448; 2: PN 450 (crtež: Z. Horvat)

Pl. 6 "Bohemian windows" – 1: SF 448; 2: SF 450 (drawing: Z. Horvat)
