Source / Izvornik: **Materials**, 2024, 17

Petrophysical Analyses of Rock Construction Materials from a Roman Rural Settlement in Podšilo Bay on Rab Island (North-East Adriatic, Croatia)

Abstract: This article presents the results of petrophysical analyses of limestones and sandstones used for the construction of the wall structures of a Roman rural settlement located in Podšilo Bay on Rab Island (Croatia). An on-site analysis of the walls indicated the use of different lithotypes, which is an uncommon case in the area. So far, no petrophysical properties of the applied materials have been tested, and their provenance has not been specified. The aim of this research was to determine their usability as construction materials in an attempt to determine the possible reasons behind the usage of multiple lithotypes and their suitability as building materials. The following procedure was used to address these issues: (1) determination of the petrographic characteristics of the rocks, (2) performance of tests to characterise the mechanical properties in a complex stress state of uniaxial tension followed by uniaxial and triaxial compression, and, finally, (3) determination of the intern

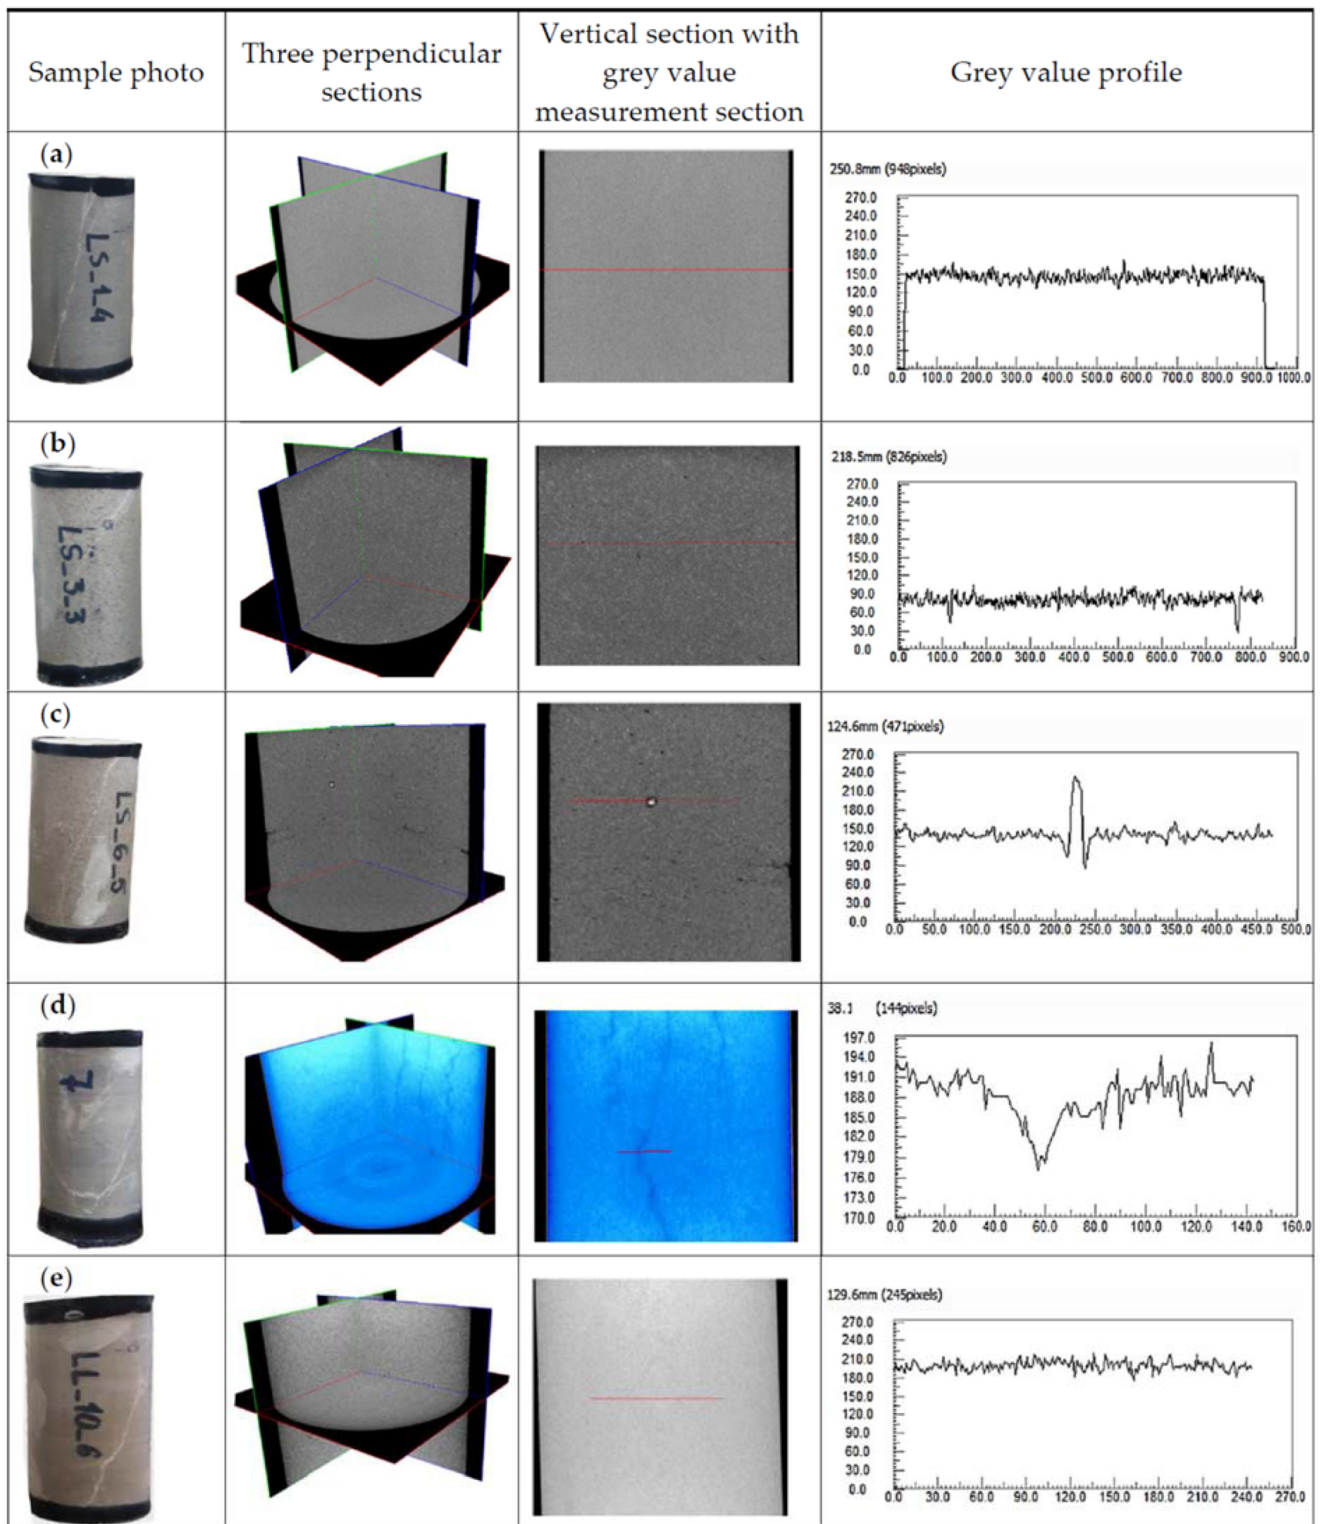
Figure 8. Microtomography images with grey value profiles for (a) type LS_1, (b) type LS_3, (c) type LS_6, (d) type LL_7, (e) type LL_10. — section line.

An image analysis of sample LS_1 showed no structural defects (Figure 8a). The entire stone was homogeneous with regard to grain size. Due to the size of individual grains being close to the imaging resolution, it was not possible to observe their details. To complement this magnification range, a SEM analysis was used, which is very suitable for such type of study (despite the small area of recognition, it provides a detailed identification of the grain characteristics)—Figure 8a. The porosity is very low, about 0.02%, and comprises pores with equivalent diameters in the range of 1.5–124.5 μm (about 97%).

The image of sample LS_3 is very similar to that of sample LS_1. The rock has a compact structure with a low porosity of about 0.08% and with a predominance of pores with an equivalent diameter of up to 0.1 mm (about 73%). The density analysis performed in the cross-section showed very high homogeneity (Figure 8b).

The XCT scan of the last sample in the sandstone group (LS_6), except for the evenly dispersed porosity, showed the presence of small voids in the sample volume, which may affect the strength. Besides voids, the presence of grains composed of very-high-density minerals was observed as white “grains” in microtomographic images (Figure 8c).

The 3D image of limestone LL_7 reflects the internal structure of the sample, where the weakness areas (depicted with a darker colour) are identified in three perpendicular sections—they most likely represent fracture/gap areas filled with secondary mineralization. These zones of weakness are characterised by quasi-parallelism, and their course is not straight. The degree of weakening of the rock’s solid fraction may correspond to the grey value profile (related to the density value) (Figure 8d).

CT images are presented with shaded grey or black colours for low CT-values and light grey or white colours for high CT-values in all subsequent shaded grey colours. The total number of levels in these colours is 256. It is well known that this CT-value is linearly related to the material density [37]. The grey value profile in Figure 8 shows the distributions of CT-values along exemplary lines in all specimens, showing the relative density variance of the analysed materials.
