Source / Izvornik: **Materials**, 2024, 17

Article

Petrophysical Analyses of Rock Construction Materials from a Roman Rural Settlement in Podšilo Bay on Rab Island (North-East Adriatic, Croatia)

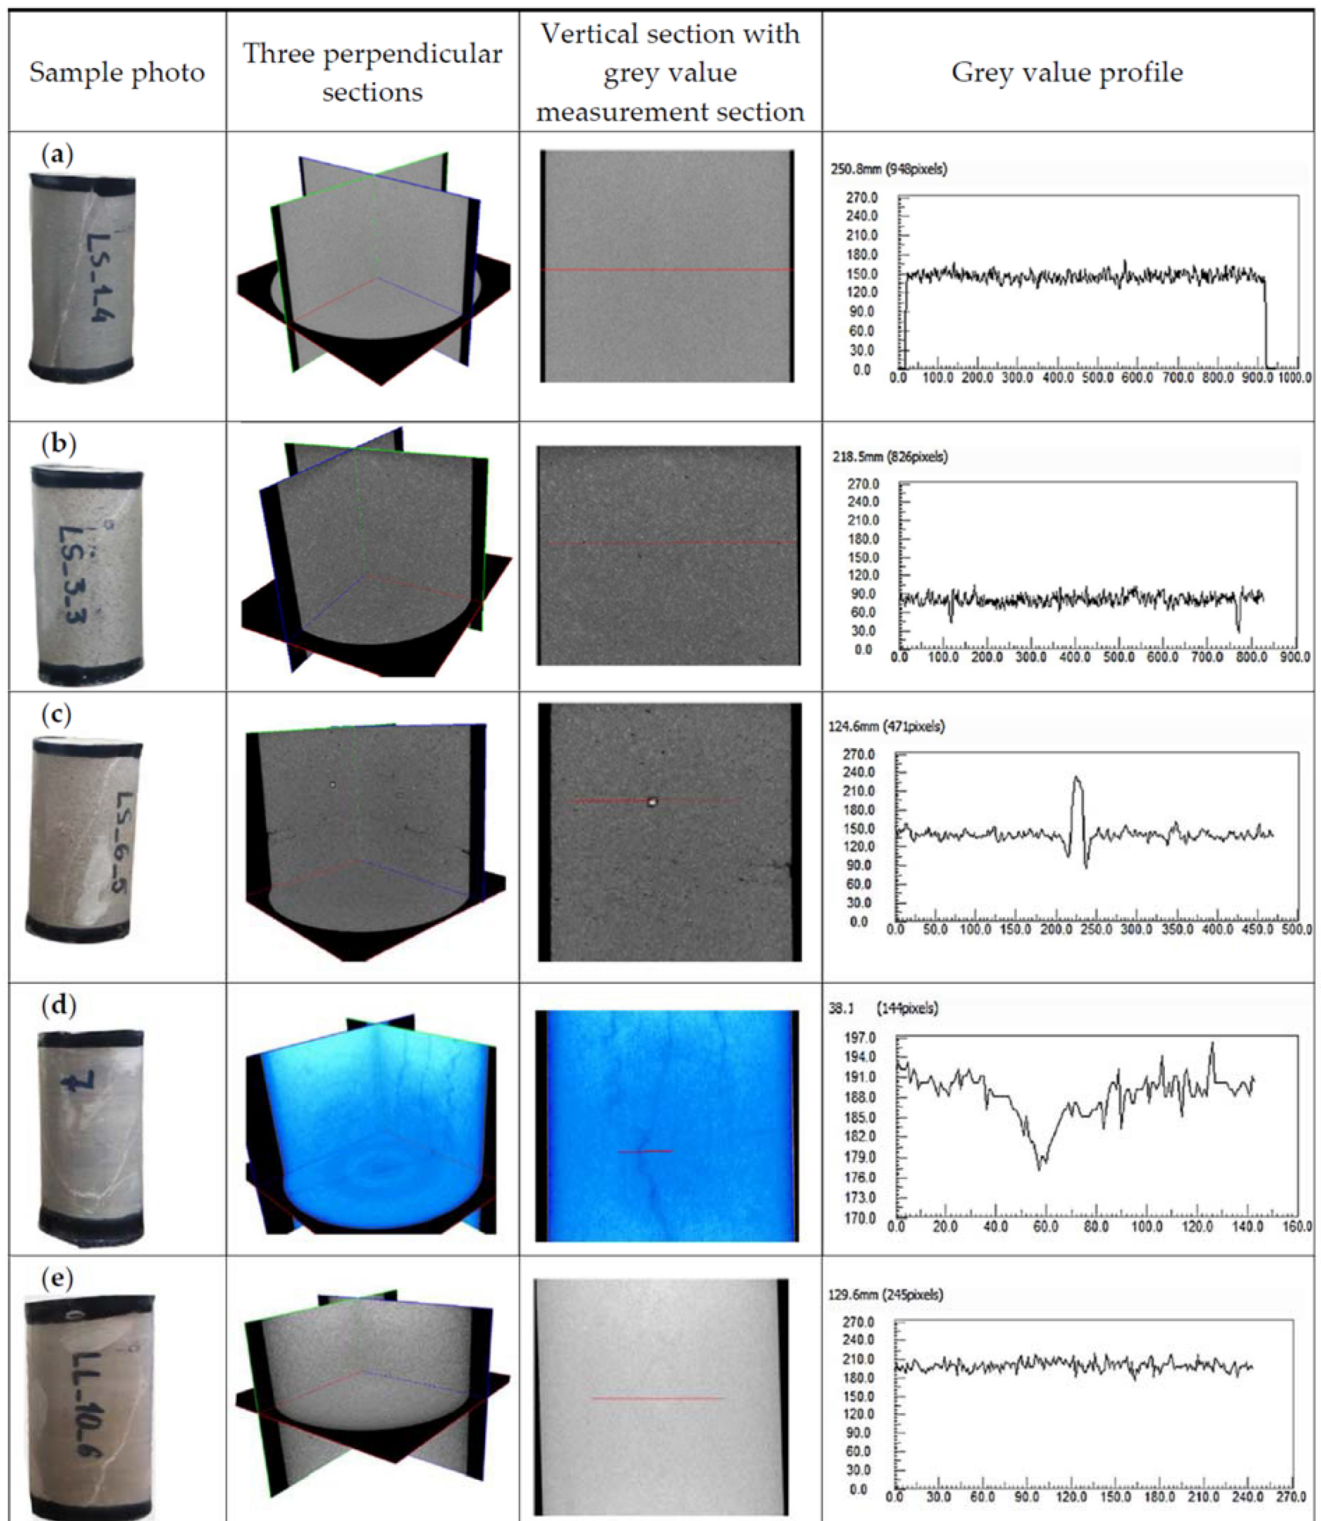
Figure 8. Microtomography images with grey value profiles for (a) type LS_1, (b) type LS_3, (c) type LS_6, (d) type LL_7, (e) type LL_10. — section line.

An image analysis of sample LS_1 showed no structural defects (Figure 8a). The entire stone was homogeneous with regard to grain size. Due to the size of individual grains being close to the imaging resolution, it was not possible to observe their details. To complement this magnification range, a SEM analysis was used, which is very suitable for such type of study (despite the small area of recognition, it provides a detailed identification of the grain characteristics)—Figure 8a. The porosity is very low, about 0.02%, and comprises pores with equivalent diameters in the range of 1.5–124.5 μm (about 97%).

The image of sample LS_3 is very similar to that of sample LS_1. The rock has a compact structure with a low porosity of about 0.08% and with a predominance of pores with an equivalent diameter of up to 0.1 mm (about 73%). The density analysis performed in the cross-section showed very high homogeneity (Figure 8b).

The XCT scan of the last sample in the sandstone group (LS_6), except for the evenly dispersed porosity, showed the presence of small voids in the sample volume, which may affect the strength. Besides voids, the presence of grains composed of very-high-density minerals was observed as white “grains” in microtomographic images (Figure 8c).

The 3D image of limestone LL_7 reflects the internal structure of the sample, where the weakness areas (depicted with a darker colour) are identified in three perpendicular sections—they most likely represent fracture/gap areas filled with secondary mineralization. These zones of weakness are characterised by quasi-parallelism, and their course is not straight. The degree of weakening of the rock’s solid fraction may correspond to the grey value profile (related to the density value) (Figure 8d).

CT images are presented with shaded grey or black colours for low CT-values and light grey or white colours for high CT-values in all subsequent shaded grey colours. The total number of levels in these colours is 256. It is well known that this CT-value is linearly related to the material density [37]. The grey value profile in Figure 8 shows the distributions of CT-values along exemplary lines in all specimens, showing the relative density variance of the analysed materials.
