Arhitektura i arhitektonska plastika burga Vrbovca kraj Huma na Sutli

Source / Izvornik: **Prilozi Instituta za arheologiju u Zagrebu, 2009, 26, 181 - 218**

Architecture and Architectural Stonework of the Mediaeval Castle of Vrbovec near Hum na Sutli

Izvorni znanstveni rad
Srednjovjekovna arheologija

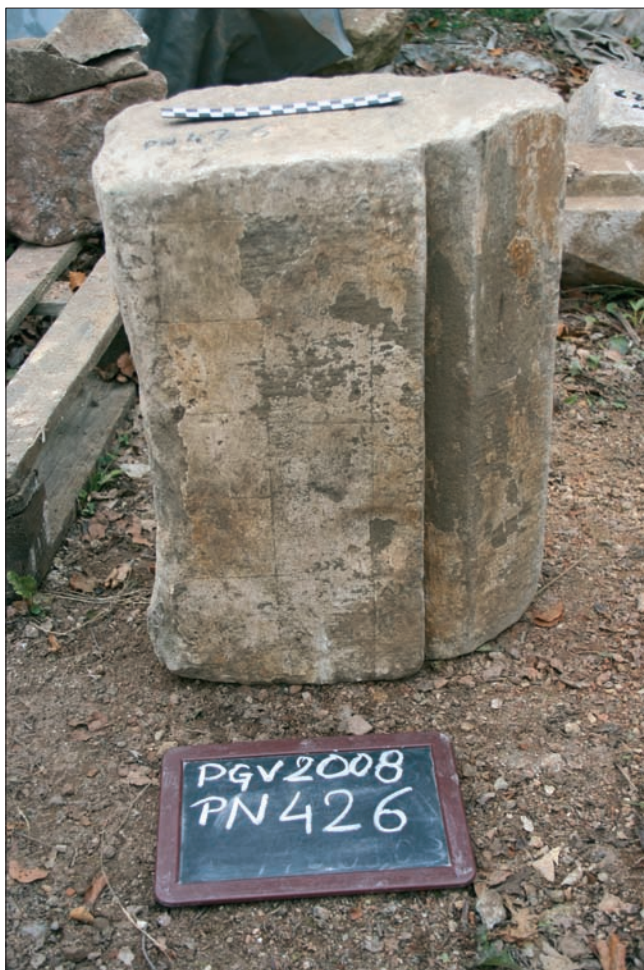
Sl. 6 Burg Vrbovec, PN 426 – lijeva baza profilacije prozora srednje veličine s ostacima žutog i oker bojanja kvadratičnih polja (foto: T. Tkalčec)

Fig. 6 The castle of Vrbovec, SF 426 – left base of the moulding of a medium-sized window with the remains of yellow and ochre painting of square fields (photo: T. Tkalčec)

pronađen u dvorištu burga, dok je PN 426 pronađen izvan jezgre burga, istočno od sjeveroistočne prostorije palasa (plan 1, sl. 5). Ulomak PN 426 je posebno zanimljiv zbog tragova bojanja pročelja bijelom i oker bojom. Prozor je nekada imao ugrađenu željeznu rešetku, koja je nasilno izvađena (T. 2:2, sl. 6).

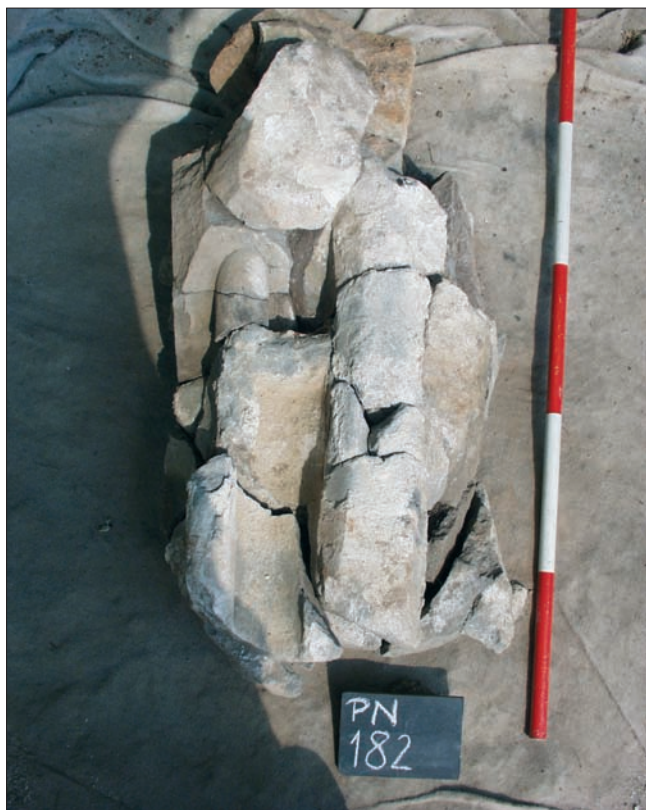
Sl. 11 Burg Vrbovec, PN 182 – "češki prozor" pronađen razmrvljen u mnoštvo ulomaka (foto: T. Tkalčec)

Fig. 11 The castle of Vrbovec, SF 182 – a "Bohemian window" preserved in a number of fragments (photo: T. Tkalčec)

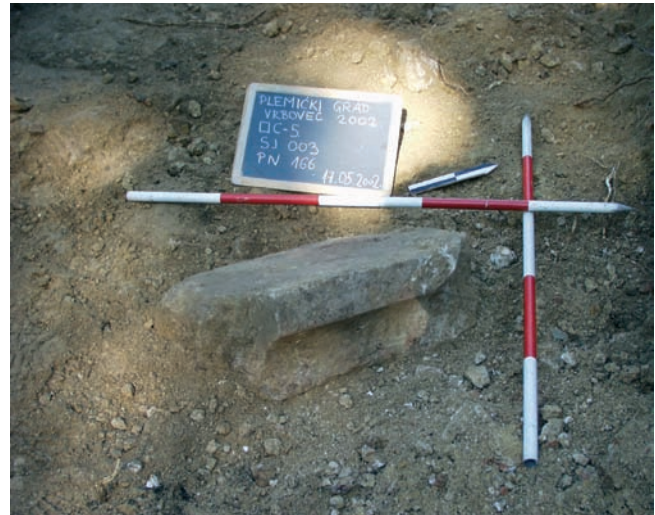
Sl. 14 Burg Vrbovec, ulomak vanjske prozorske klupčice PN 166 *in situ* (foto: T. Tkalčec)

Fig. 14 Vrbovec castle, a fragment of an exterior stone bench SF 166 *in situ* (photo: T. Tkalčec)

¹⁶The fragment of a bench could not have arrived in that place in the Modern period, because it was found in intact layer SU 003, a layer of collapse of the medieval fortified town. In the courtyard, this layer was covered with an undisturbed layer from the Modern period. This means that a contamination of that layer in the long period following the collapse of the fortified town could not have taken place.

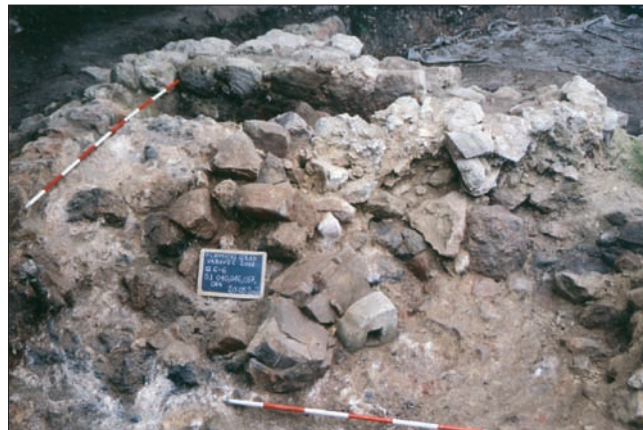
Sl. 17 Burg Vrbovec, pronalazak spolije PN 181 i neposredno do nje "češkog prozora" PN 182 (foto: T. Tkalčec)

Fig. 17 Vrbovec castle, a find of spolia SF 181 and adjacent to it a "Bohemian window" SF 182 (photo: T. Tkalčec)
