Arhitektura i arhitektonska plastika burga Vrbovca kraj Huma na Sutli

Architecture and Architectural Stonework of the Mediaeval Castle of Vrbovec near Hum na Sutli

Izvorni znanstveni rad
Srednjovjekovna arheologija

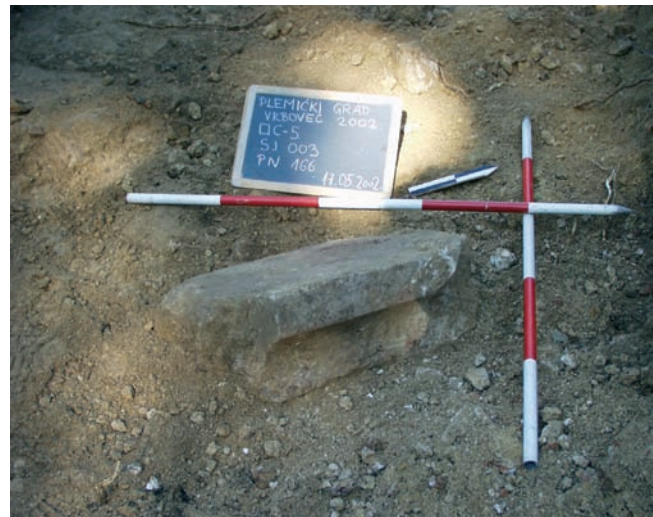
Sl. 14 Burg Vrbovec, ulomak vanjske prozorske klupčice PN 166 *in situ* (foto: T. Tkalčec)

Fig. 14 Vrbovec castle, a fragment of an exterior stone bench SF 166 *in situ* (photo: T. Tkalčec)
