# Arhitektura i arhitektonska plastika burga Vrbovca kraj Huma na Sutli

## *Architecture and Architectural Stonework of the Mediaeval Castle of Vrbovec near Hum na Sutli*

Izvorni znanstveni rad  
Srednjovjekovna arheologija

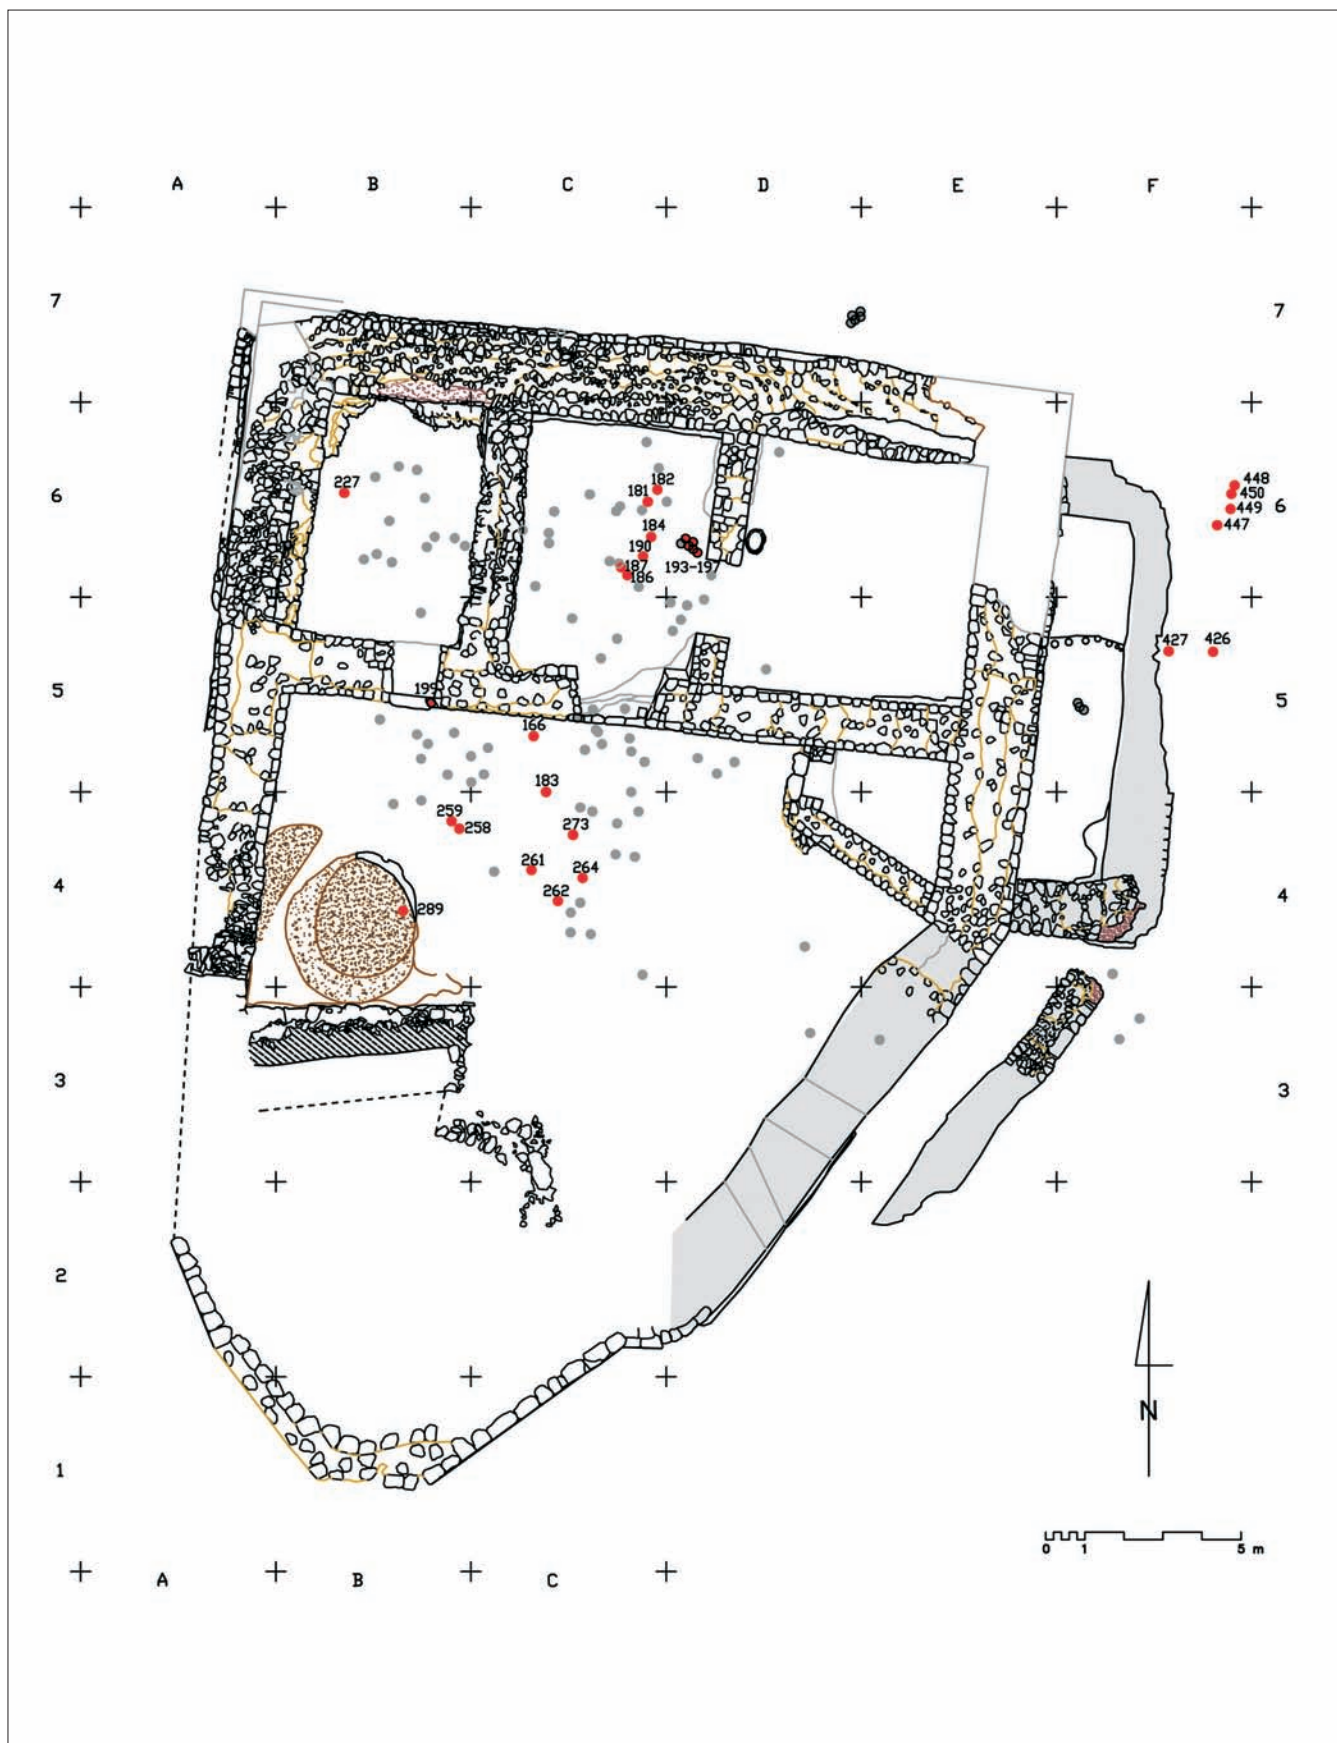
Plan 1 Burg Vrbovec, Klenovec Humski, situacijski plan 2008. g. (crtež: M. Vojtić i K. Vujica; dorada i snimak arhitektonske plastike: T. Tkalčec)

Plan 1 Castle of Vrbovec, Klenovec Humski, situation plan in 2008 (drawing: M. Vojtić and K. Vujica; finishing and positioning of architectural stonework: T. Tkalčec)

U ukupnim dosadašnjim arheološkim istraživanjima definiran je tlocrt obodnog zida burga i istraženi su u cjelini ostaci i prostori prizemlja sjevernog dijela kompleksa (plan 1). Burg je poligonalnoga tlocrta, vanjskih dimenzija 21 m (istok–zapad) x 29,8 m (sjever–jug). Sastoji se od palasa na sjeveru (u prizemlju troprostorno podijeljenog), branič-kule na jugu, tj. jugozapadu, cisterne u jugozapadnome dijelu dvorišta uz kulu te manje istočne prostorije nepravilnoga tlocrta (Tomičić et al. 2003a, 172, slika; Tomičić et al. 2003b, 135, sl. 1; Tomičić, Tkalčec 2005, 69, sl. 2). Ulaz je (u nekoj graditeljskoj fazi burga) mogao biti na istočnoj strani, oko sredine istočnoga obrambenog zida. Na tome su prostoru pronađeni elementi (sjevernije pozicionirani tragovi drvenih stupova te zidovi izvan gabarita jezgre burga) koji bi se mogli tumačiti sustavom obrane ulaza (Tkalčec 2009, sl. 1). Jedan burg je tijekom vremena svoje egzistencije mo-

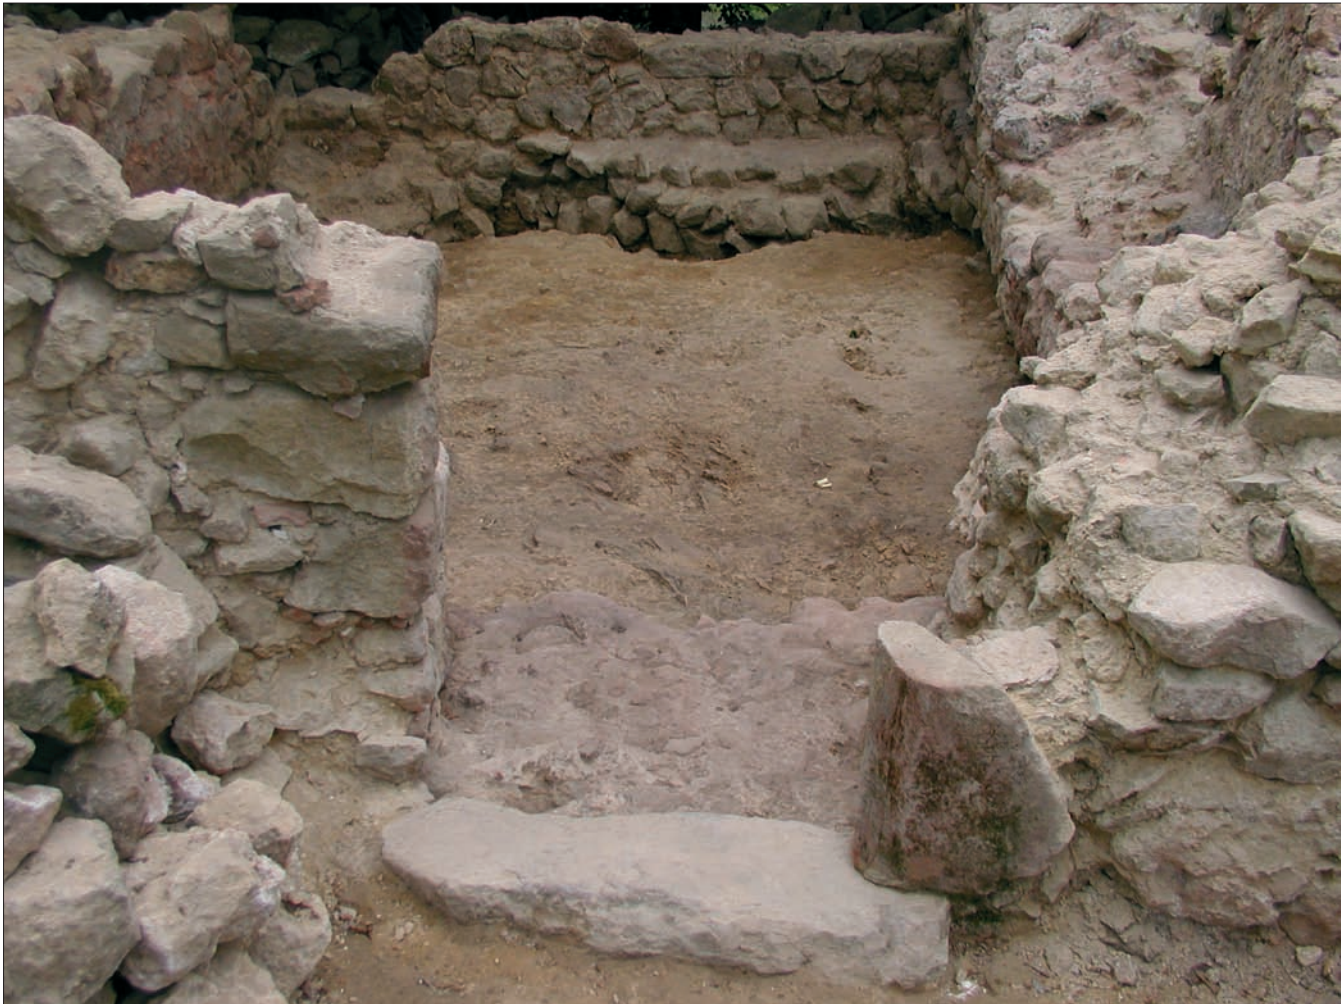
Sl. 1 Burg Vrbovec, pogled s juga na ulaz u kuhinju i dovratnik PN 199 tijekom arheoloških istraživanja 2003. g. (foto: M. Dizdar)  
 Fig. 1 The castle of Vrbovec, a view from the south to the kitchen entrance and door jamb SF 199 during archaeological investigations in 2003 (photo: M. Dizdar)

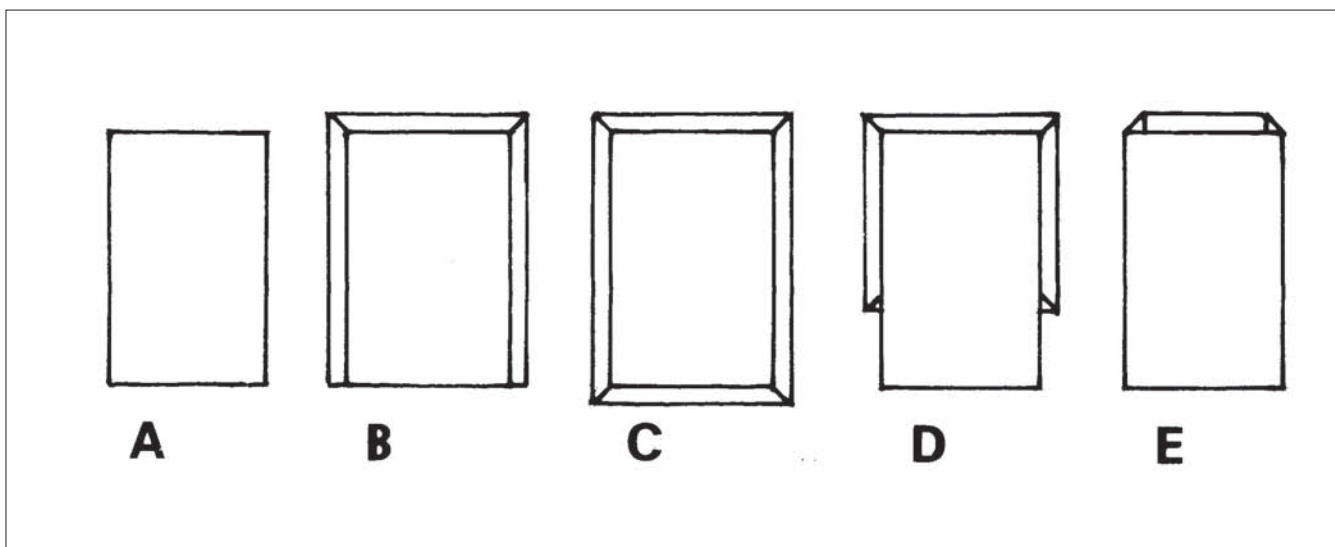
Sl. 2 Uobičajeno oblikovanje kamena doprozornika s ukošenim rubom (crtež: Z. Horvat)  
 Fig. 2 The usual form of a stone window jamb with a beveled edge (drawing: Z. Horvat)

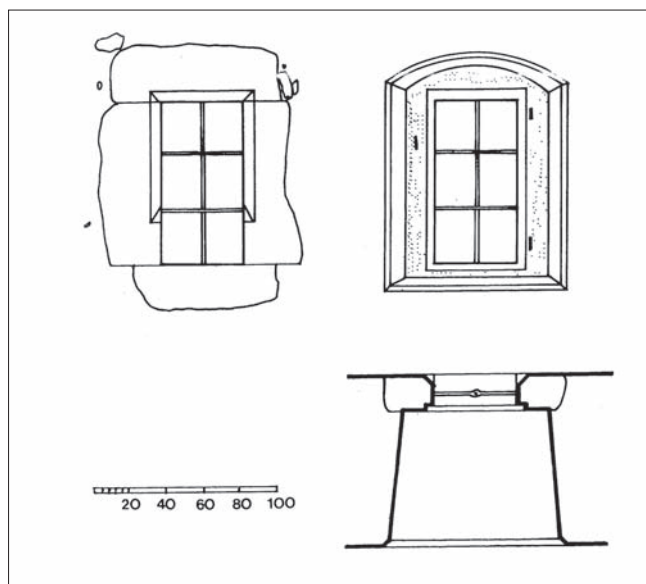
Sl. 3 Ozalj, burg i palas Nikole Zrinskog, prozor u zapadnom zidu prizemlja (pogled izvana, iznutra i tlocrt) (crtež: Z. Horvat)

Fig. 3 Ozalj, the castle and the palace of Nikola Zrinski, a window in the western wall of the ground-floor (a view from the outside, inside and a ground-plan) (drawing: Z. Horvat)

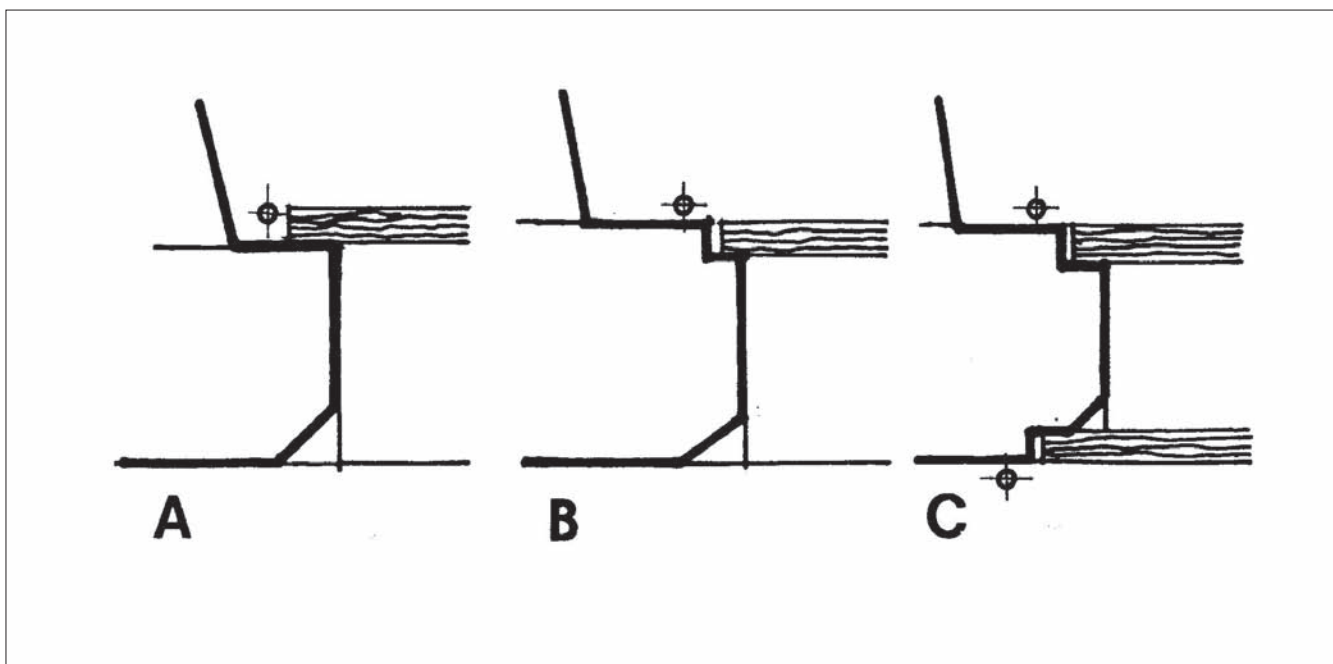
Sl. 4 Uobičajeni načini izvođenja utora za krilo na doprozorcima (A–bez utora, B–s jednim utorom; unutrašnja strana, C–s dva utora; vanjska strana (donji utor je za drveni kapak) (crtež: Z. Horvat)

Fig. 4 The usual forms of casement grooves on window jambs (A–without a groove, B–with one groove; interior, C–with two grooves; exterior (the lower groove is for a wooden casement) (drawing: Z. Horvat)

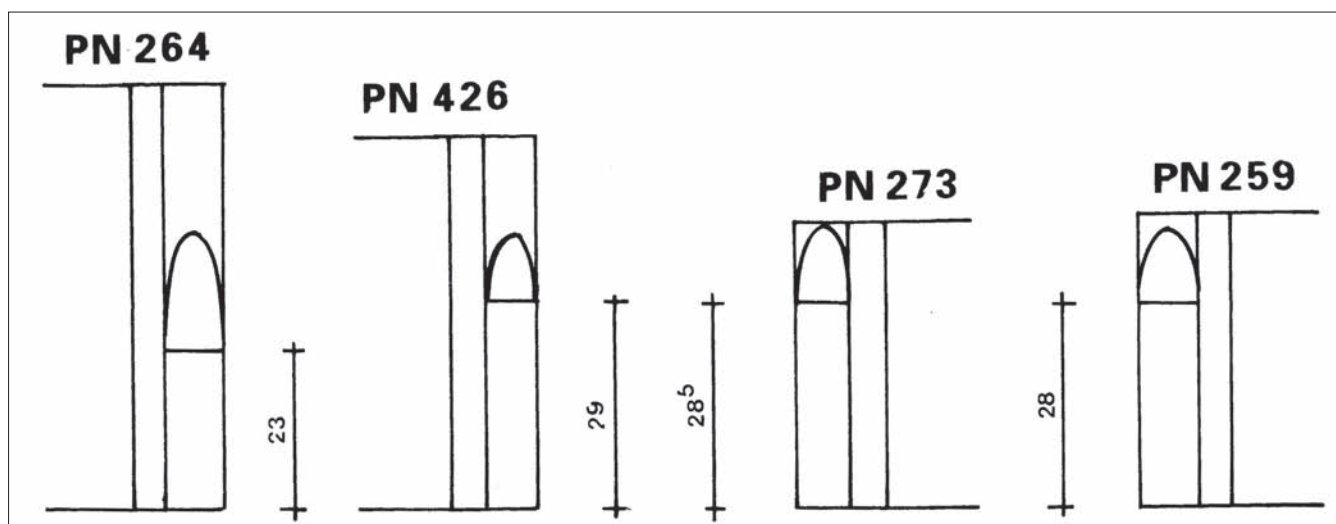
Sl. 5 Usporedni prikaz baza profilacija prozora srednje veličine (crtež: Z. Horvat)  
 Fig. 5 A comparison of moulding bases of medium-sized windows (drawing: Z. Horvat)

pronađen u dvorištu burga, dok je PN 426 pronađen izvan jezgre burga, istočno od sjeveroistočne prostorije palasa (plan 1, sl. 5). Ulomak PN 426 je posebno zanimljiv zbog tragova bojanja pročelja bijelom i oker bojom. Prozor je nekada imao ugrađenu željeznu rešetku, koja je nasilno izvađena (T. 2:2, sl. 6).

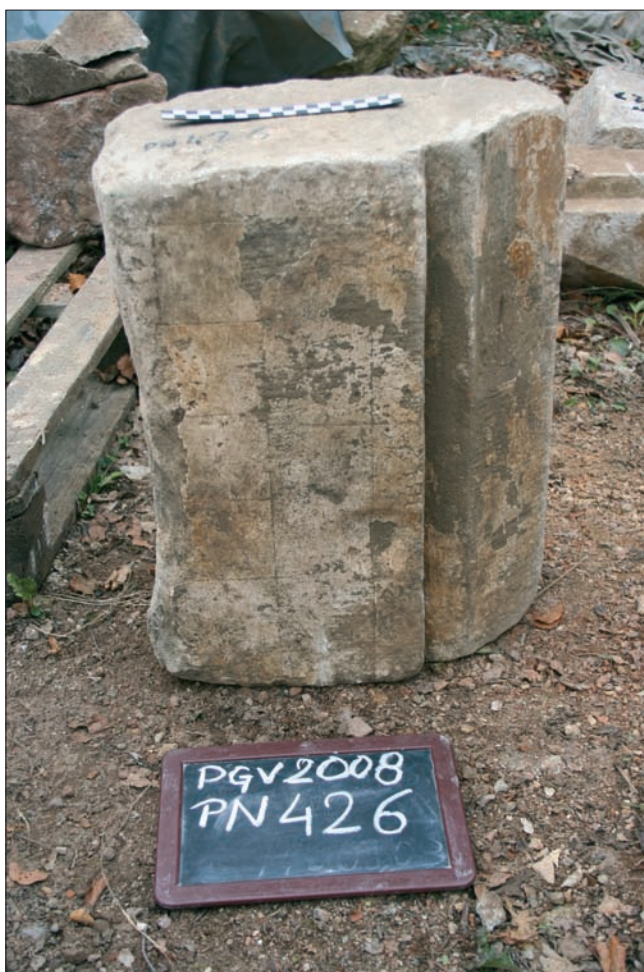
Sl. 6 Burg Vrbovec, PN 426 – lijeva baza profilacije prozora srednje veličine s ostacima žutog i oker bojanja kvadratičnih polja (foto: T. Tkalčec)

Fig. 6 The castle of Vrbovec, SF 426 – left base of the moulding of a medium-sized window with the remains of yellow and ochre painting of square fields (photo: T. Tkalčec)

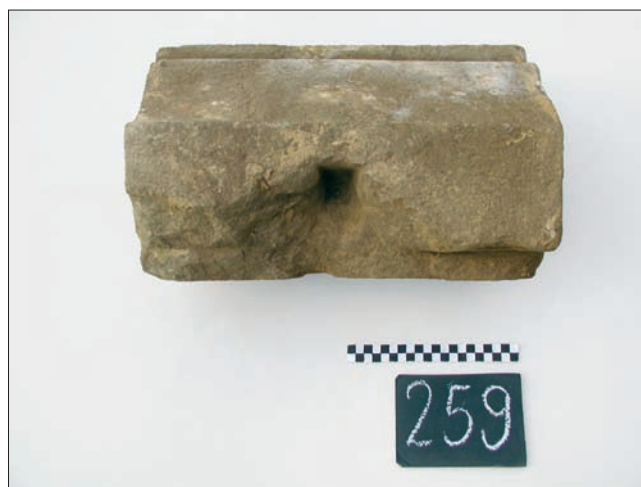
Sl. 7 Burg Vrbovec, PN 259 – desna baza profilacije prozora s tragovima naknadnoga nasilnog oštećenja utora za ugrađivanje željezne rešetke (foto: T. Tkalčec)

Fig. 7 The castle of Vrbovec, SF 259 – the right base of a window moulding with traces of subsequent violent damage of the groove for the iron railing (photo: T. Tkalčec)

Fragments of the stone frame of window SF 258 have quite damaged mouldings, without any characteristic features. Nevertheless, considering the spot of discovery, they undoubtedly form part of the same window as SF 259 (Pl. 4:1).

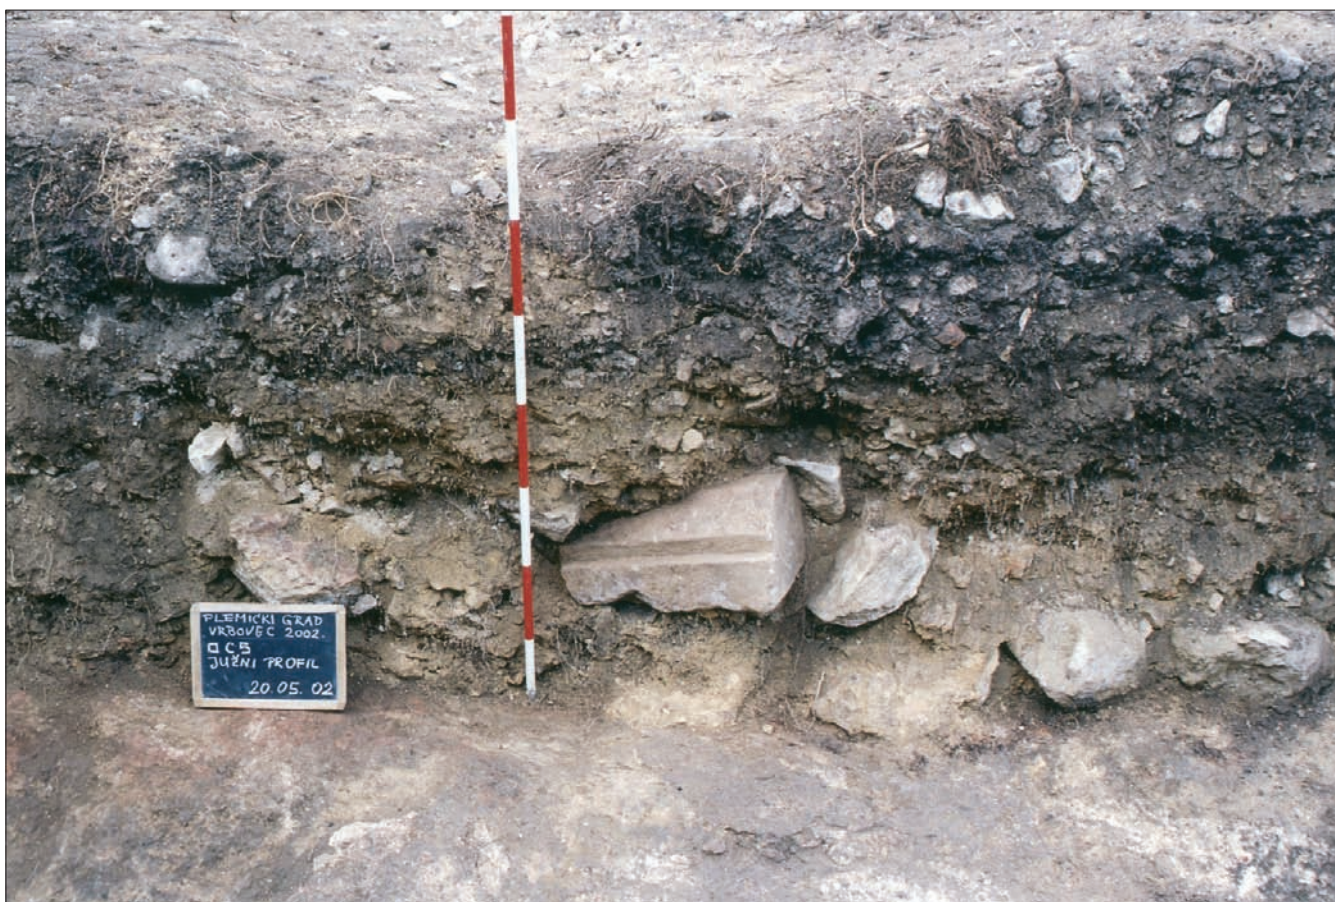
Sl. 8 Burg Vrbovec, položaj ulomka prozora srednje veličine PN 183 *in situ* u sloju ruševine SJ 003 (foto: T. Tkalčec)

Fig. 8 The castle of Vrbovec, the position of a fragment of a medium-sized window SF 183 *in situ* in the debris layer SU 003 (photo: T. Tkalčec)

Fragment SF 183, from a stone frame of a medium-sized window, formerly with a railing within the opening, may have had an outer and interior casement. A carver's mark was incised on the back surface, like on SF 184. Instead of a groo-

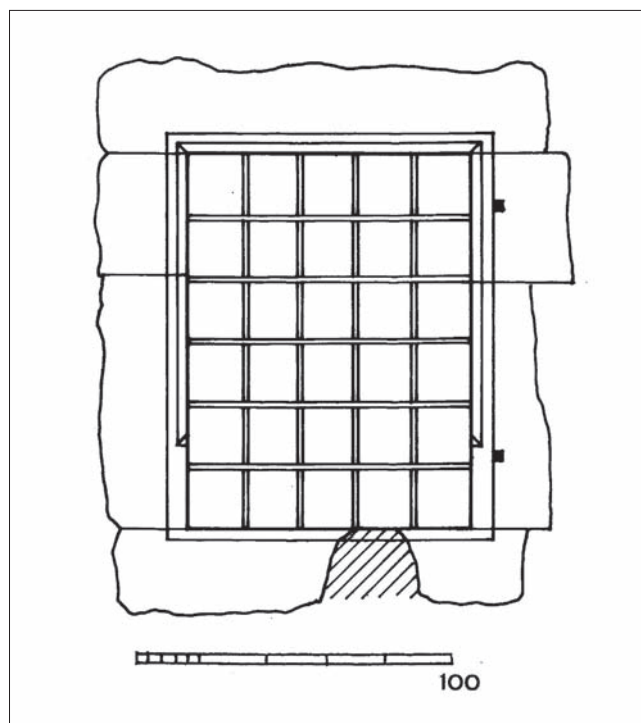
Sl. 9 Varaždin, prozor kuhinje u prizemlju Staroga grada (crtež: Z. Horvat)

Fig. 9 *Varaždin, a kitchen window in the ground-floor of the Old Town (drawing: Z. Horvat)*

Examples of medium-sized windows are found on the castles of Samobor, Valpovo, Ozalj, Đurđevac, Brinje, the castle in Ogulin and Old Town Varaždin (Fig. 9). Another niche was situated behind the window. It probably reached the floor, while inside the niche there may have been built-in stone benches. Windows of this type had a fairly substantial moulding, and may have been of the "Bohemian" type, with glazing bars. However, not one fragment that would corroborate this assumption has been found at that place. Besides, the "Bohemian windows" would not have had a railing

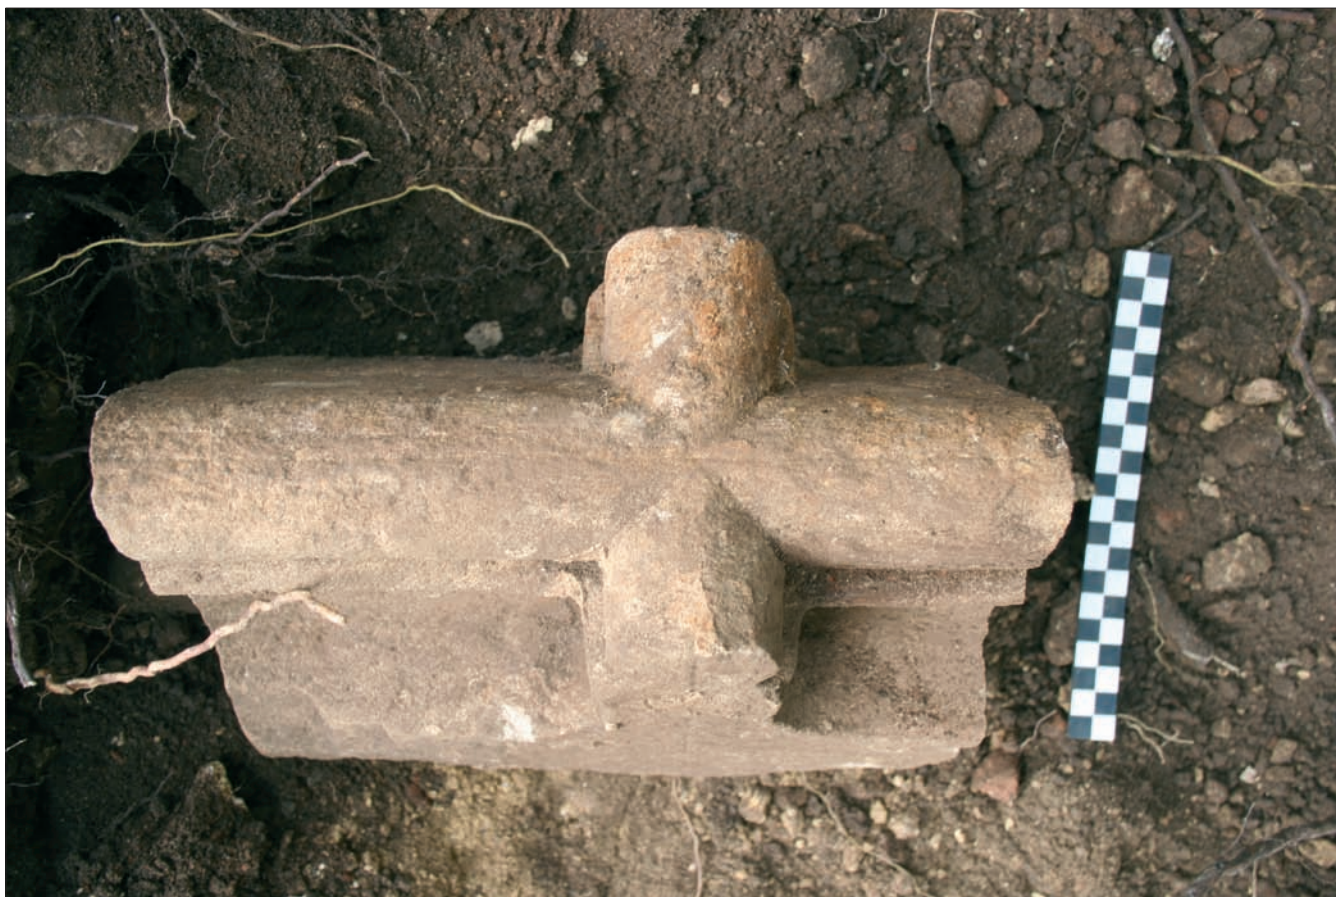
Sl. 10 Burg Vrbovec, ulomak horizontalnog šprljka "češkog prozora" PN 448 (foto: T. Tkalčec)

Fig. 10 The castle of Vrbovec, a fragment of a horizontal glazing bar of a "Bohemian window" SF 448 (photo: T. Tkalčec)

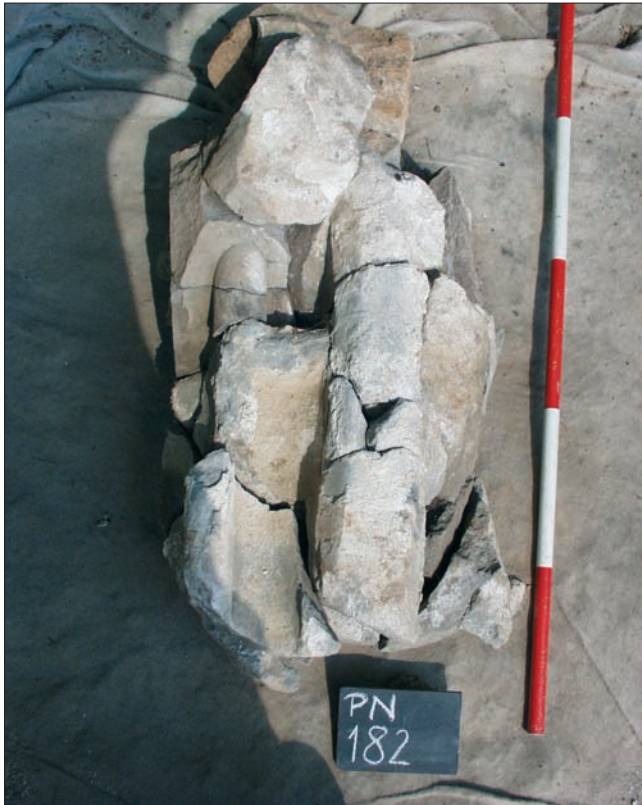
Sl. 11 Burg Vrbovec, PN 182 – "češki prozor" pronađen razmrvljen u mnoštvo ulomaka (foto: T. Tkalčec)

Fig. 11 The castle of Vrbovec, SF 182 – a "Bohemian window" preserved in a number of fragments (photo: T. Tkalčec)

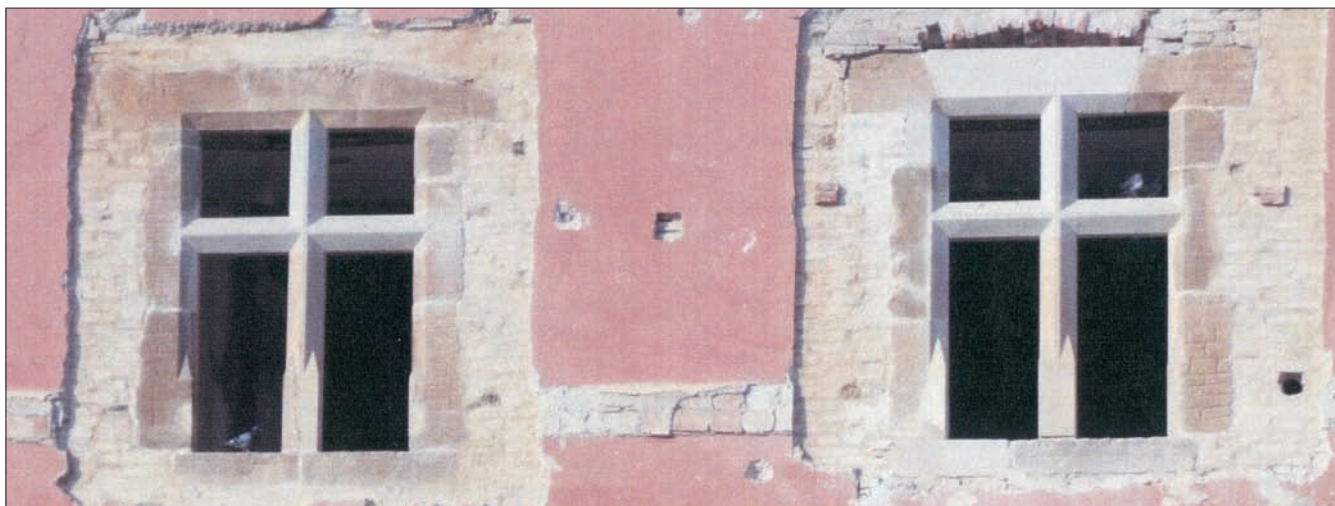
Sl. 12 Ilok – palača Odescalchi, nekadašnji palas knezova Iločkih, južno pročelje II. kata (foto: Đ. Šimičić)

Fig. 12 Ilok – Odescalchi palace, former palace of the Dukes of Ilok, southern façade of the 2nd floor (photo: Đ. Šimičić)

Bohemian windows were regularly glazed, as confirmed on Vrbovec by the finds of fragments of window glass. They admitted light to representative rooms and residential chambers, like examples of windows on the palace of the Dukes of Ilok in Ilok, discovered during the 2000 recovery works and recently reconstructed (Fig. 12). Stone benches suitable for working by daylight presumably stood behind such windows (Horvat Z. 1997, 52–57). Although there were only few finds of large fragments providing sufficient information on their appearance and furnishing, we can still be reasonably certain that they had a basket-shaped iron railing on the outside, which allowed one to lean through the window and have a better view of the surroundings (Fig. 13). The presence of a railing implied that window casements opened inwards. A small stone corbel bench, as part of the lower portion of the window jamb, was habitually crafted on the outside. One of the fragments found at Vrbovec – SF 166 – probably belonged to one such bench.

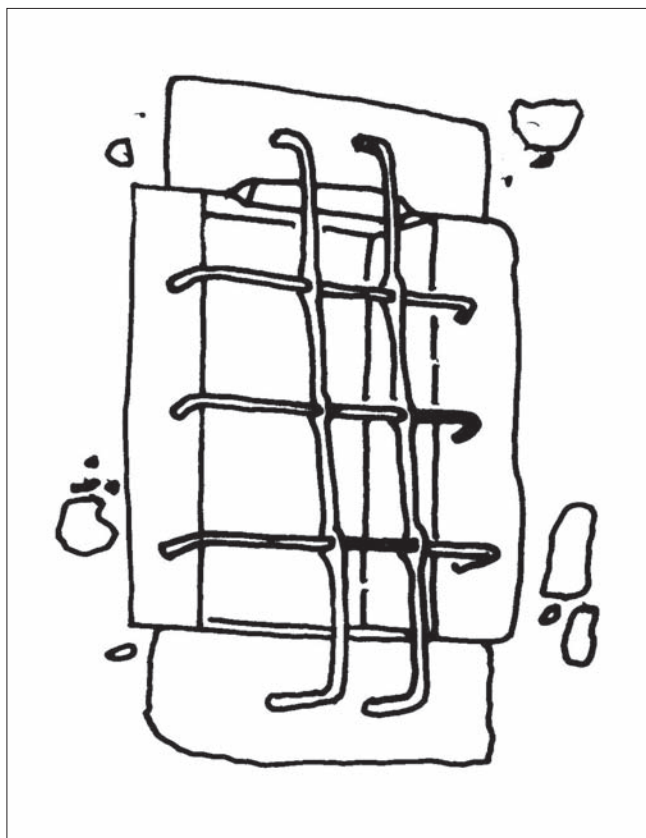
Sl. 13 Zrin, pokušaj rekonstrukcije košaraste rešetke na manjem prozoru (crtež: Z. Horvat)

Fig. 13 Zrin, a reconstruction of a basket-shaped railing on a smaller window (drawing: Z. Horvat)

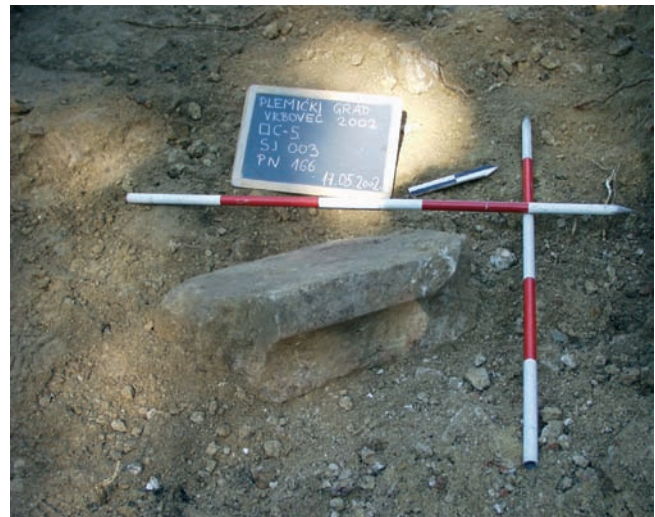
Sl. 14 Burg Vrbovec, ulomak vanjske prozorske klupčice PN 166 *in situ* (foto: T. Tkalčec)

Fig. 14 Vrbovec castle, a fragment of an exterior stone bench SF 166 *in situ* (photo: T. Tkalčec)

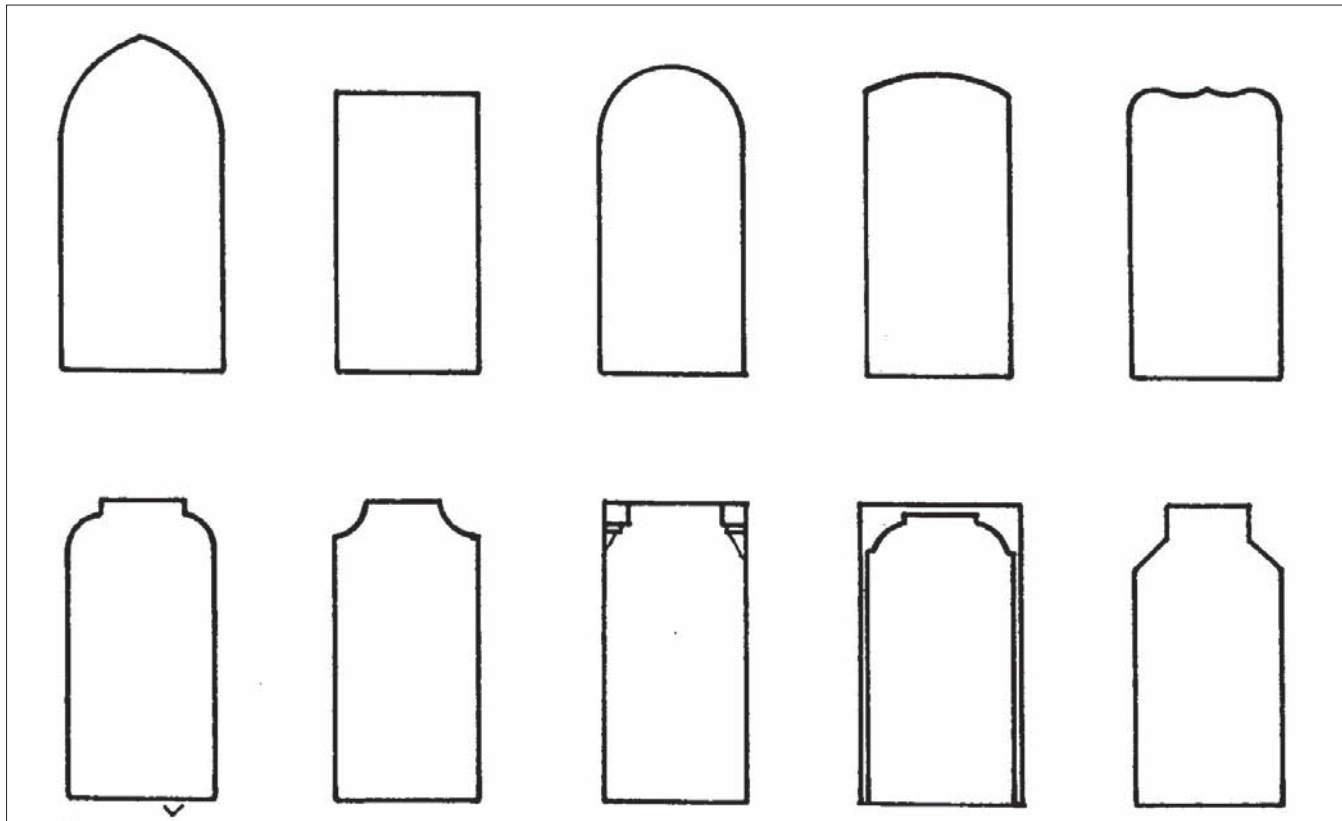
Sl. 15 Uobičajeni oblici okvira vratiju tijekom srednjeg vijeka (13. – početak 16. stoljeća) (Horvat Z. 2002)  
 Fig. 15 Customary forms of door frames during the Middle Ages (13th– beginning of the 16th century) (Horvat Z. 2002)

Cjelovito je istražena unutrašnjost prizemnih prostorija sjevernog dijela burga. Taj je prostor prvobitno bio raščlanjen na manju zapadnu prostoriju u kojoj je bila smještena kuhinja te veliku istočnu prostoriju gospodarske namjene, a poslije je pregrađen u tri prostorije, još u vremenu kada je burg funkcionirao. Od te tri prostorije, dvije imaju ulaze iz dvorišta. Zidovi su prilične debljine – vanjski 196–200 cm, dok su unutrašnji ponešto tanji: zapadni pregradni zid je širine 120 cm, istočni 92 cm, a unutrašnji zidovi prema dvorištu široki su 141–145 cm. Pod prostorija bio je zaravnani živi kamen. Zapadnu se prostoriju, prema arheološkim nalazima, može odrediti kao kuhinju, s tragovima ognjišta, ulomcima kuhinjskog posuđa i sl. Ulaz u kuhinju je djelomično očuvan, s pragom i dijelom kamena dovratnika PN 199,<sup>2</sup> profiliranog jednostavnim ukošenjem (sl. 1). Niša vratiju na unutrašnjoj strani dovratnika široka je 106 cm pa se u naravi može očitati svijetla širina 76 cm. Na tom području pronađen je i karakterističan ulomak kamena nadvratnika PN 150, oblikovanog “na heljdino zrno” (sl. 15, dolje lijevo, T. 8), o čemu će biti više riječi u daljnjem tekstu.

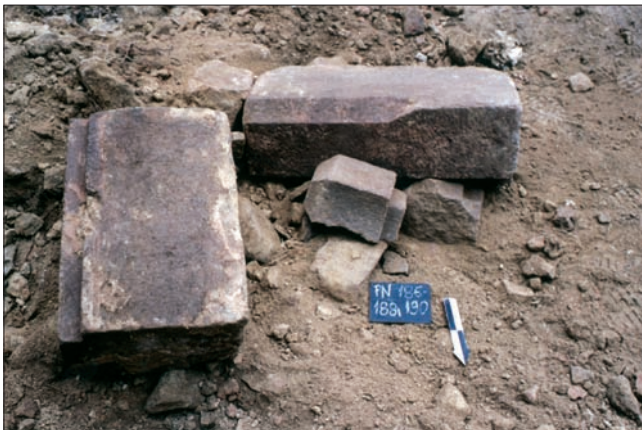
Sl. 16 Burg Vrbovec, dijelovi okvira vrata – lijevo PN 190, u sredini PN 187, gore PN 186 (foto: T. Tkalčec)

Fig. 16 Vrbovec castle, fragments of a door frame – left SF 190, centre SF 187, above SF 186 (photo: T. Tkalčec)

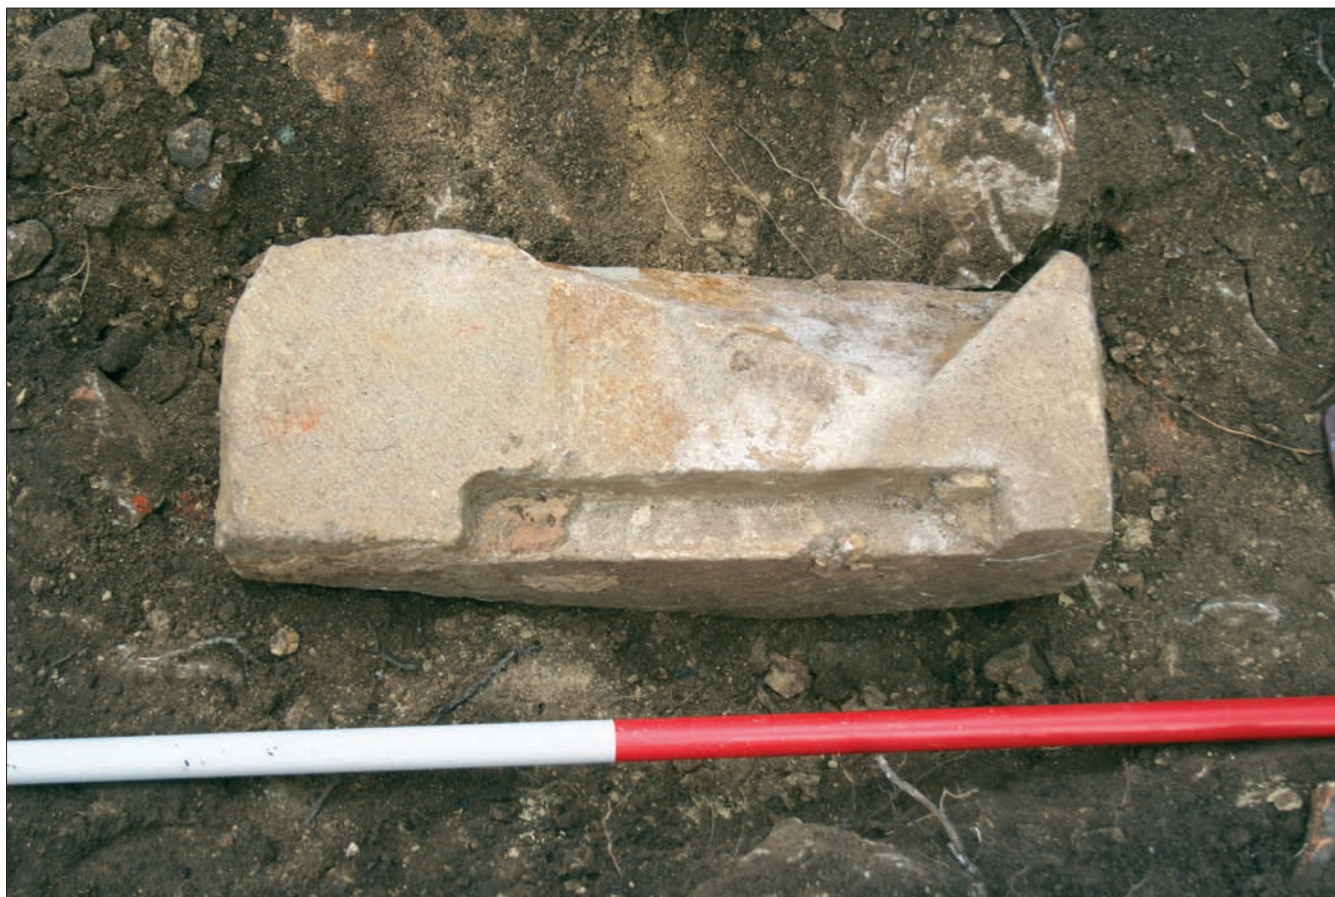
Sl. 18 Burg Vrbovec, pronalazak okvira manjeg prozora PN 447 (foto: T. Tkalčec)  
 Fig. 18 Vrbovec castle, a find of a frame of a smaller window SF 447 (photo: T. Tkalčec)

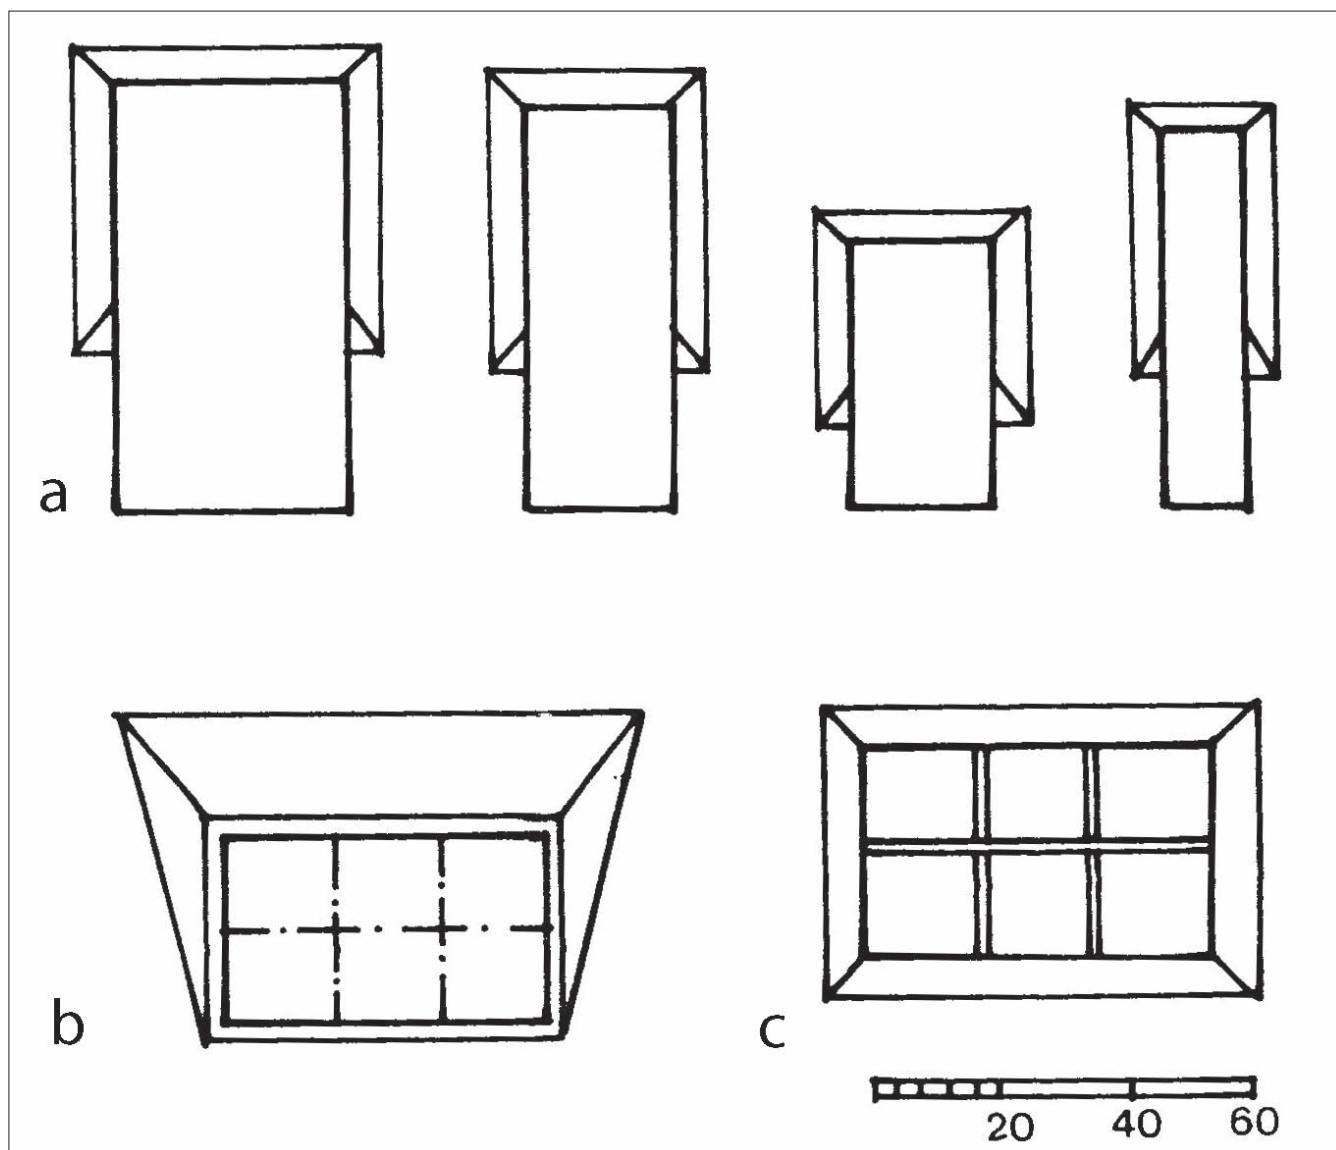
Sl. 19 Ribnik, prikaz prozora s burga: a–tipični prozori 15. st.; b–prozor podruma s ekscentričnim oblikom prema gore otvorenog okvira; c–prozor gospodarskih prostorija sa sva četiri skošena ruba (crtež: Z. Horvat)

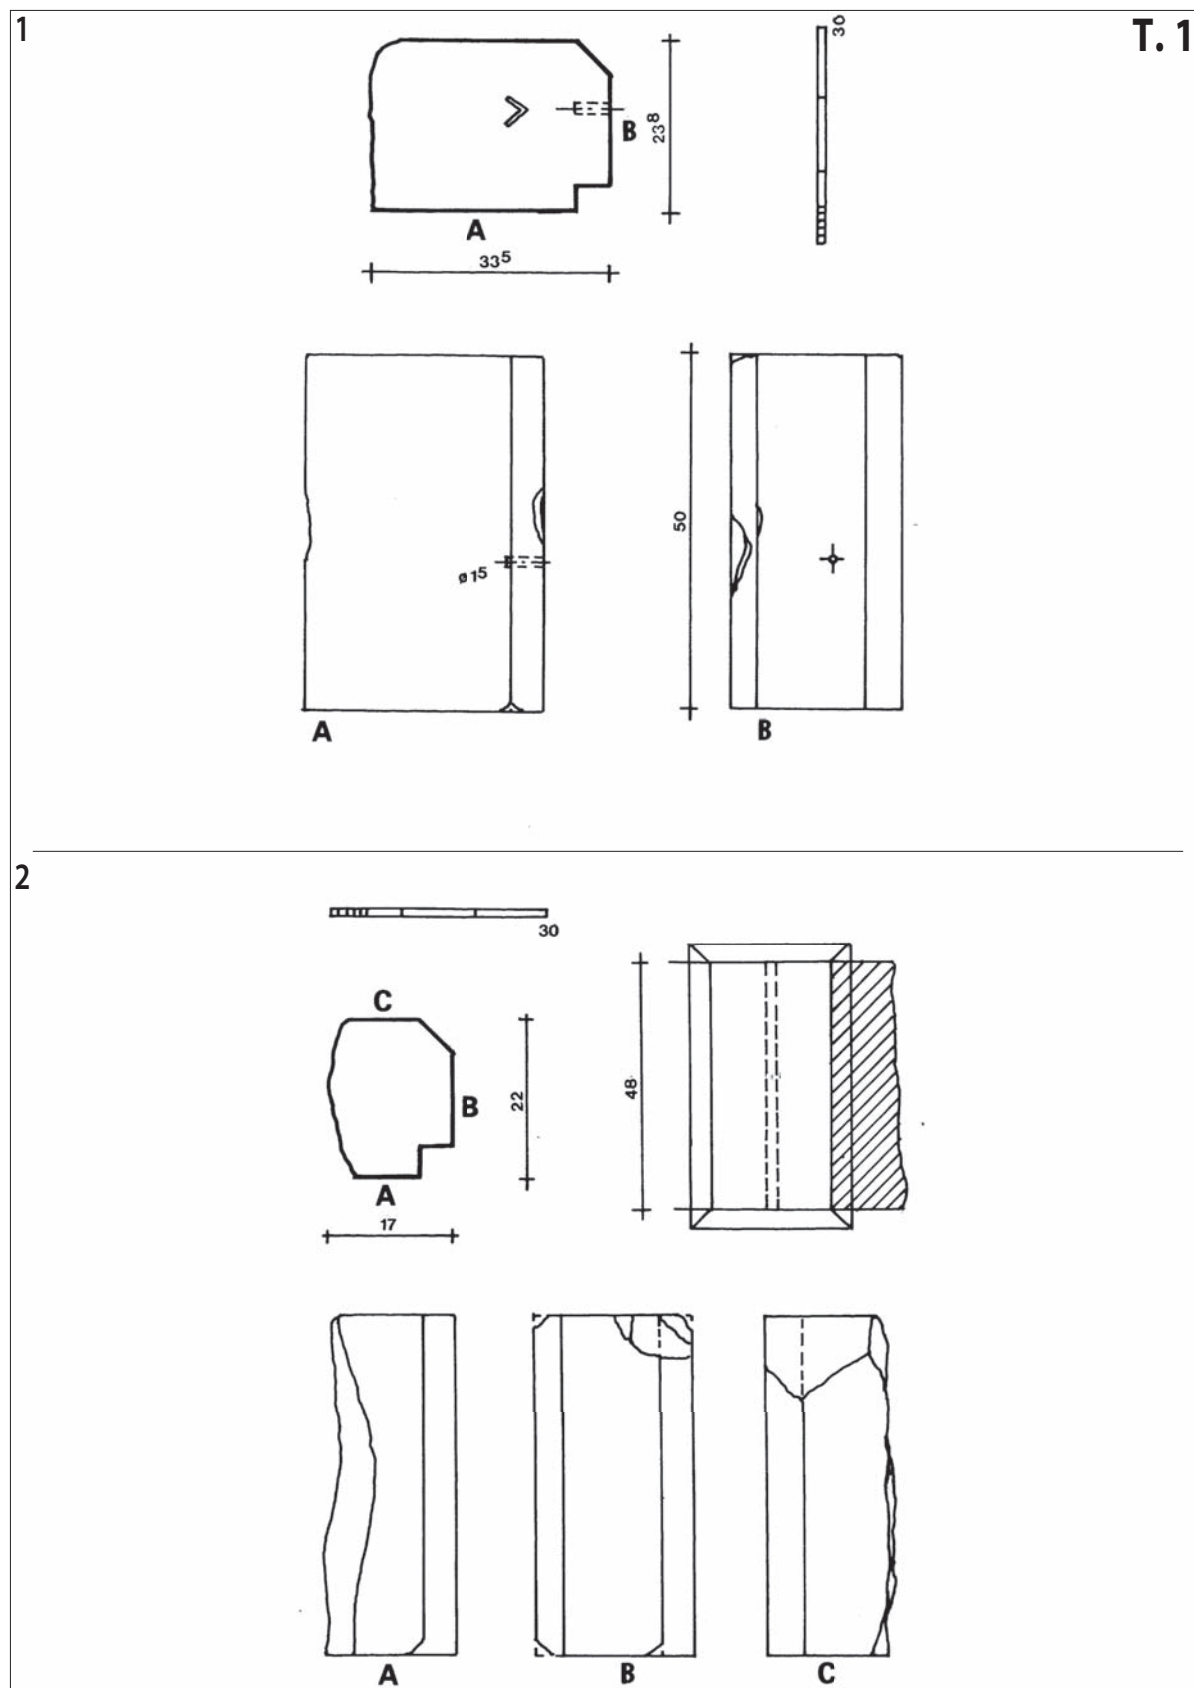
T. 1 Manji prozori – 1: PN 184; 2: PN 227 (desno gore – mogući izgled prozora i pozicija ulomka) (crtež: Z. Horvat)  
 Pl. 1 Small-sized windows – 1: SF 184; 2: SF 227 (above right – a possible appearance of a window and positions of fragments) (drawing: Z. Horvat)
