# Arhitektura i arhitektonska plastika burga Vrbovca kraj Huma na Sutli

## *Architecture and Architectural Stonework of the Mediaeval Castle of Vrbovec near Hum na Sutli*

Izvorni znanstveni rad  
Srednjovjekovna arheologija

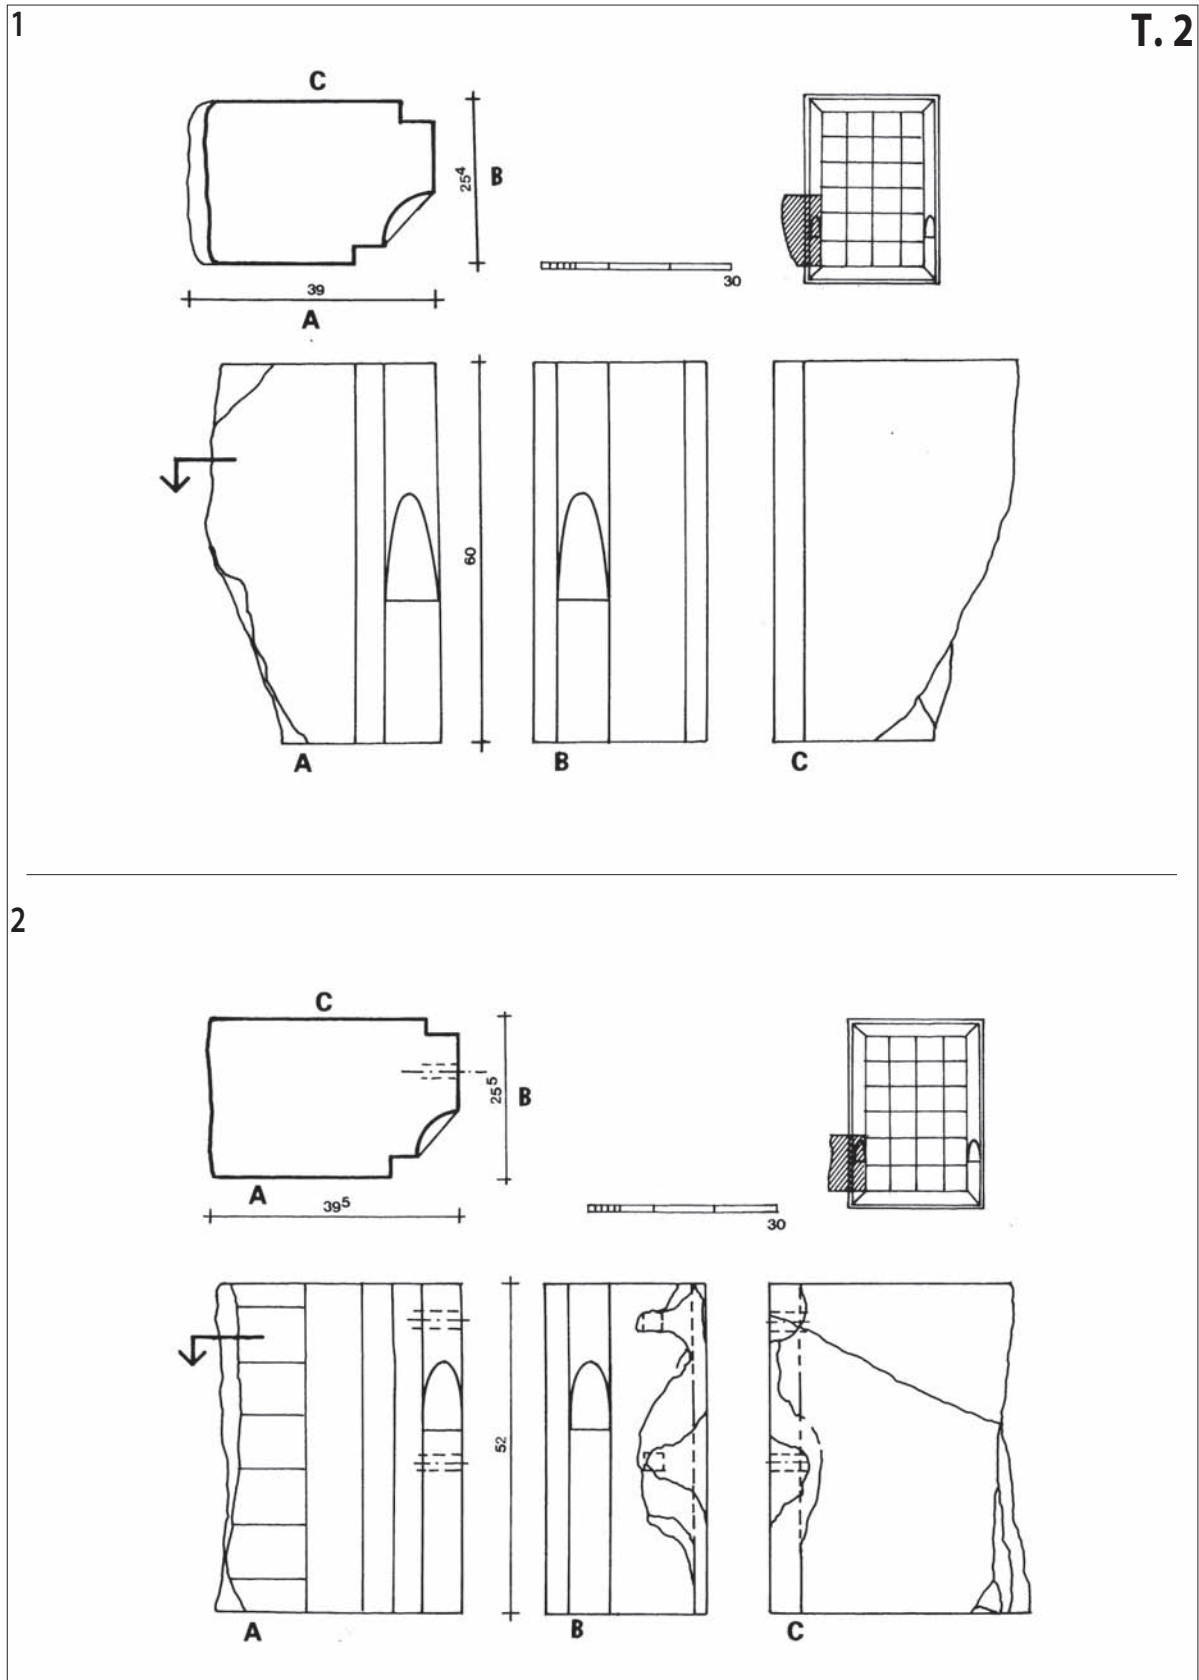
T. 2 Prozori srednje veličine – 1: PN 264; 2: PN 426 (crtež: Z. Horvat)  
 Pl. 2 Medium-sized windows – 1: SF 264; 2: SF 426 (drawing: Z. Horvat)

pronađen u dvorištu burga, dok je PN 426 pronađen izvan jezgre burga, istočno od sjeveroistočne prostorije palasa (plan 1, sl. 5). Ulomak PN 426 je posebno zanimljiv zbog tragova bojanja pročelja bijelom i oker bojom. Prozor je nekada imao ugrađenu željeznu rešetku, koja je nasilno izvađena (T. 2:2, sl. 6).

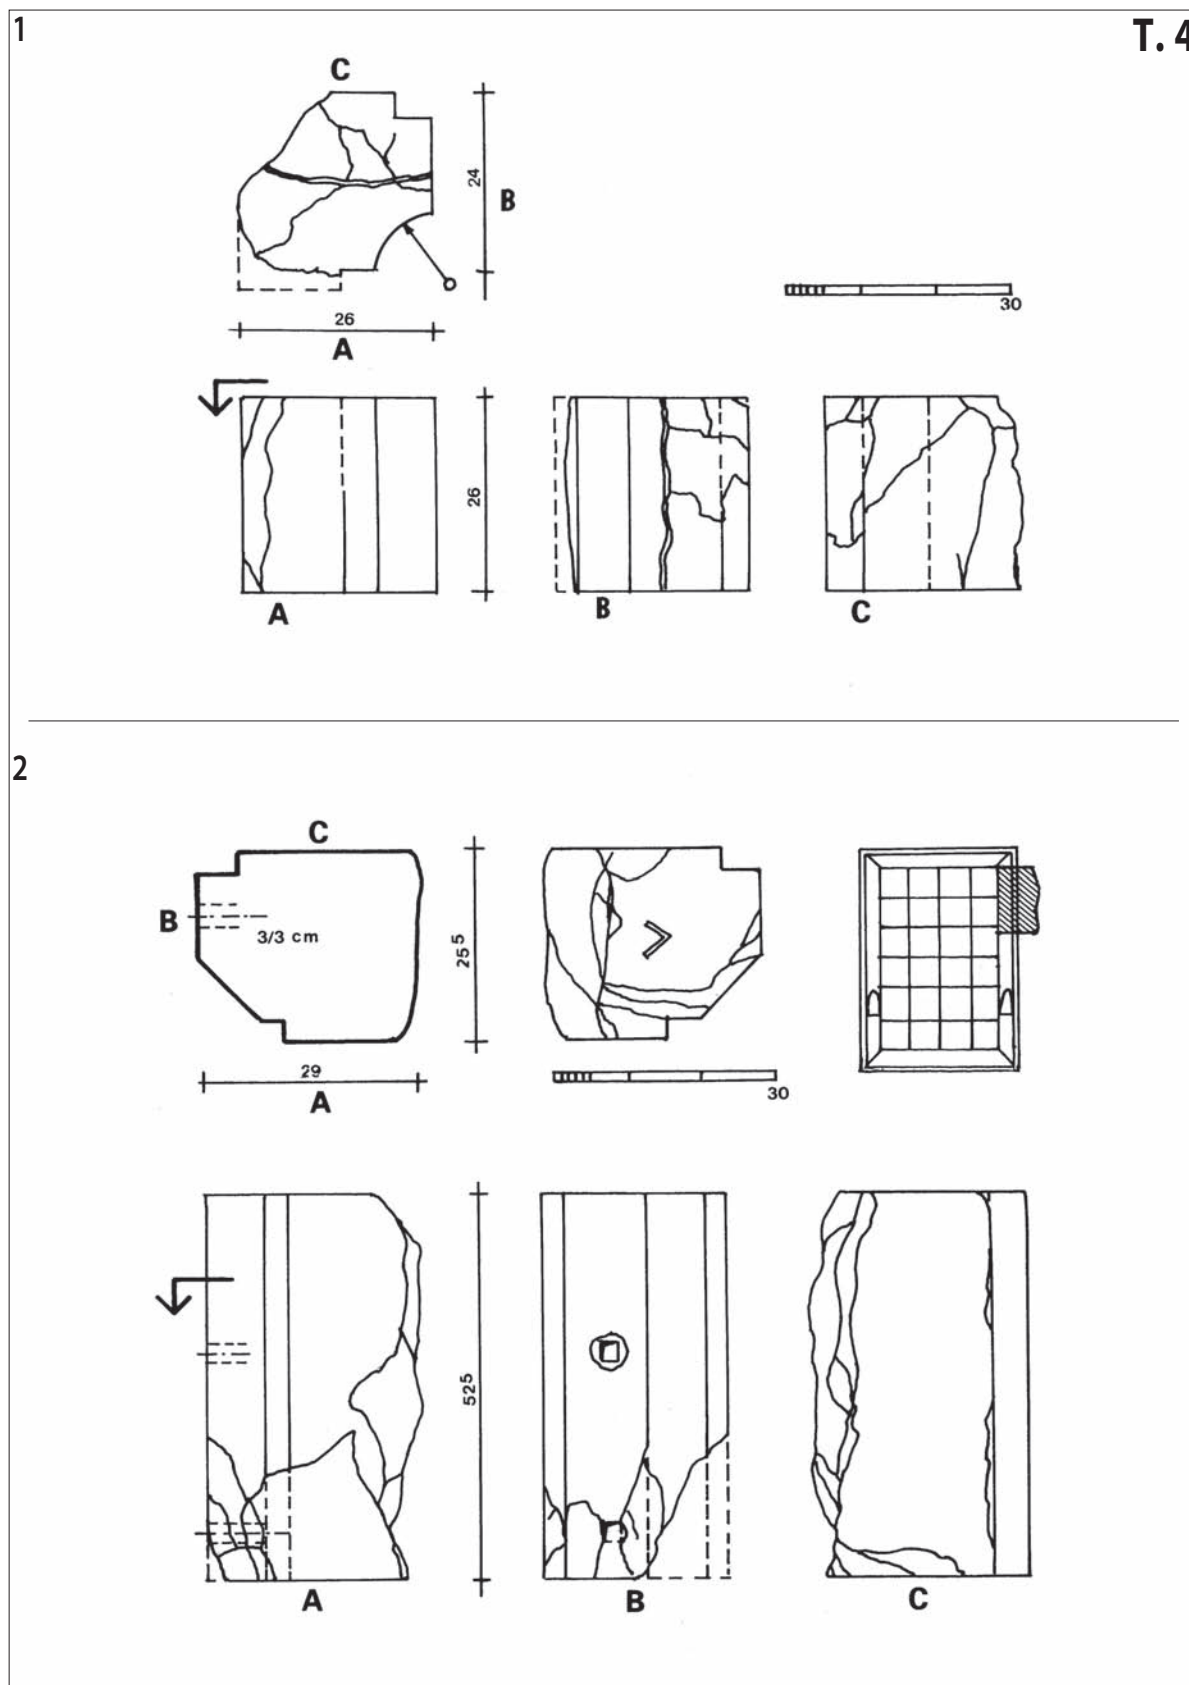
T. 4 Prozori srednje veličine – 1: PN 258; 2: PN 183 (crtež: Z. Horvat)  
 Pl. 4 Medium-sized windows – 1: SF 258; 2: SF 183 (drawing: Z. Horvat)

Fragments of the stone frame of window SF 258 have quite damaged mouldings, without any characteristic features. Nevertheless, considering the spot of discovery, they undoubtedly form part of the same window as SF 259 (Pl. 4:1).

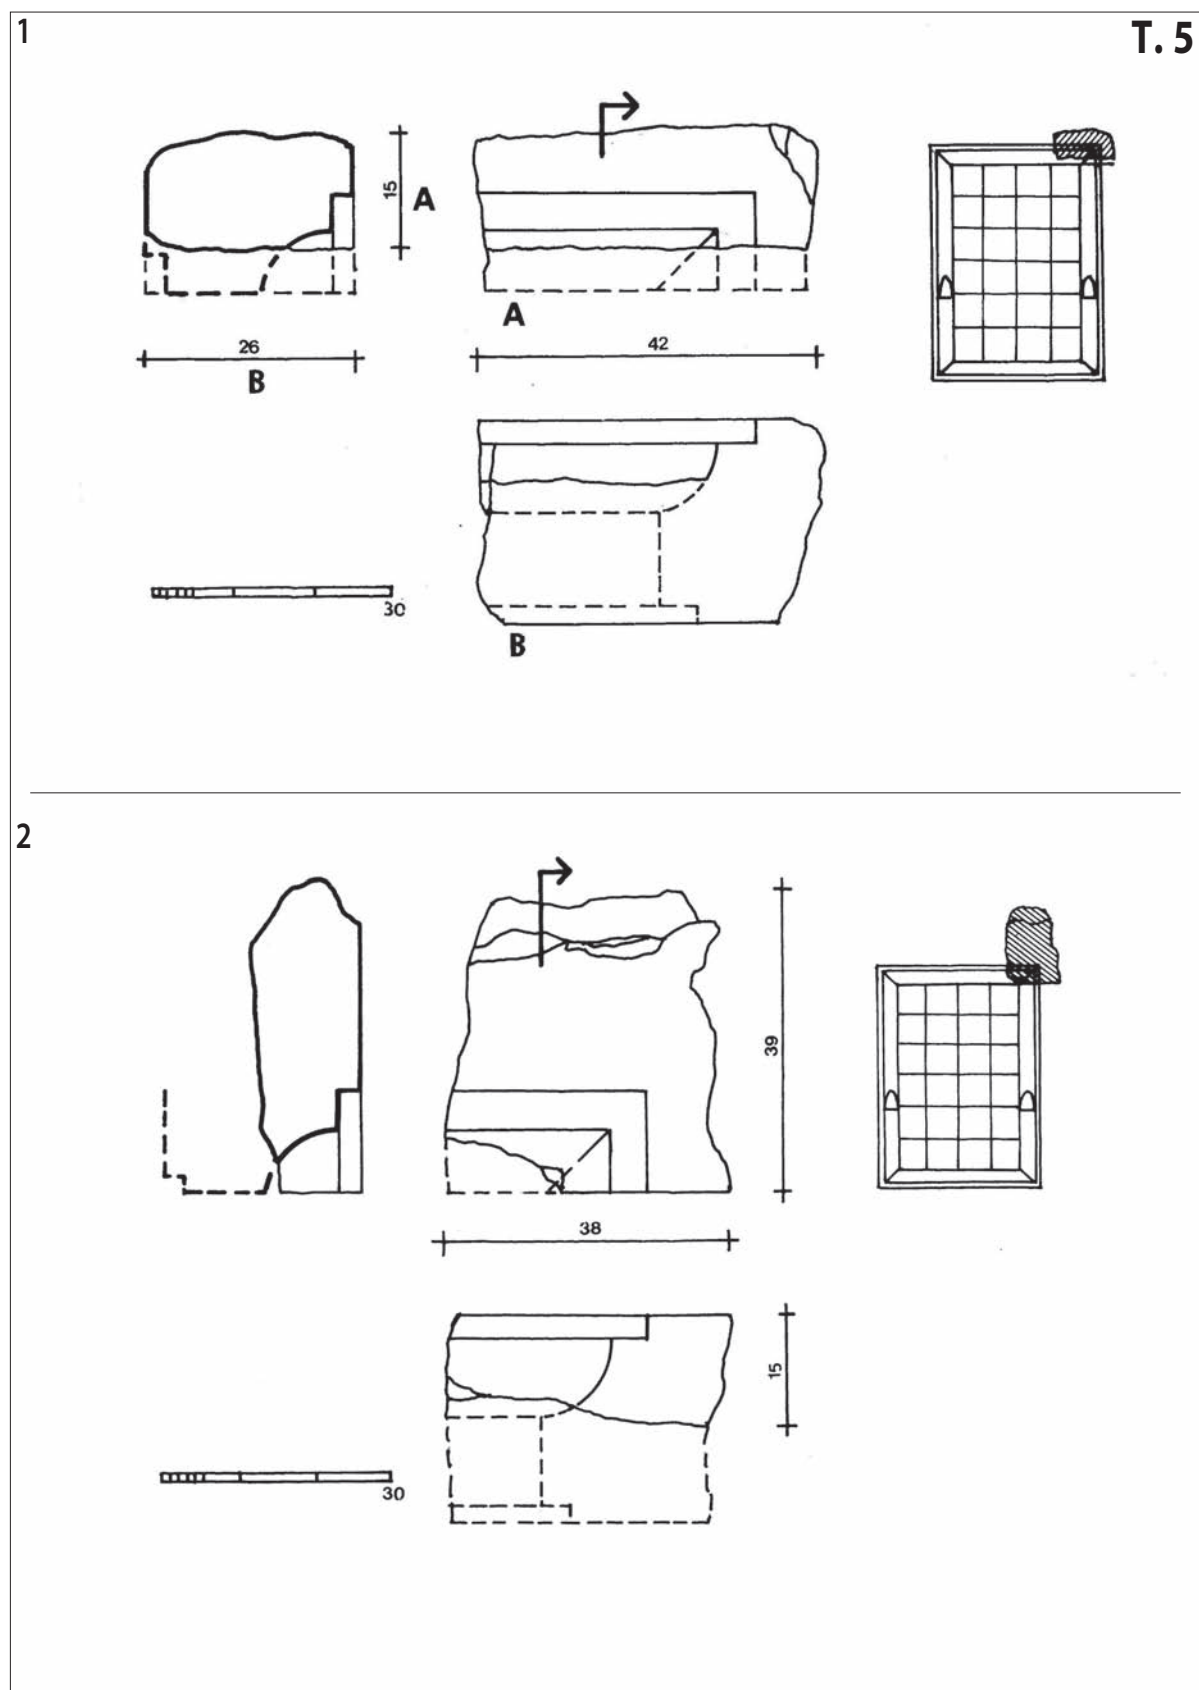
T. 5 Prozori srednje veličine – 1: PN 261; 2: PN 262 (crtež: Z. Horvat)  
Pl. 5 Medium-sized windows – 1: SF 261; 2: SF 262 (drawing: Z. Horvat)

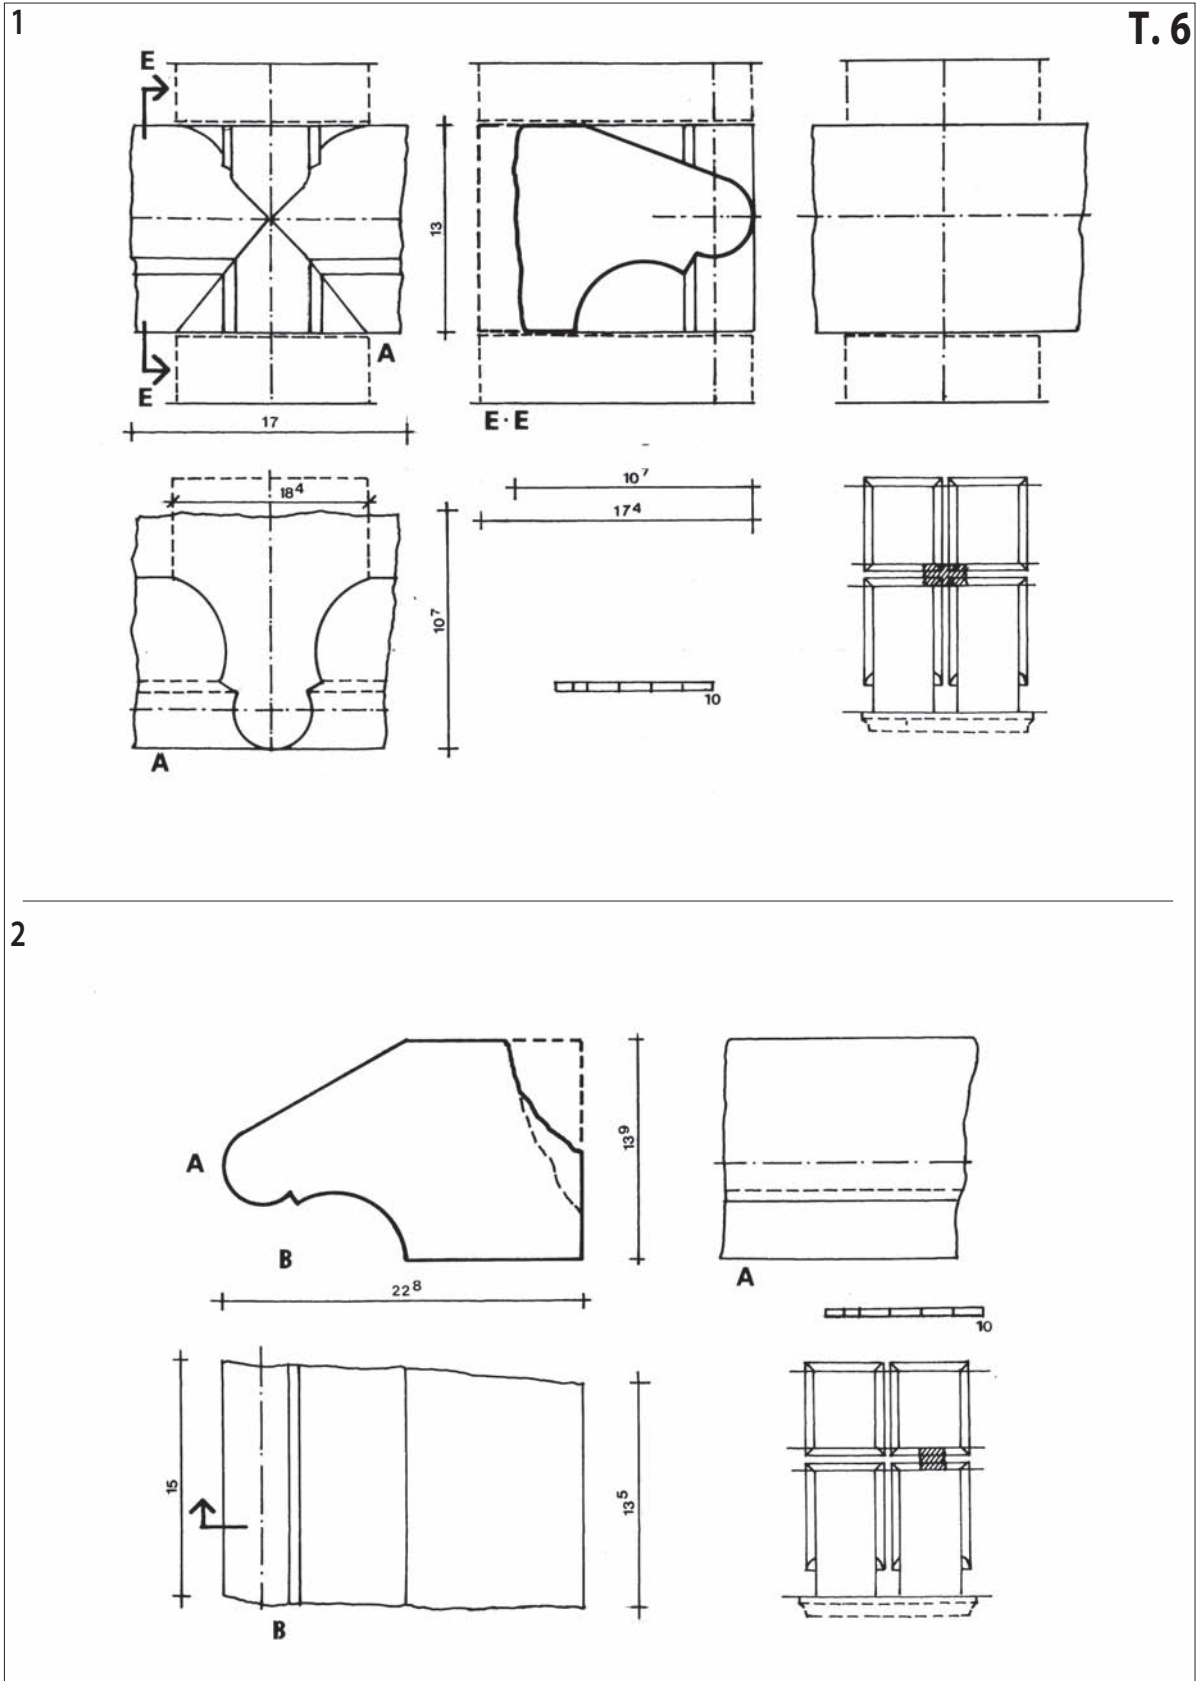
T. 6 "Češki prozori" – 1: PN 448; 2: PN 450 (crtež: Z. Horvat)

Pl. 6 "Bohemian windows" – 1: SF 448; 2: SF 450 (drawing: Z. Horvat)

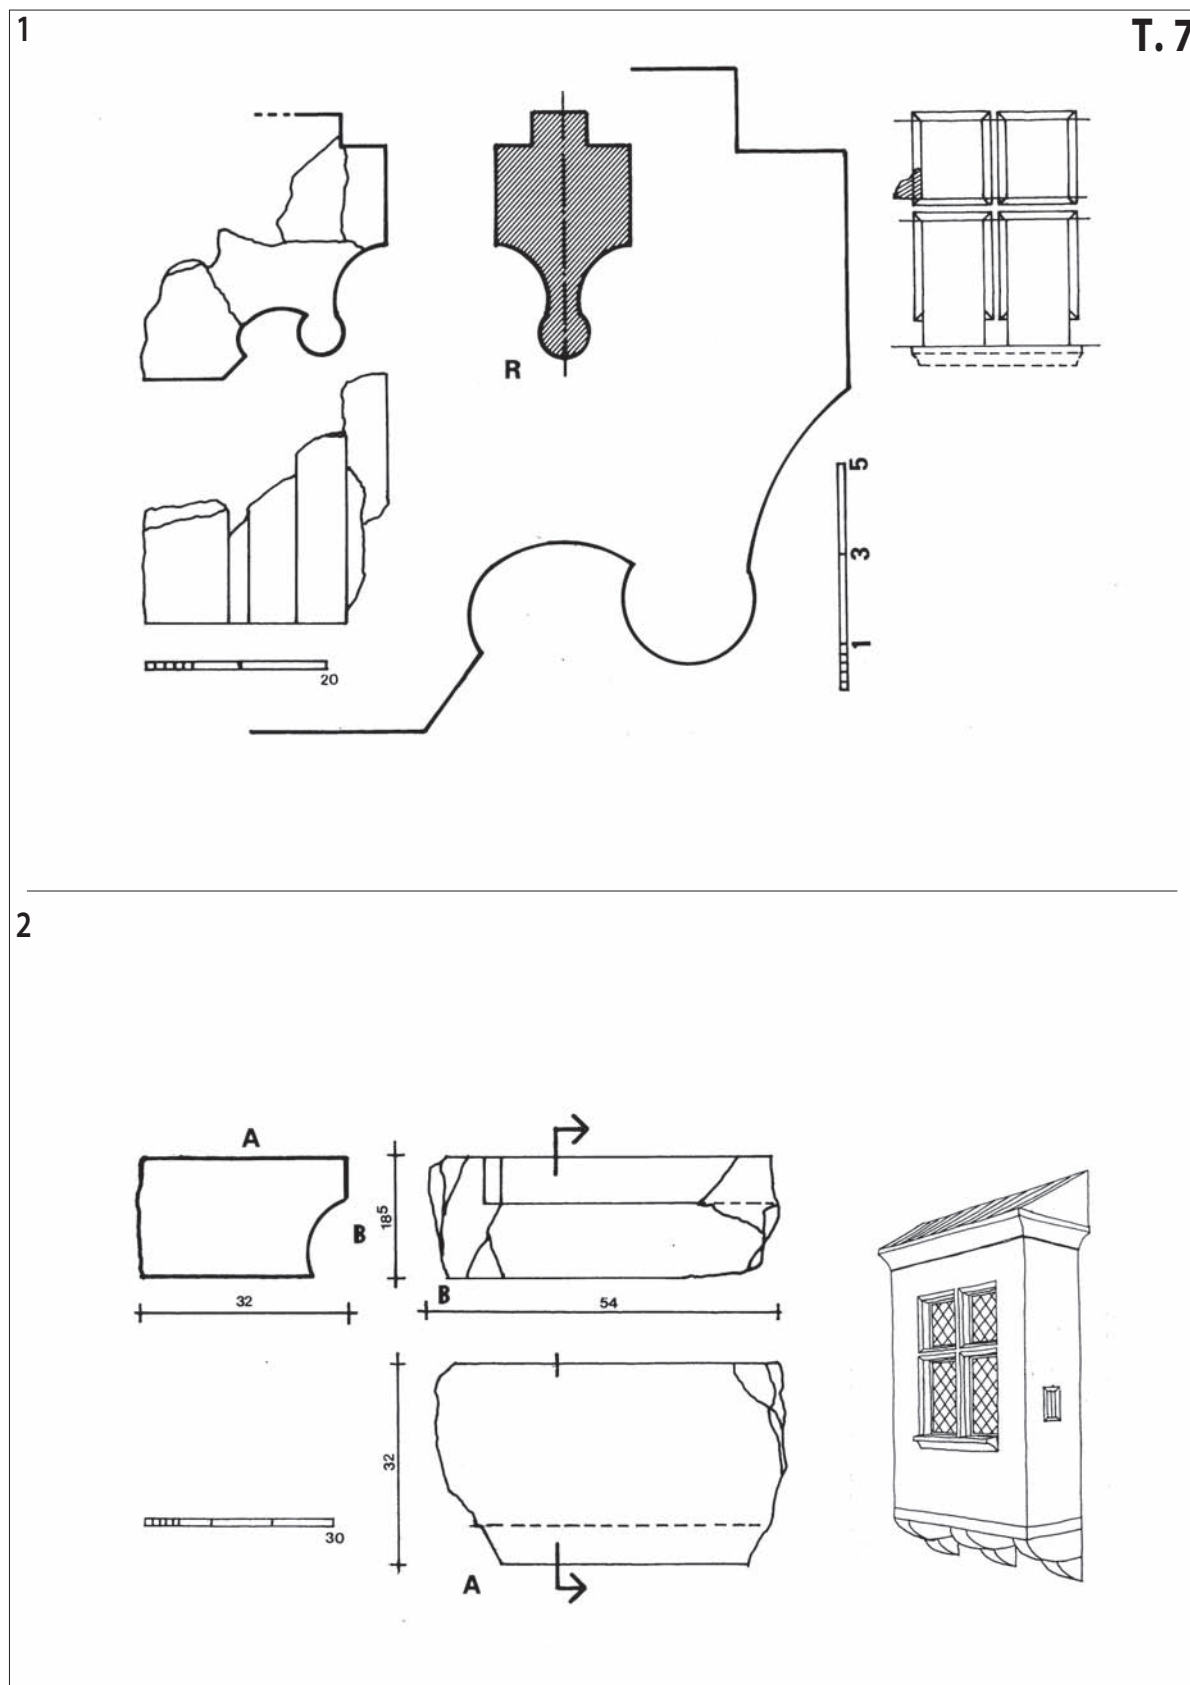
T. 7 "Češki prozor" – 1: PN 193–197; 2: ulomak klupčice PN 166 (crtež: Z. Horvat)

Pl. 7 "Bohemian window" – 1: SF 193–197; 2: fragment of a small bench: SF 166 (drawing: Z. Horvat)

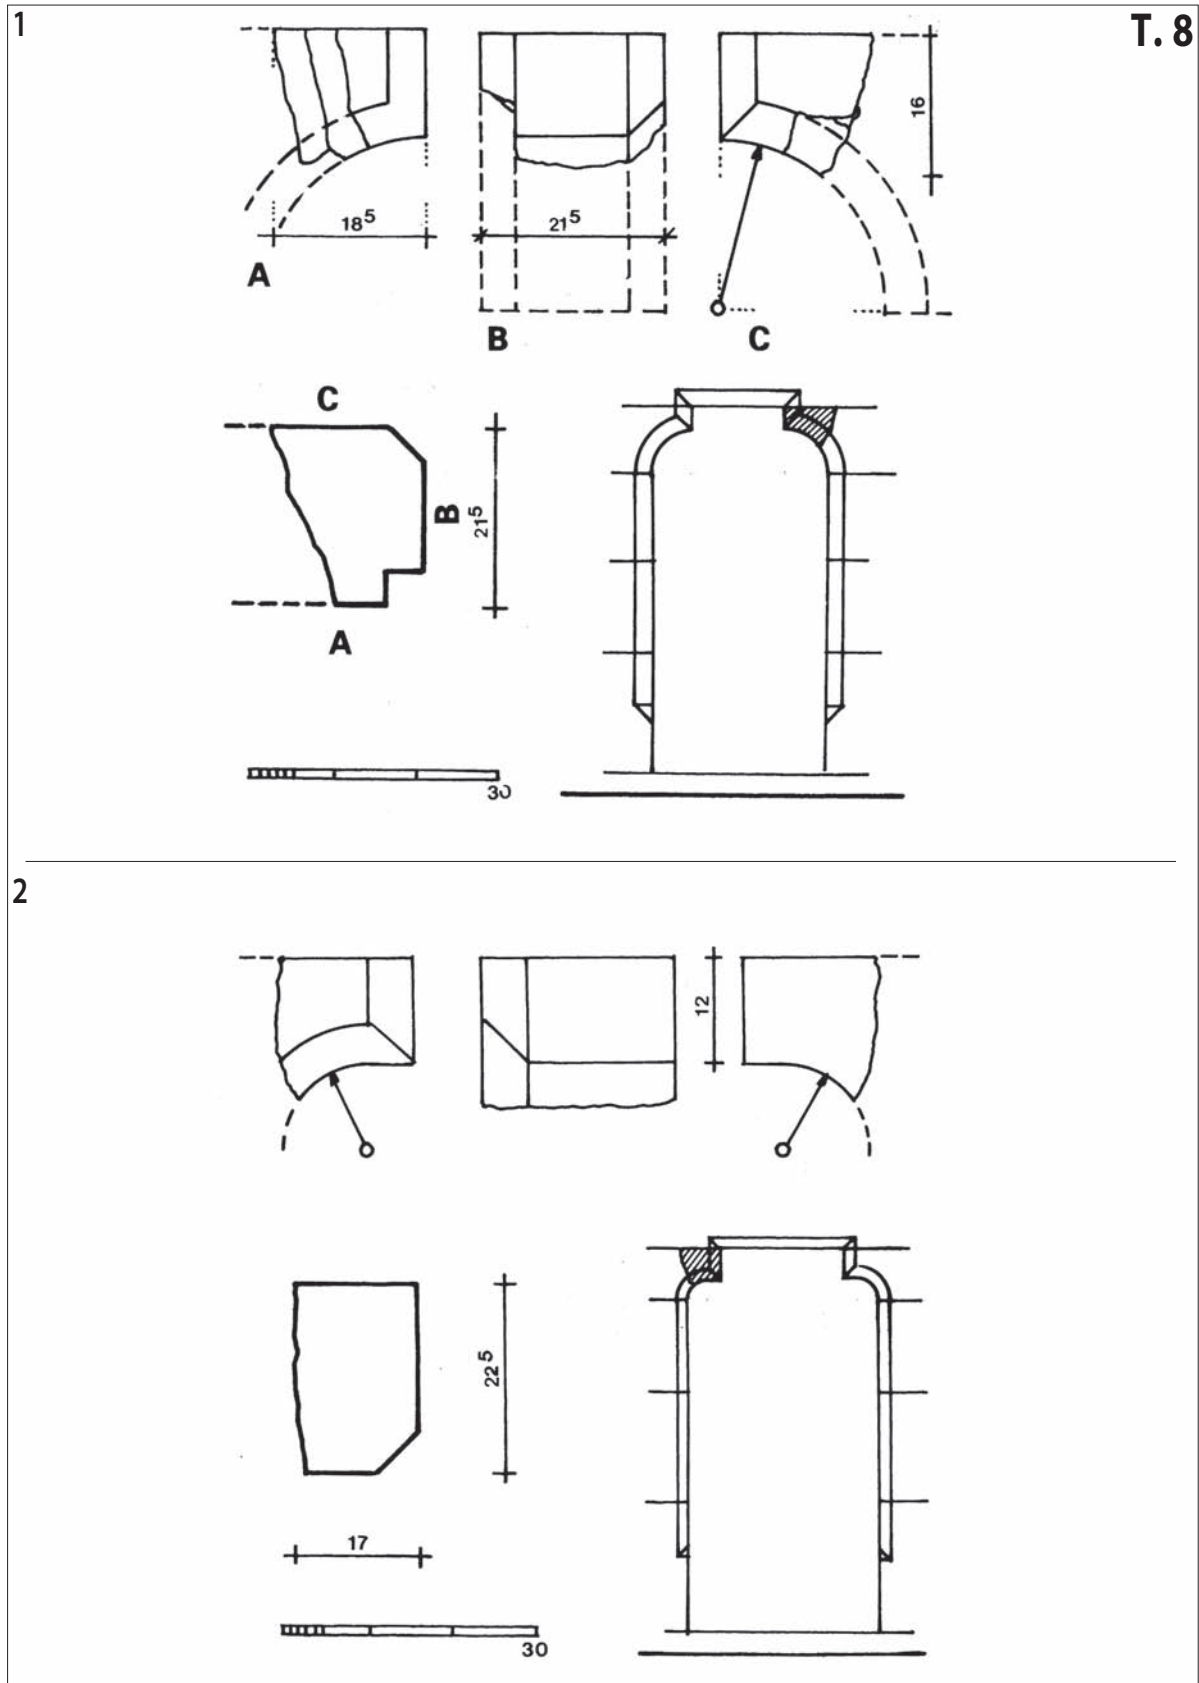
T. 8 Dovratnici – 1: PN 187; 2: PN 150 (crtež: Z. Horvat)  
Pl. 8 Door jambs – 1: SF 187; 2: SF 150 (drawing: Z. Horvat)

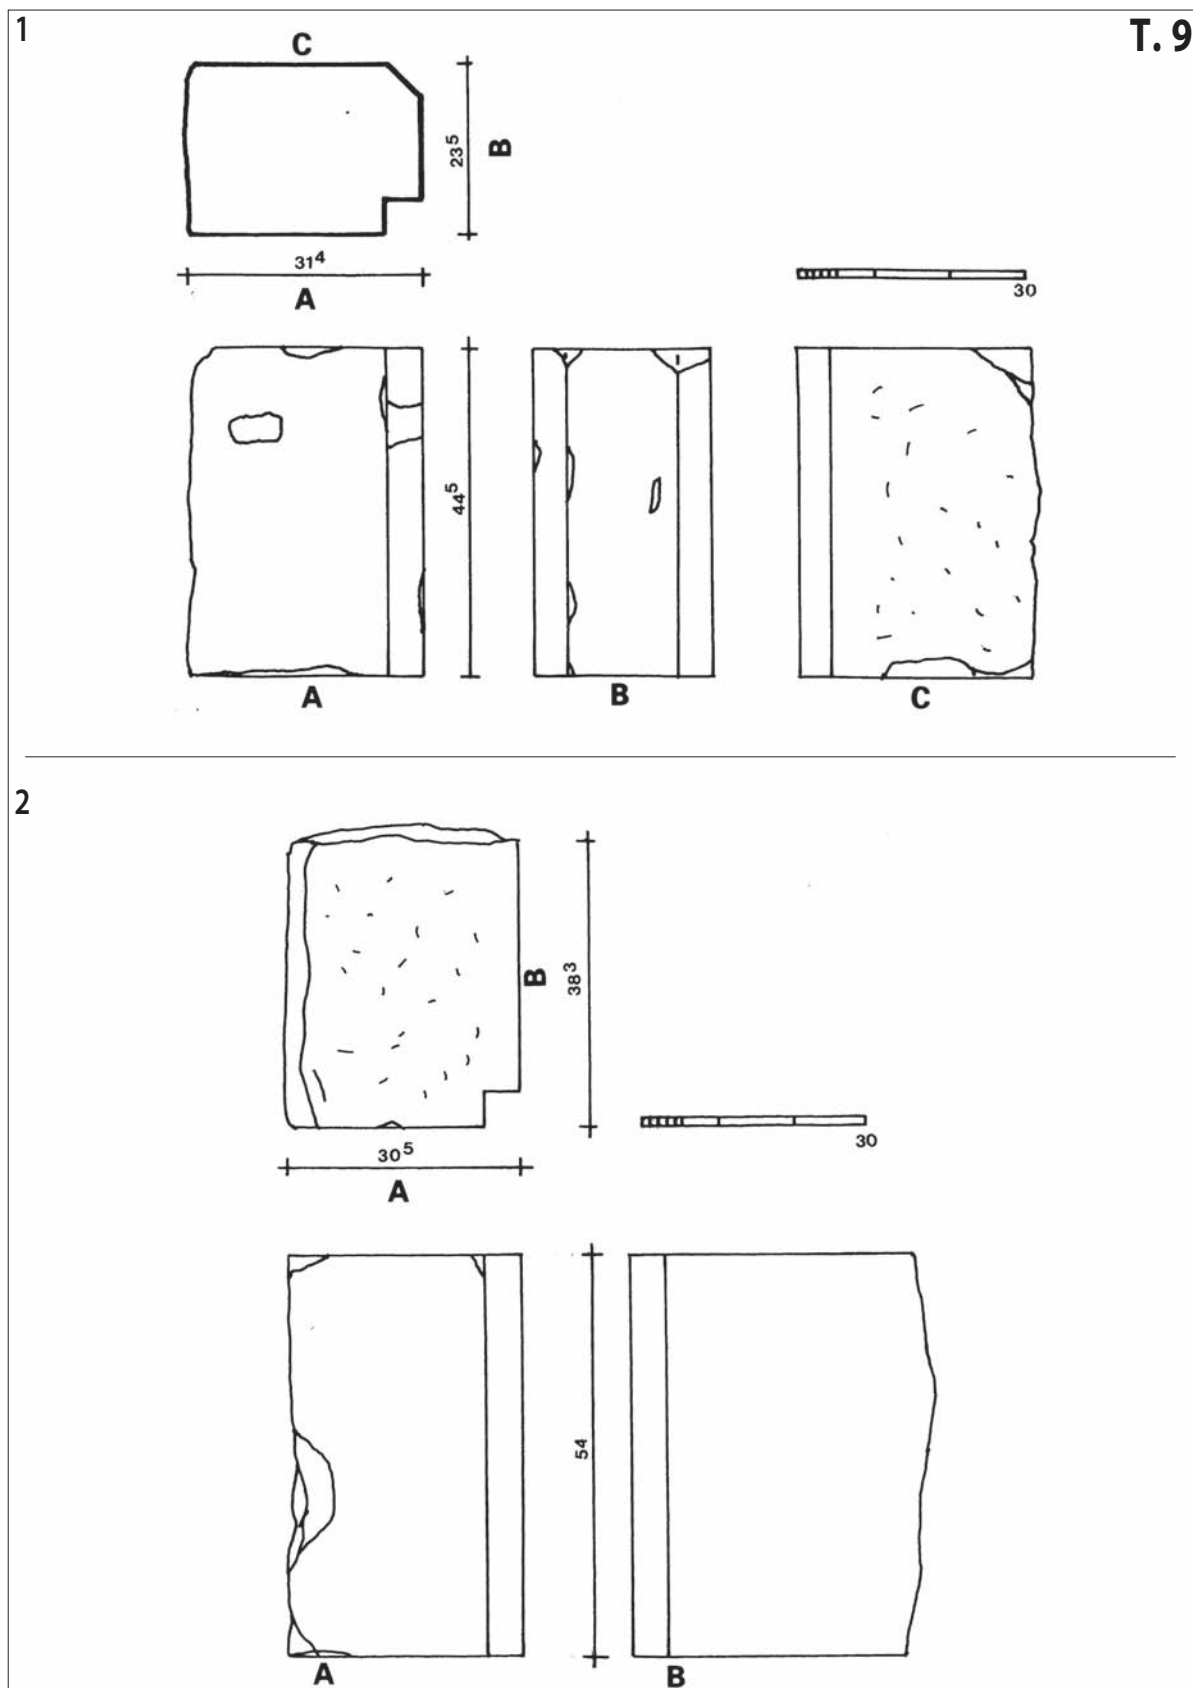
T.9 Dovratnici – 1: PN 190; 2: PN 289 (crtež: Z. Horvat)  
Pl.9 Door jambs – 1: SF 190; 2: SF 289 (drawing: Z. Horvat)

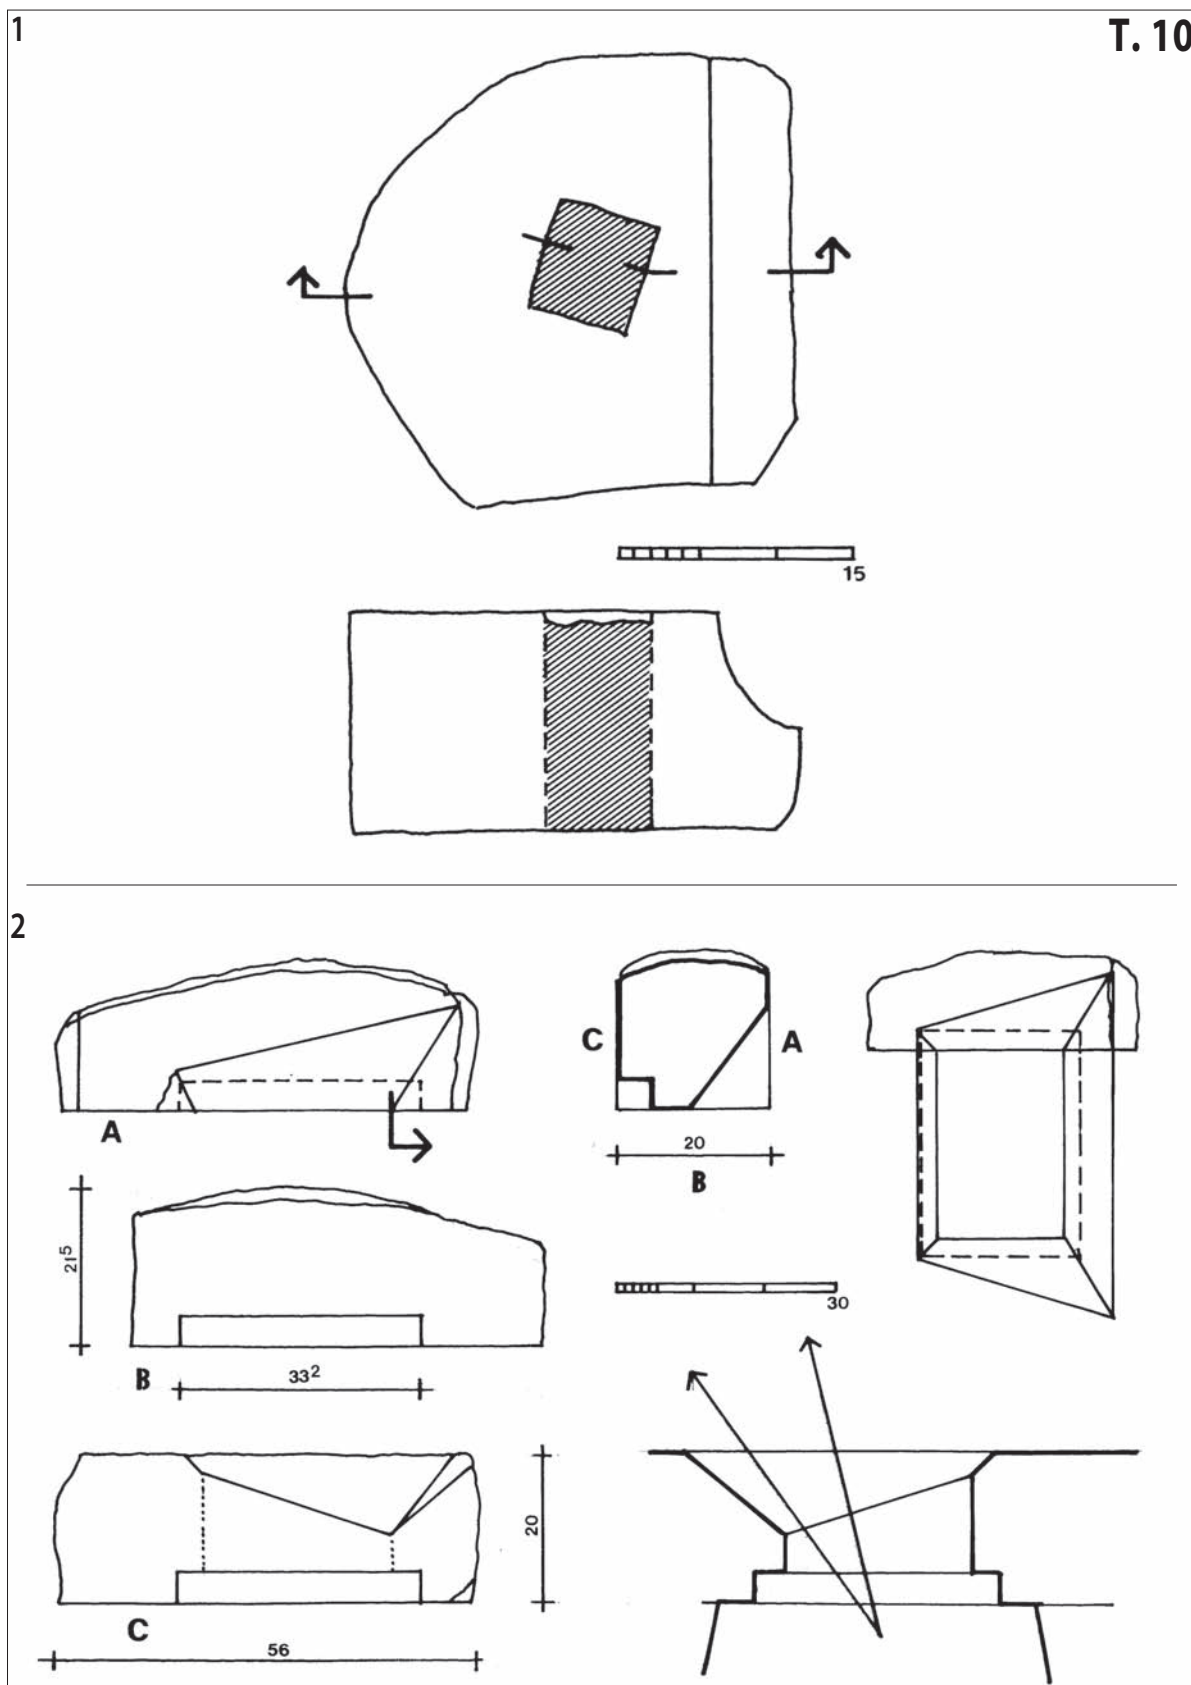
T. 10 Ulomci specifične namjene – 1: PN 181– brusni kamen korišten kao spolij; 2: PN 447 – mali prozor specifične namjene (crtež: Z. Horvat)
