Arhitektura i arhitektonska plastika burga Vrbovca kraj Huma na Sutli

Architecture and Architectural Stonework of the Mediaeval Castle of Vrbovec near Hum na Sutli

Izvorni znanstveni rad
Srednjovjekovna arheologija

U radu je prikazan burg Vrbovec, smješten na krajnjem zapadu Hrvatskoga zagorja. Nakon iznošenja pregleda opisa i položaja burga, osnovnih povijesnih podataka i rezultata arheoloških istraživanja, arhitektura burga se razmatra i u širem kontekstu. Naziru se tri faze gradnje. Prvu fazu svjedoči sam tlocrt burga, drugu, osim ziđa, iskazuje množina kvalitetnih ulomaka arhitektonske profane plastike i poneka zaostala pojedinost u zidovima. Treća faza gradnje pripada razdoblju ranoga novog vijeka, kada se ruševni zidovi burga, nakon njegova stradavanja, koriste u svrhe stražarskih mjesta. Izdvajaju se nalazi vrlo kvalitetne klesane arhitektonske plastike, odnosno kamenih okvira prozora i vratiju, koji pripadaju drugoj fazi burga. Analizom je ustanovljeno da se radi o vremenu prvih desetljeća 15. stoljeća, kada je burg u vlasništvu srednjoeuropskih magnata – grofova Celjskih, koji ga bogato i stilski opremaju u duhu onoga doba.

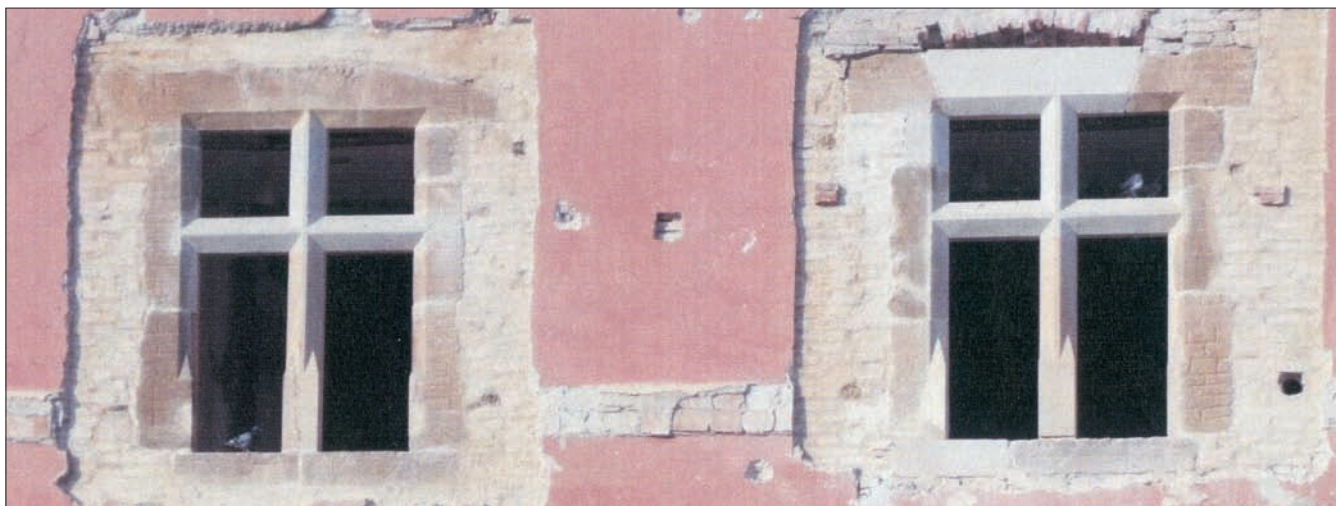
Sl. 12 Ilok – palača Odescalchi, nekadašnji palas knezova Iločkih, južno pročelje II. kata (foto: Đ. Šimičić)

Fig. 12 Ilok – Odescalchi palace, former palace of the Dukes of Ilok, southern façade of the 2nd floor (photo: Đ. Šimičić)

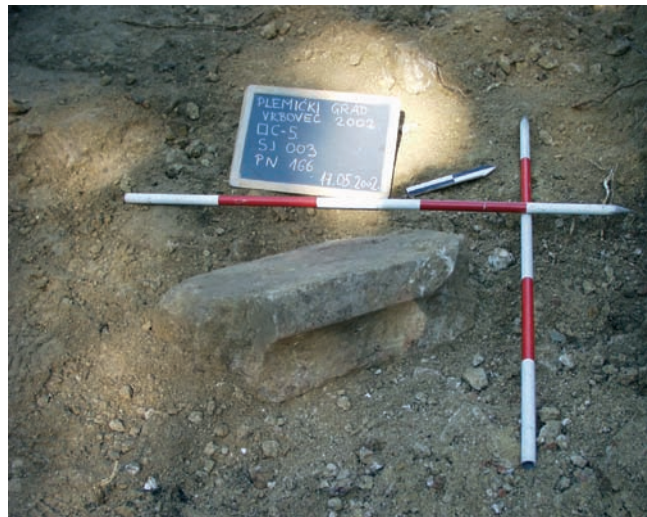
Sl. 14 Burg Vrbovec, ulomak vanjske prozorske klupčice PN 166 *in situ* (foto: T. Tkalčec)

Fig. 14 Vrbovec castle, a fragment of an exterior stone bench SF 166 *in situ* (photo: T. Tkalčec)

¹⁶The fragment of a bench could not have arrived in that place in the Modern period, because it was found in intact layer SU 003, a layer of collapse of the medieval fortified town. In the courtyard, this layer was covered with an undisturbed layer from the Modern period. This means that a contamination of that layer in the long period following the collapse of the fortified town could not have taken place.

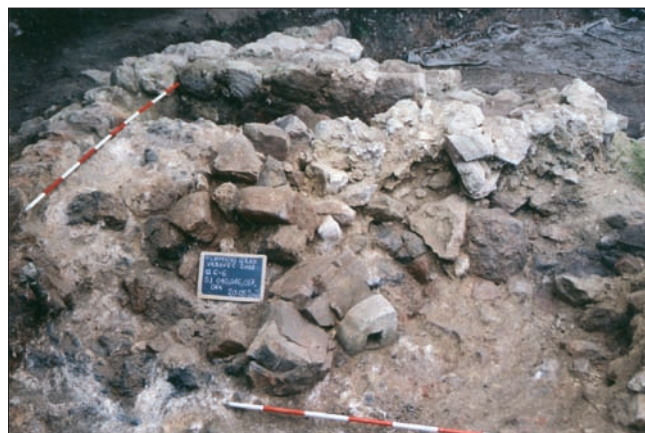
Sl. 17 Burg Vrbovec, pronalazak spolije PN 181 i neposredno do nje "češkog prozora" PN 182 (foto: T. Tkalčec)

Fig. 17 Vrbovec castle, a find of spolia SF 181 and adjacent to it a "Bohemian window" SF 182 (photo: T. Tkalčec)
