Arhitektura i arhitektonska plastika burga Vrbovca kraj Huma na Sutli

Architecture and Architectural Stonework of the Mediaeval Castle of Vrbovec near Hum na Sutli

*Original scientific paper
Medieval archaeology*

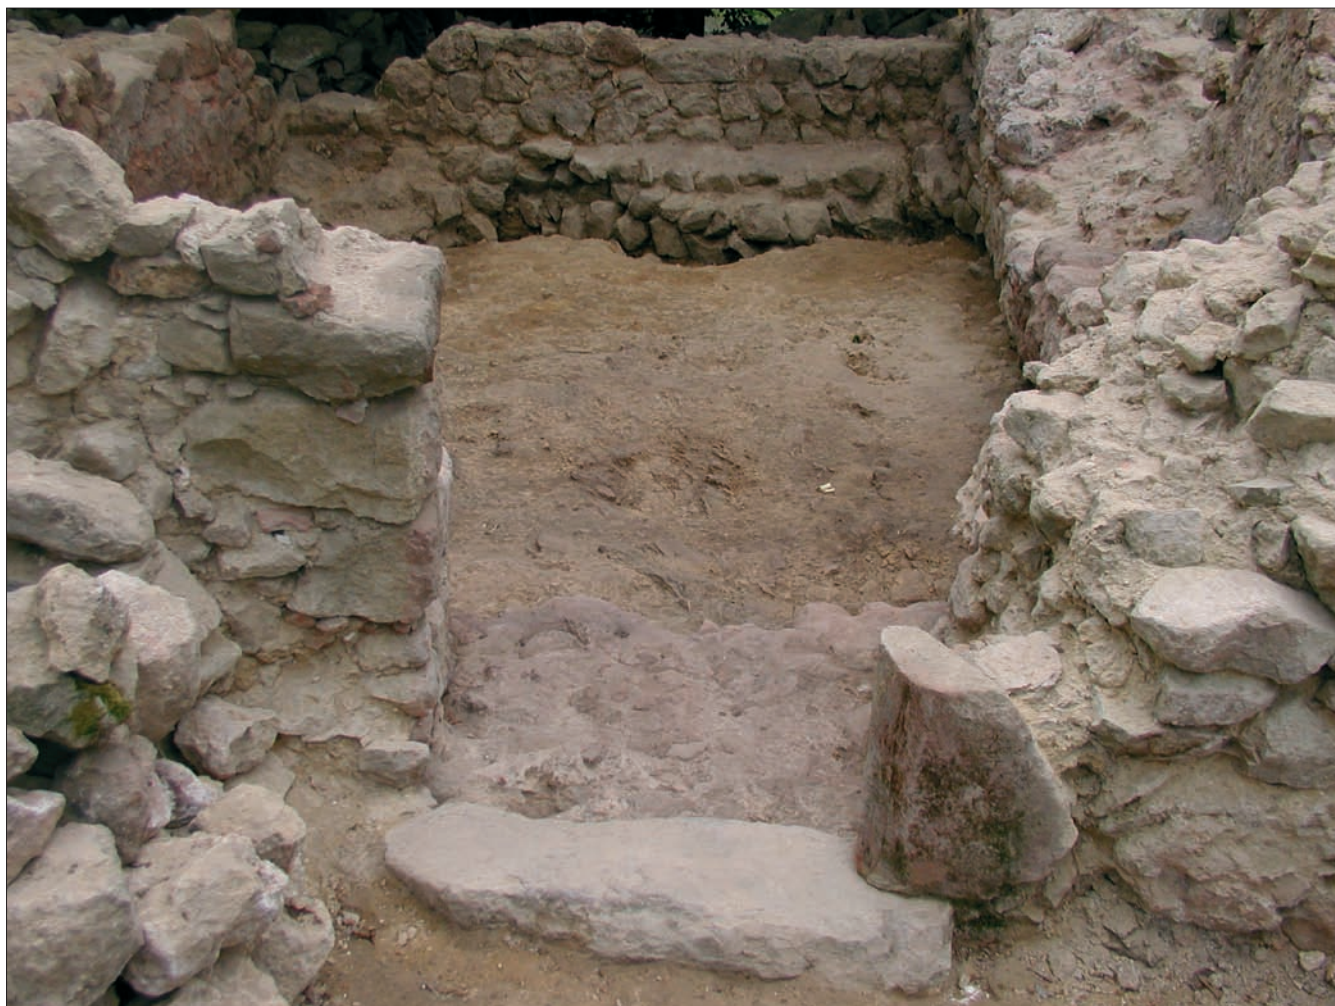
Sl. 1 Burg Vrbovec, pogled s juga na ulaz u kuhinju i dovratnik PN 199 tijekom arheoloških istraživanja 2003. g. (foto: M. Dizdar)
 Fig. 1 The castle of Vrbovec, a view from the south to the kitchen entrance and door jamb SF 199 during archaeological investigations in 2003 (photo: M. Dizdar)

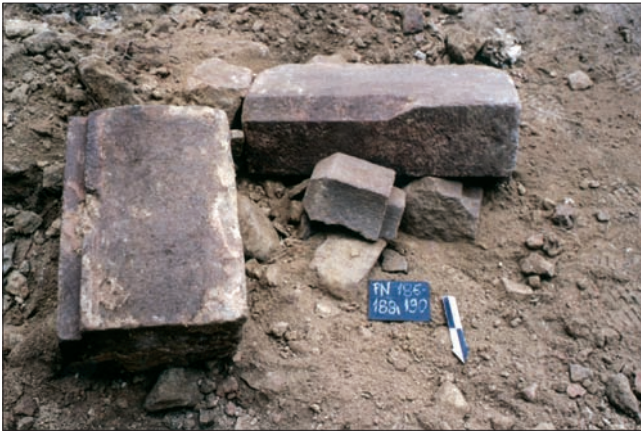
Sl. 16 Burg Vrbovec, dijelovi okvira vrata – lijevo PN 190, u sredini PN 187, gore PN 186 (foto: T. Tkalčec)

Fig. 16 Vrbovec castle, fragments of a door frame – left SF 190, centre SF 187, above SF 186 (photo: T. Tkalčec)

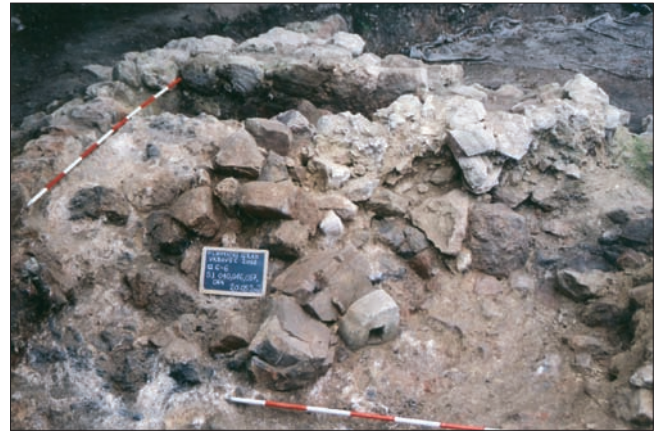
Sl. 17 Burg Vrbovec, pronalazak spolije PN 181 i neposredno do nje "češkog prozora" PN 182 (foto: T. Tkalčec)

Fig. 17 Vrbovec castle, a find of spolia SF 181 and adjacent to it a "Bohemian window" SF 182 (photo: T. Tkalčec)
