Arhitektura i arhitektonska plastika burga Vrbovca kraj Huma na Sutli

Architecture and Architectural Stonework of the Mediaeval Castle of Vrbovec near Hum na Sutli

Izvorni znanstveni rad
Srednjovjekovna arheologija

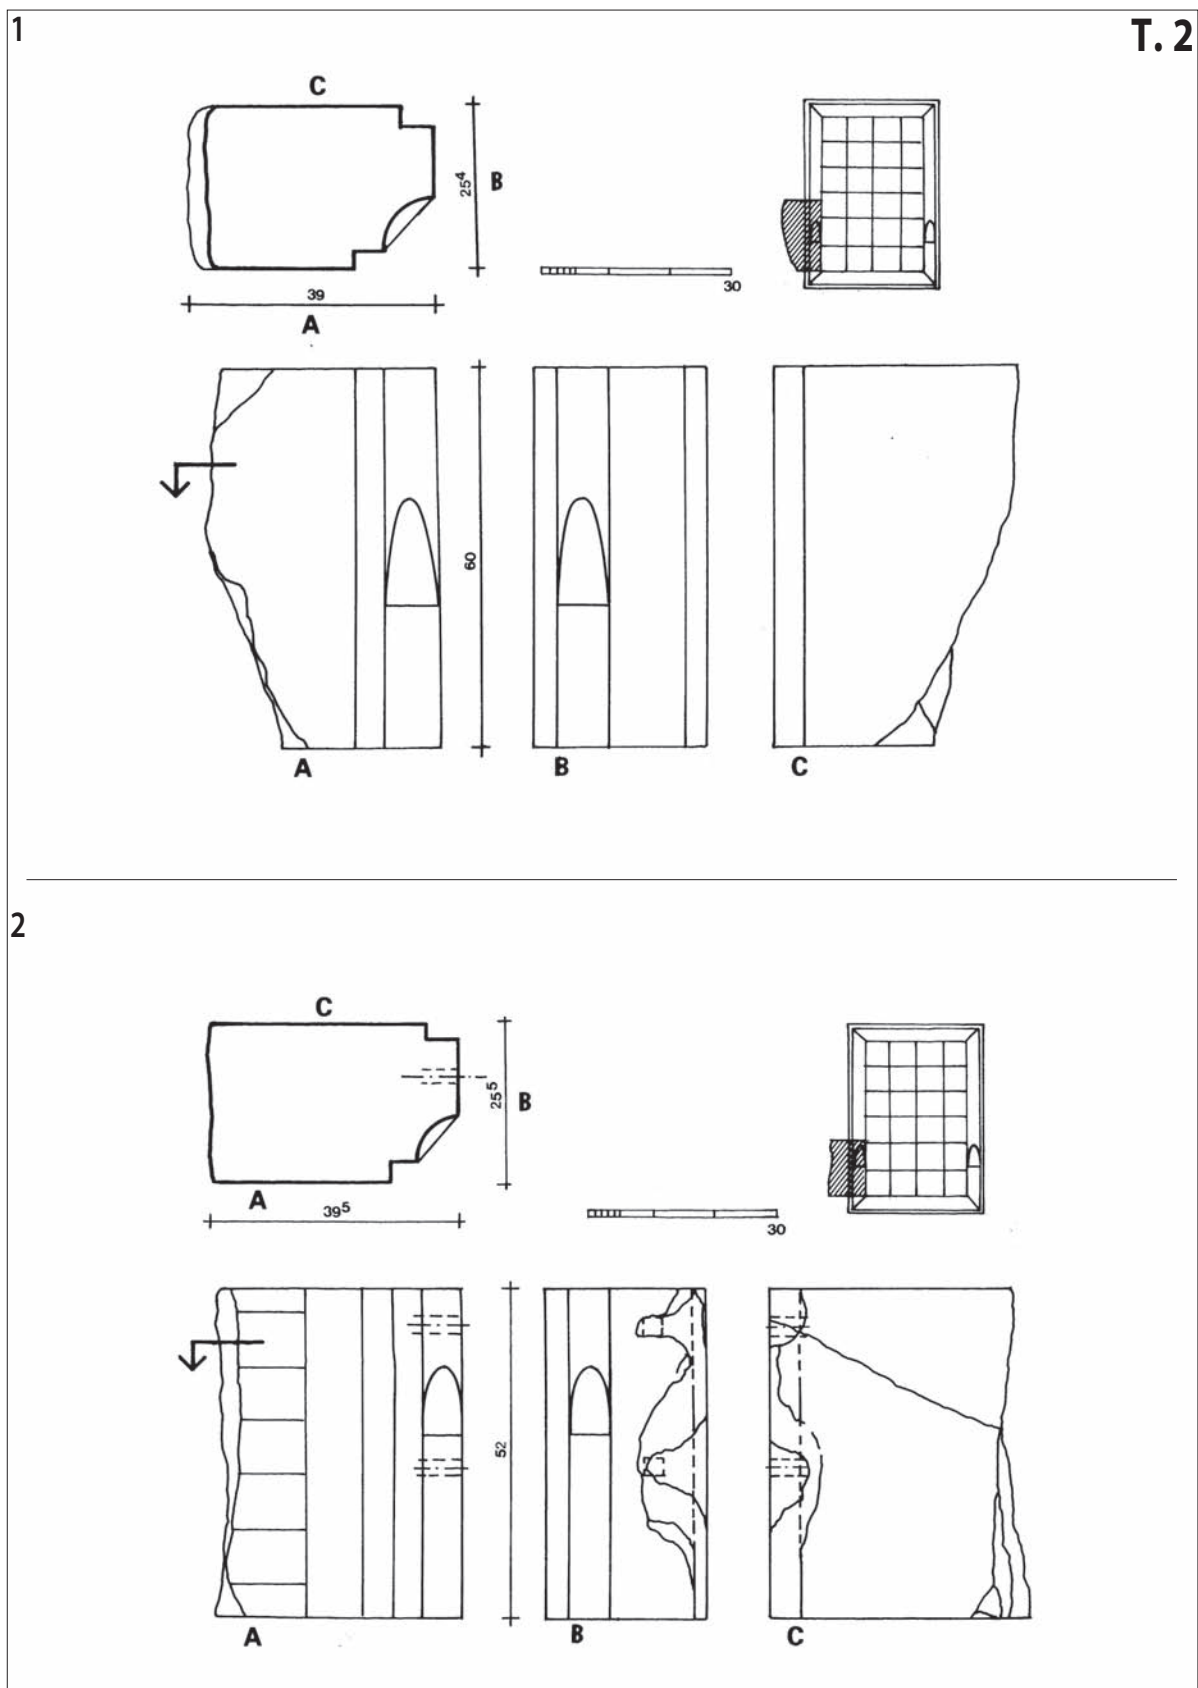
T. 2 Prozori srednje veličine – 1: PN 264; 2: PN 426 (crtež: Z. Horvat)
 Pl. 2 Medium-sized windows – 1: SF 264; 2: SF 426 (drawing: Z. Horvat)

pronađen u dvorištu burga, dok je PN 426 pronađen izvan jezgre burga, istočno od sjeveroistočne prostorije palasa (plan 1, sl. 5). Ulomak PN 426 je posebno zanimljiv zbog tragova bojanja pročelja bijelom i oker bojom. Prozor je nekada imao ugrađenu željeznu rešetku, koja je nasilno izvađena (T. 2:2, sl. 6).
