Petrophysical Analyses of Rock Construction Materials from a Roman Rural Settlement in Podšilo Bay on Rab Island (North-East Adriatic, Croatia)

Source / Izvornik: **Materials**, 2024, 17

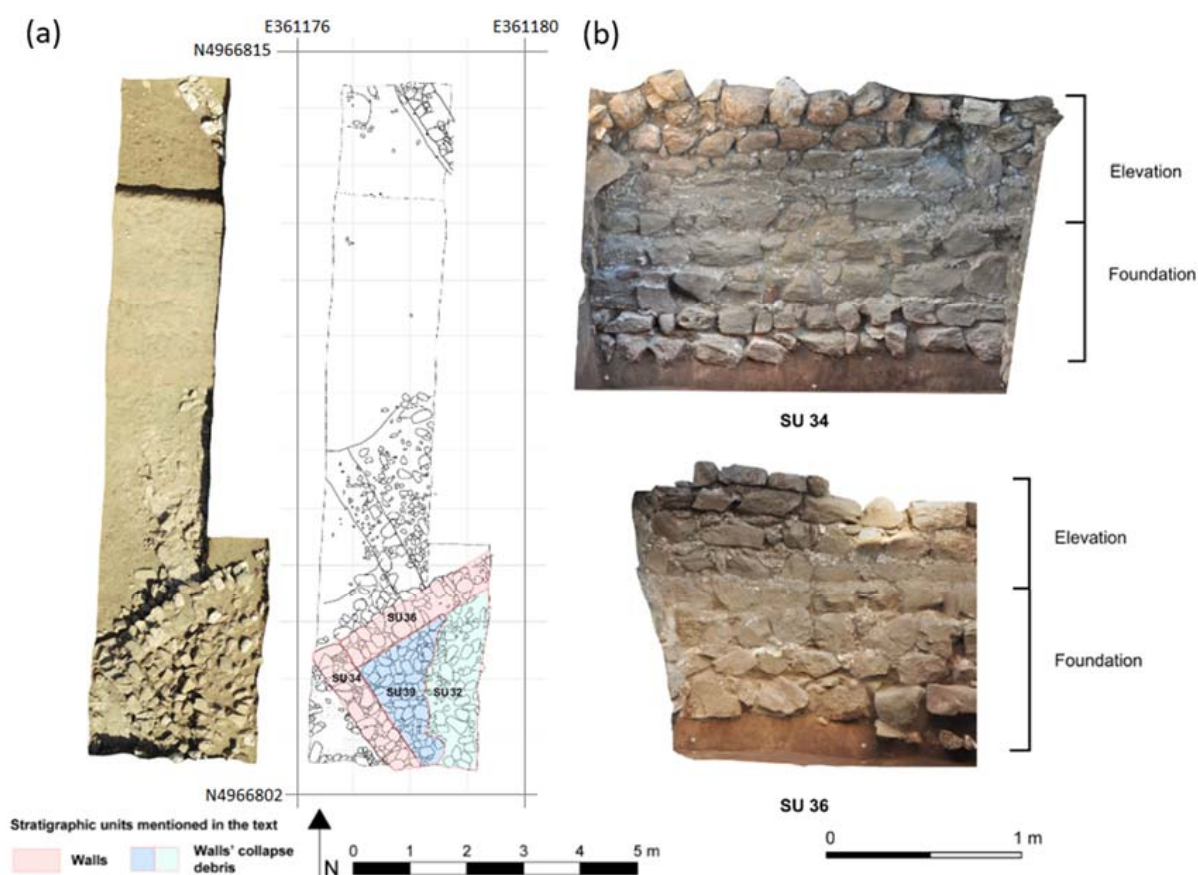
Figure 4. Excavation of the Roman structures at Beli grad. (a) Photograph and map of the trench with marked archaeological layers (drawing by K. Rabięga, modified), (b) cleared part of the preserved internal walls SU 34 and SU 36.

The material for petrophysical and endurance research was collected during excavation in Trench 2 in the Beli grad area of Podšilo Bay (Figure 4a,b). The trench was aimed to explore parts of the eastern wing of a building of probable residential use. Part of the stratigraphy in the southern part of Trench 2 comprised a thick layer of rubble collapsed from the adjacent walls—SU 34, 36. The foundation of these walls was mostly constructed with irregular, medium-sized blocks of sandstone and limestone, bound with lime mortar only in their upper part. The wall structure consists of two leaves built of roughly worked sandstone and limestone blocks, joined by lime mortar so that they form regular rows of various heights. The wall core consists of smaller stones bound together with mortar. Walls SU 34 and SU 36 were probably the internal walls of the building (Figure 4b).

Stone samples were collected from SU 32, SU 36, and SU 39 (Figure 4a). SU 32 constitutes the upper part of the destruction debris mixed with soil, SU 36 is the wall extending from NE to SW in the trench from which a loose stone was extracted, while SU 39 is another layer of collapsed stones that lies below SU 32, roughly mixed with soil.

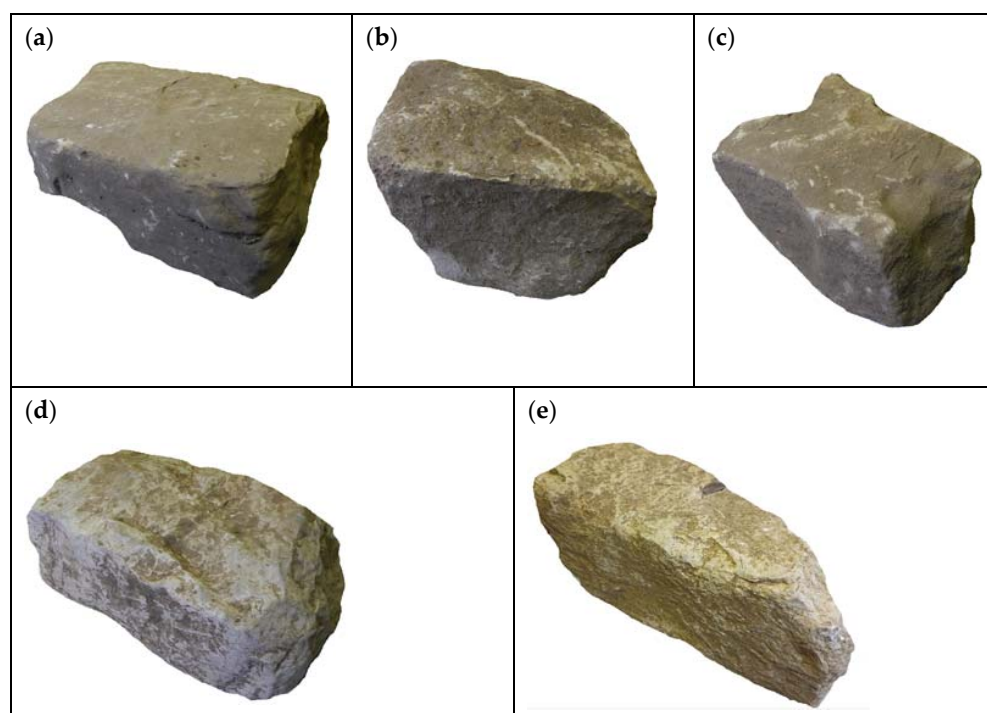
Figure 6. Stone blocks selected for further analysis. (a) Type LS_1, dark-grey fine-grained sandstone; (b) type LS_3, light-brown medium-grained sandstone; (c) type LS_6, light grey fine-grained sandstone; (d) type LL_7, dark grey mudstone; (e) type LL_10, grey sparitic limestone; LS (Lopar Sandstone), LL (Lopar Limestone).

Three lithological types of sandstones were distinguished (Figure 6). The studied stone blocks mainly had rounded edges. Macroscopically, for the fresh fracture in sample LS_1, they were dark grey with a low-intensity and short-lived reaction with 10% hydrochloric acid, in sample LS_3—light brown with an intense and long-lasting reaction with 10% hydrochloric acid, while in sample LS_6—light grey with the most intense reaction with hydrochloric acid. The reaction occurred with both the grains and the binder. Based on the grain size (Figure 6a–c), the rock types were classified as medium-grained (LS_3) and fine

Macroscopically, two lithological types of limestone were distinguished (Figure 6): dark grey LL_7 with an intense but short-lived reaction with 10% hydrochloric acid, and grey LL_10 with an intense and long-lived reaction with 10% hydrochloric acid. Figure 6 clearly shows the rounded edges of the stone blocks. Optical microscopy observations show that, according to the classification by Folk [35,36], the rock types include mudstone (LL_7) and sparitic limestone (LL_10), whose matrix is intersected with veins of coarse crystalline calcium carbonate. In both cases, numerous small bivalve and foraminifera shells were observed in thin sections (Figure 7d,e). SEM images show a grey background, which, according to the chemical analysis, is composed entirely of calcium carbonate. SEM-EDS analysis revealed average oxygen contents at 28.7 and 28.5 percent and calcium contents of

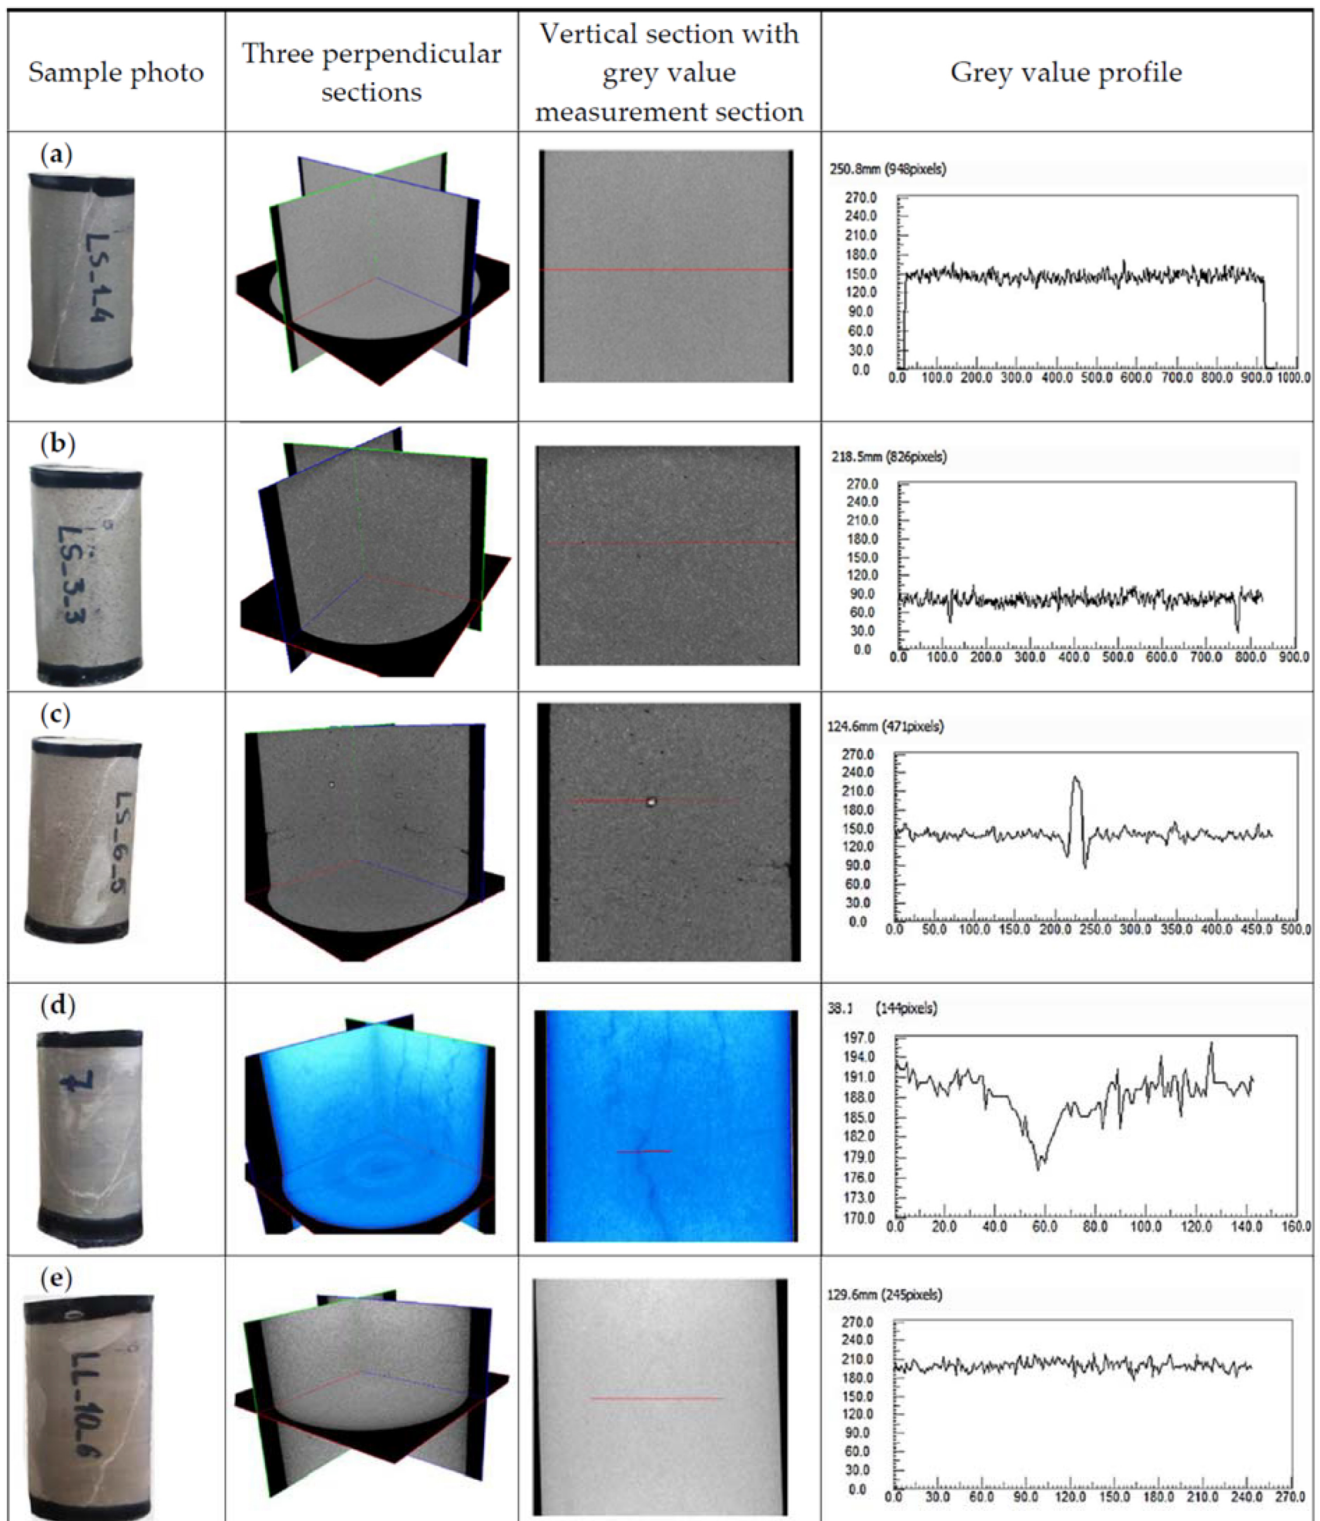
Figure 8. Microtomography images with grey value profiles for (a) type LS_1, (b) type LS_3, (c) type LS_6, (d) type LL_7, (e) type LL_10. — section line.

An image analysis of sample LS_1 showed no structural defects (Figure 8a). The entire stone was homogeneous with regard to grain size. Due to the size of individual grains being close to the imaging resolution, it was not possible to observe their details. To complement this magnification range, a SEM analysis was used, which is very suitable for such type of study (despite the small area of recognition, it provides a detailed identification of the grain characteristics)—Figure 8a. The porosity is very low, about 0.02%, and comprises pores with equivalent diameters in the range of 1.5–124.5 μm (about 97%).

The image of sample LS_3 is very similar to that of sample LS_1. The rock has a compact structure with a low porosity of about 0.08% and with a predominance of pores with an equivalent diameter of up to 0.1 mm (about 73%). The density analysis performed in the cross-section showed very high homogeneity (Figure 8b).

The XCT scan of the last sample in the sandstone group (LS_6), except for the evenly dispersed porosity, showed the presence of small voids in the sample volume, which may affect the strength. Besides voids, the presence of grains composed of very-high-density minerals was observed as white “grains” in microtomographic images (Figure 8c).

The 3D image of limestone LL_7 reflects the internal structure of the sample, where the weakness areas (depicted with a darker colour) are identified in three perpendicular sections—they most likely represent fracture/gap areas filled with secondary mineralization. These zones of weakness are characterised by quasi-parallelism, and their course is not straight. The degree of weakening of the rock’s solid fraction may correspond to the grey value profile (related to the density value) (Figure 8d).

CT images are presented with shaded grey or black colours for low CT-values and light grey or white colours for high CT-values in all subsequent shaded grey colours. The total number of levels in these colours is 256. It is well known that this CT-value is linearly related to the material density [37]. The grey value profile in Figure 8 shows the distributions of CT-values along exemplary lines in all specimens, showing the relative density variance of the analysed materials.
